Re: Erin Heights Golf Course - Erin - Arborist Report and TPP

Arborist Report  
&  
Tree Protection Plan

Erin Heights Golf Course  
Erin, ON

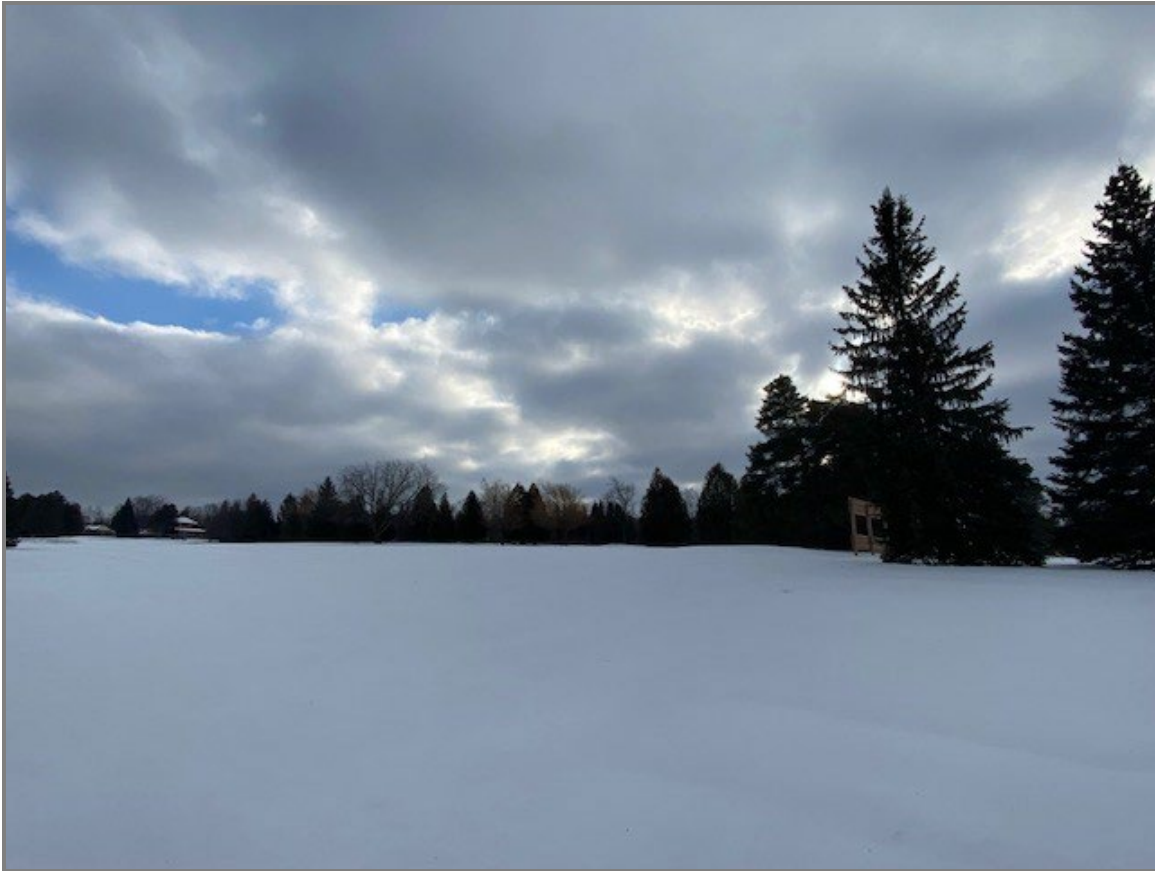
Photo #1: Trees no. 315-323 looking south.

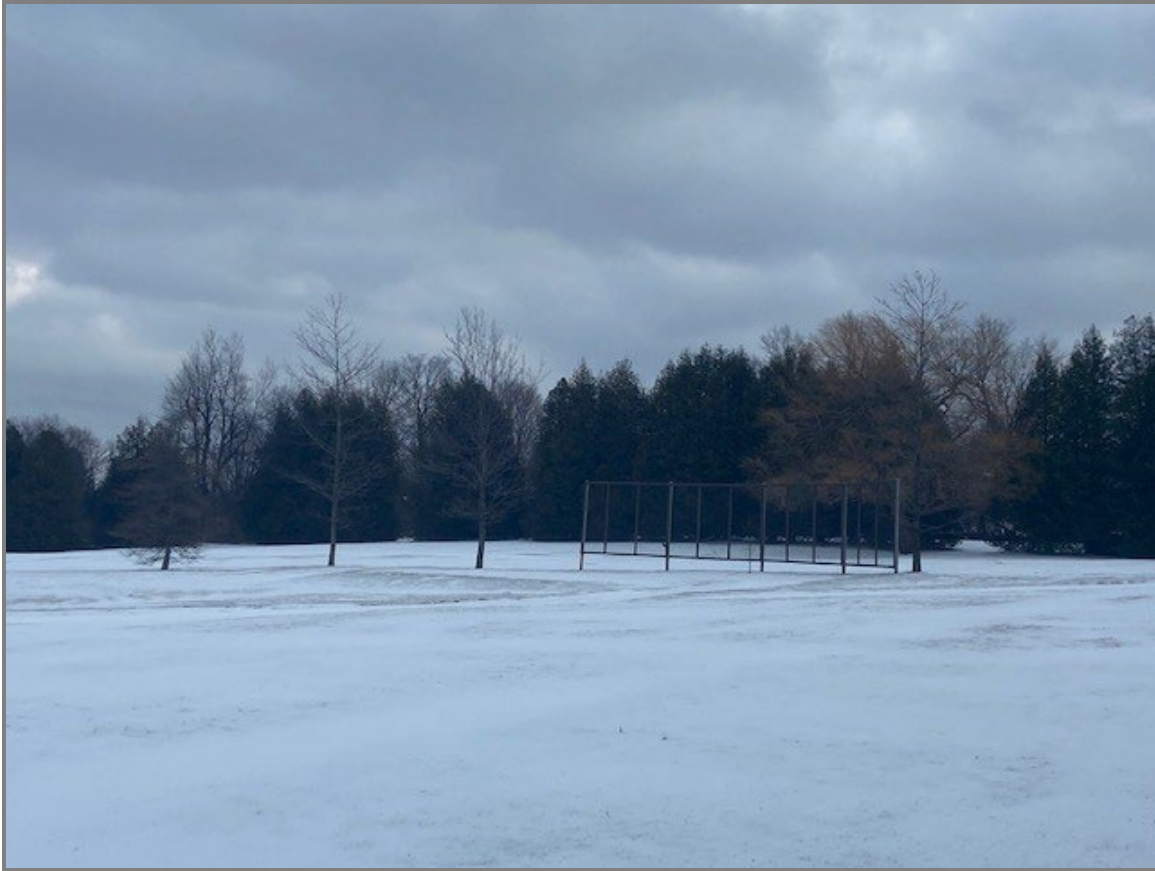
Photo #3: Trees no. 347-351 looking southeast.

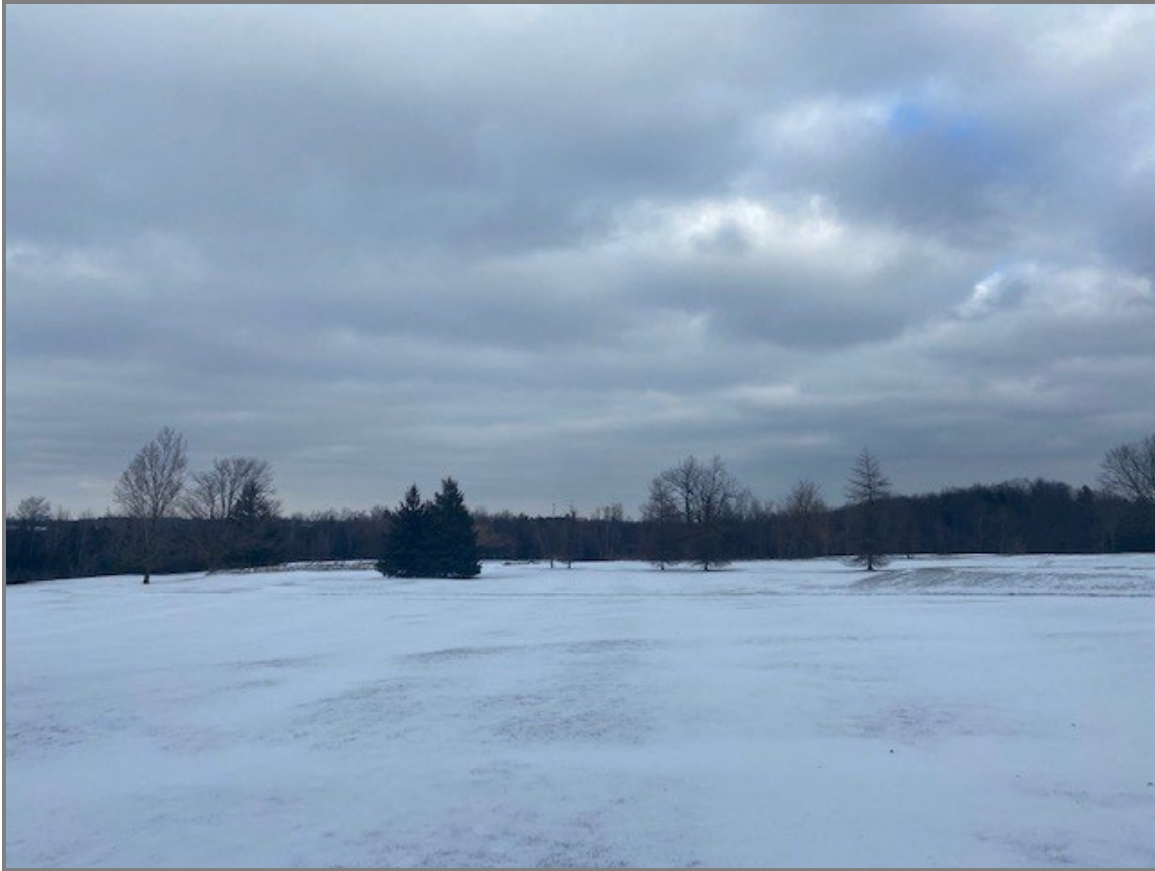
| Tree # | Species<br>Common Name<br>(Biological Name) | D<br>B<br>H<br>(cm) | Condition | Category | Comments | Recommendation | M<br>T<br>P<br>Z<br>(M) |
|---|---|---|---|---|---|---|---|
| 360 | Black Cherry<br><i>Prunus serotina</i> | 63 | P | 1 | - multiple limb failures, large deadwood, in decline, split<br>- in conflict with proposed grading | R | |

Photo #4: Trees no. 355-362 looking northeast.

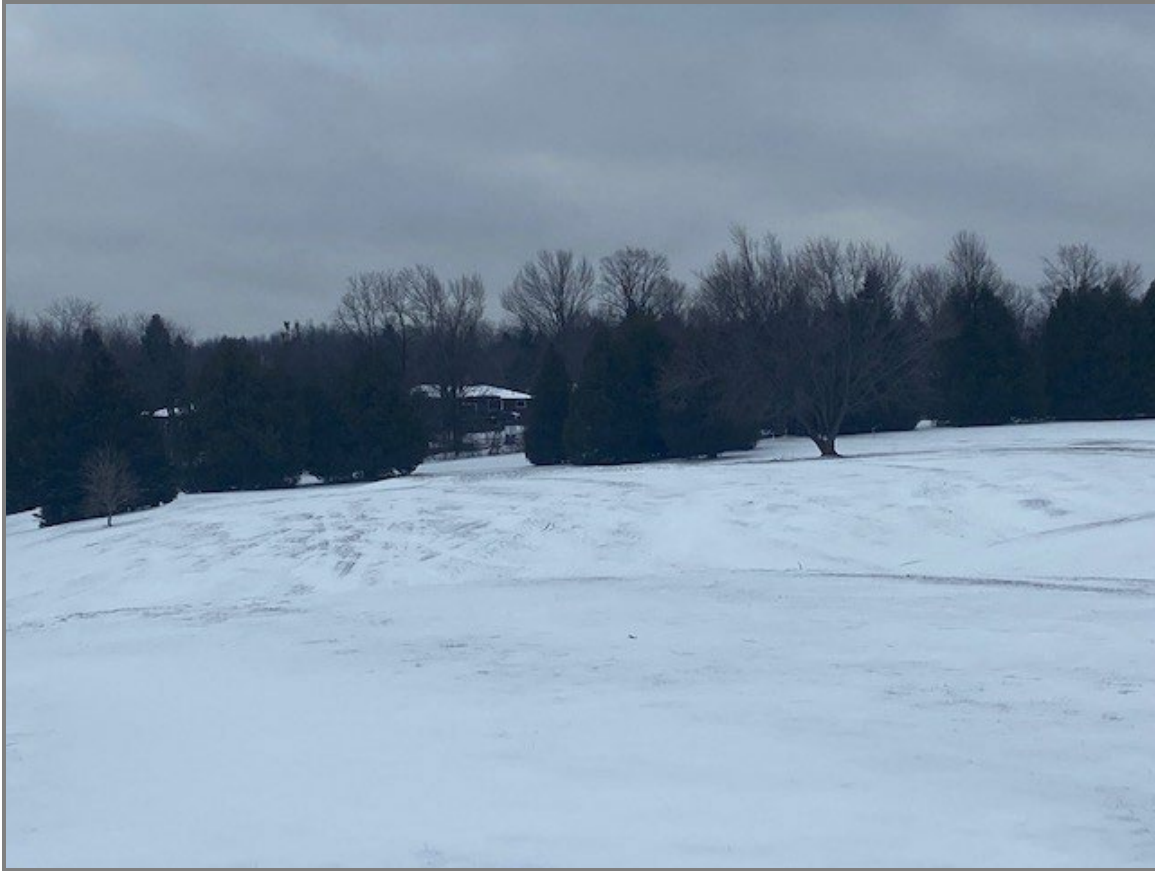
| Tree # | Species<br>Common Name<br>(Biological Name) | D<br>B<br>H<br>(cm) | Condition | Category | Comments | Recommendation | M<br>T<br>P<br>Z<br>(M) |
|---|---|---|---|---|---|---|---|
| 967 | Eastern White Cedar<br><i>Thuja occidentalis</i><br>(54) | 24-<br>86 | F-<br>G | 1 | - in conflict with proposed grading | R | |

Photo #5: Trees no. 363-364 and 967 looking southeast.

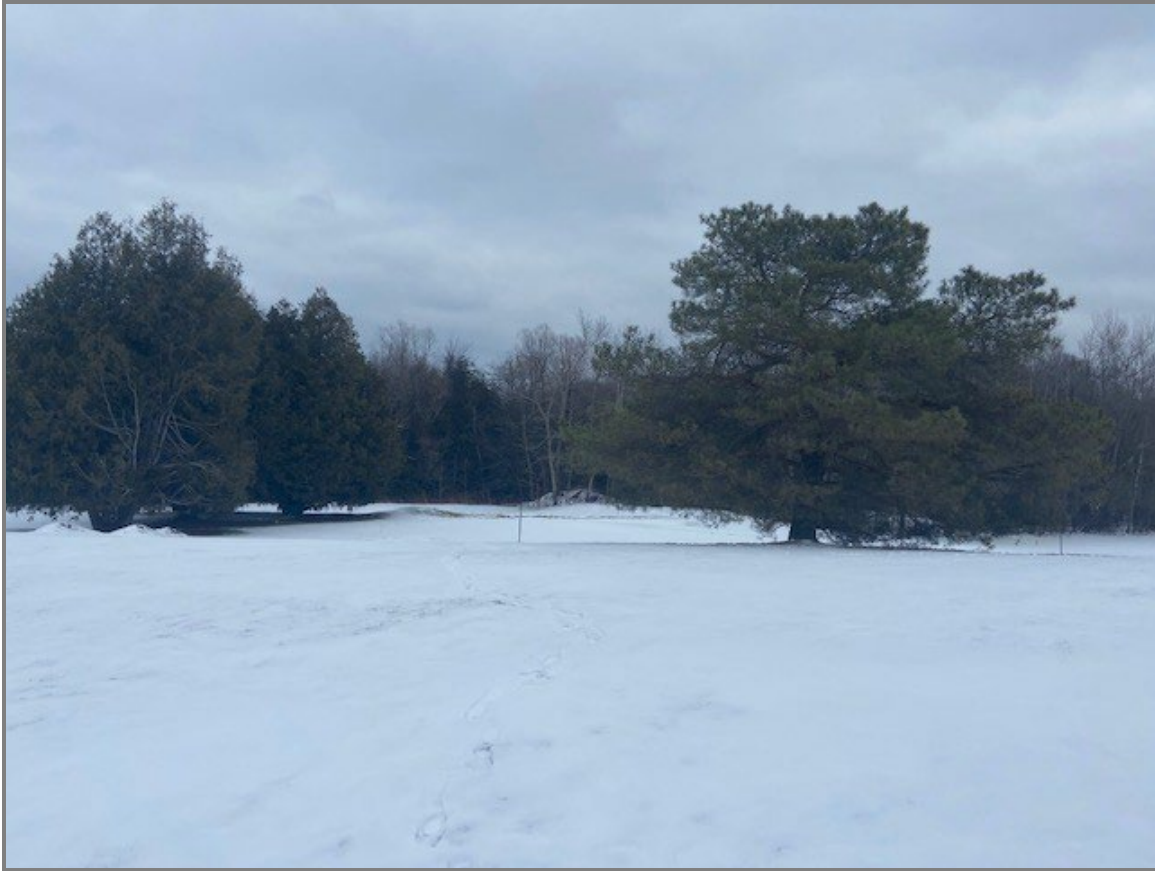
Photo #6: Trees no. 365-366 and N62 looking northeast.
