Erosion Mitigation Assessment West Credit River (Erin Branch)

Town of Erin, Wellington County

Report Title: Erosion Mitigation Assessment
Credit River Tributary
Town of Erin, Wellington County

Project Number: PN21060

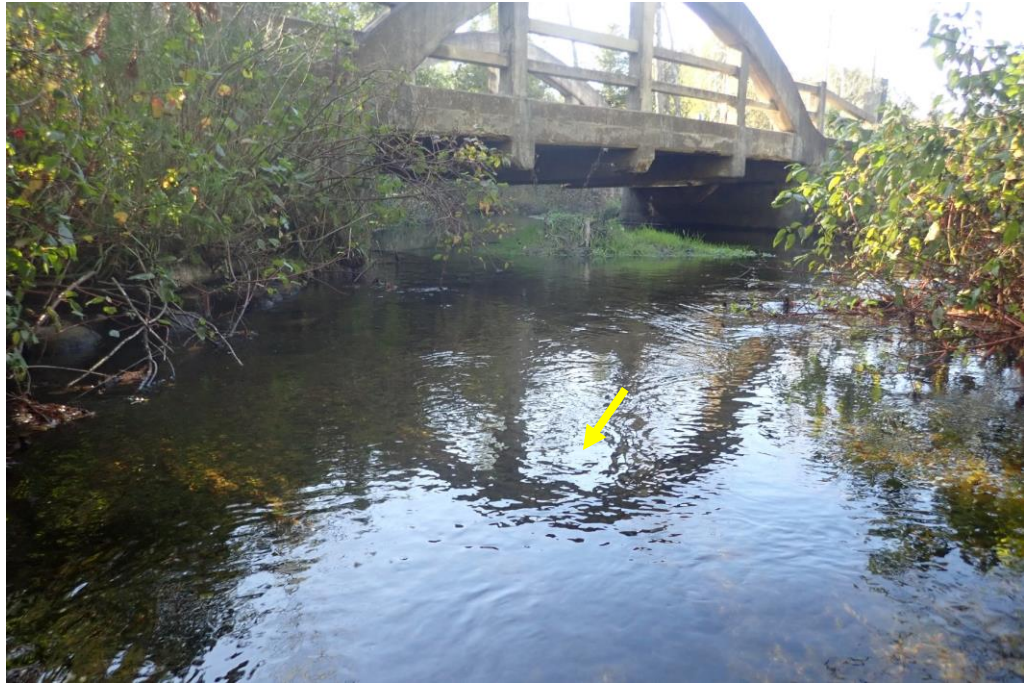
Photo 1
Reach TCR-1

Photo taken facing upstream at the 8th Line bridge crossing. The yellow arrow denotes flow direction.

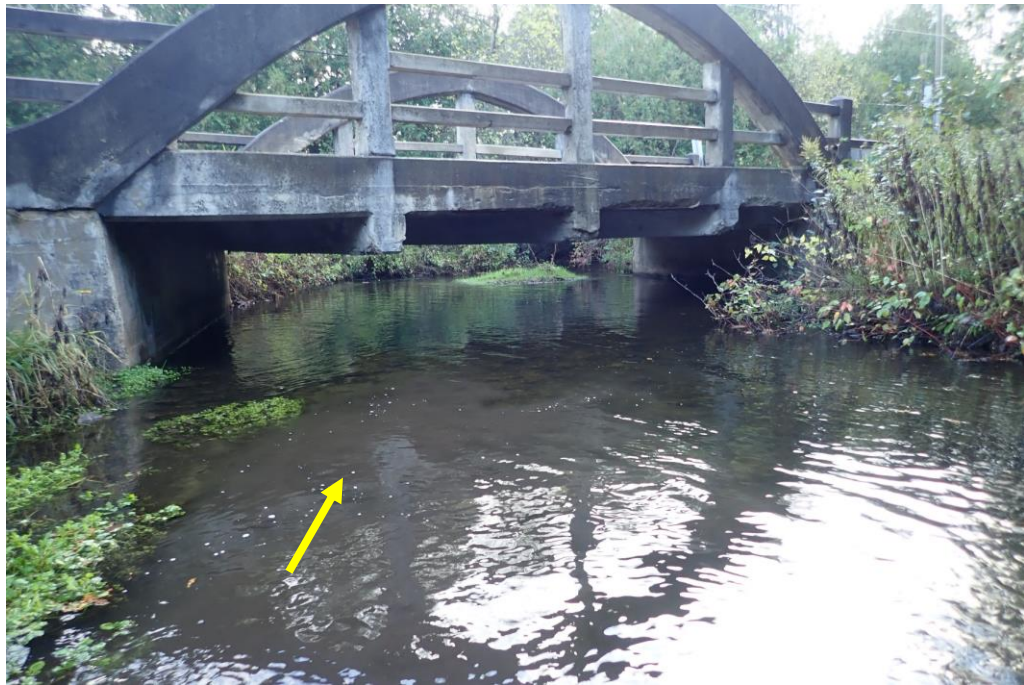
Photo 2
Reach TCR-1

Despite the wetted width of the channel extending to both footings, no significant evidence of instability was observed for the 8th Line bridge crossing.

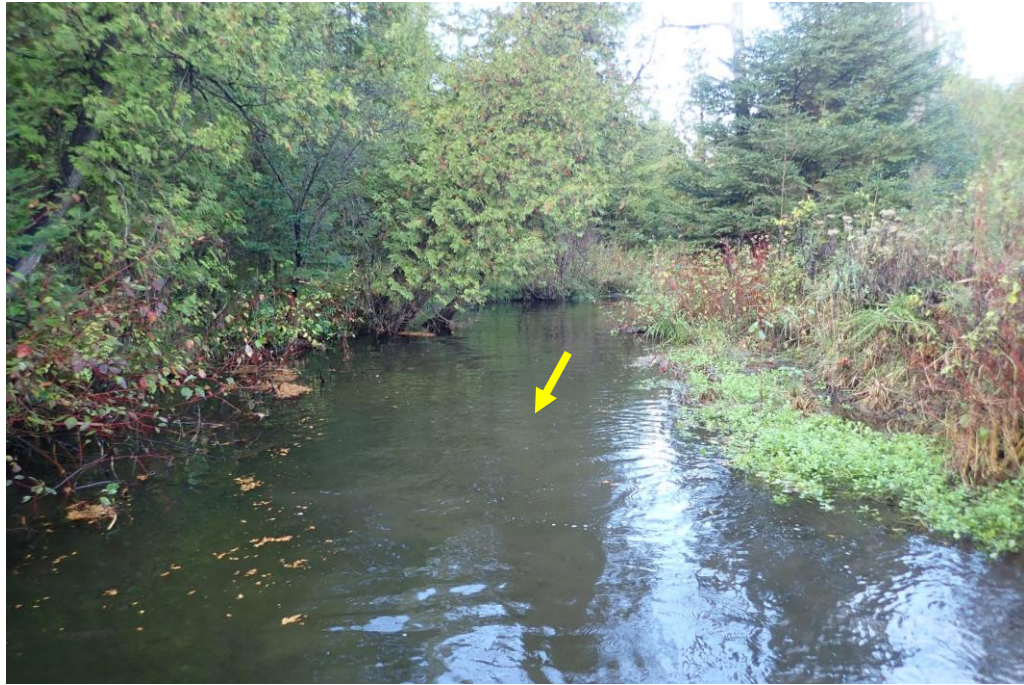
Photo 3
Reach TCR-1

Directly upstream of the 8th Line bridge is a slow-flowing run feature. The right banks contain thick, stabilizing vegetation whereas the left bank contains mostly grasses.

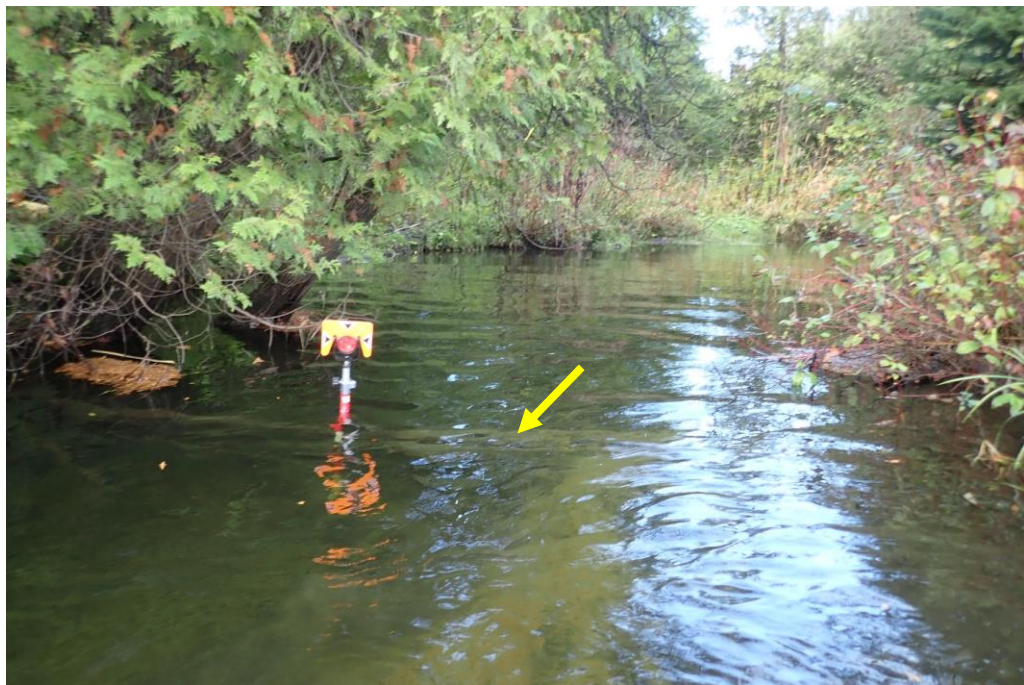
Photo 4
Reach TCR-1

Large, deep scour pools are common throughout the reach, and are often associated with woody debris structures.

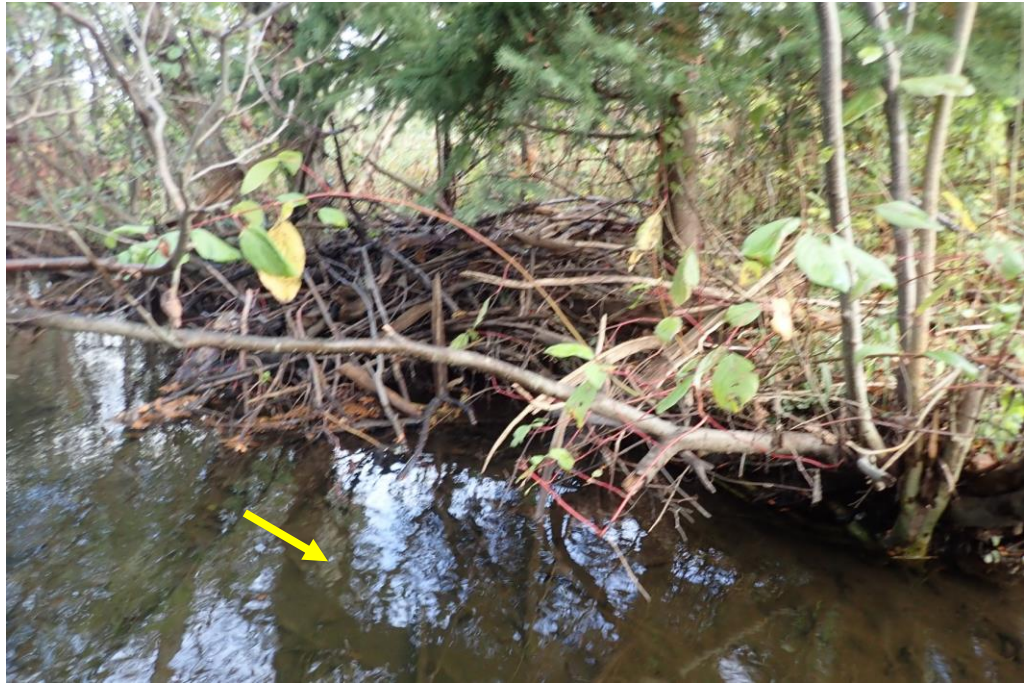
Photo 7
Reach TCR-1

Exposed roots were predominantly from mature trees. Minor bank undercutting was observed in several locations.

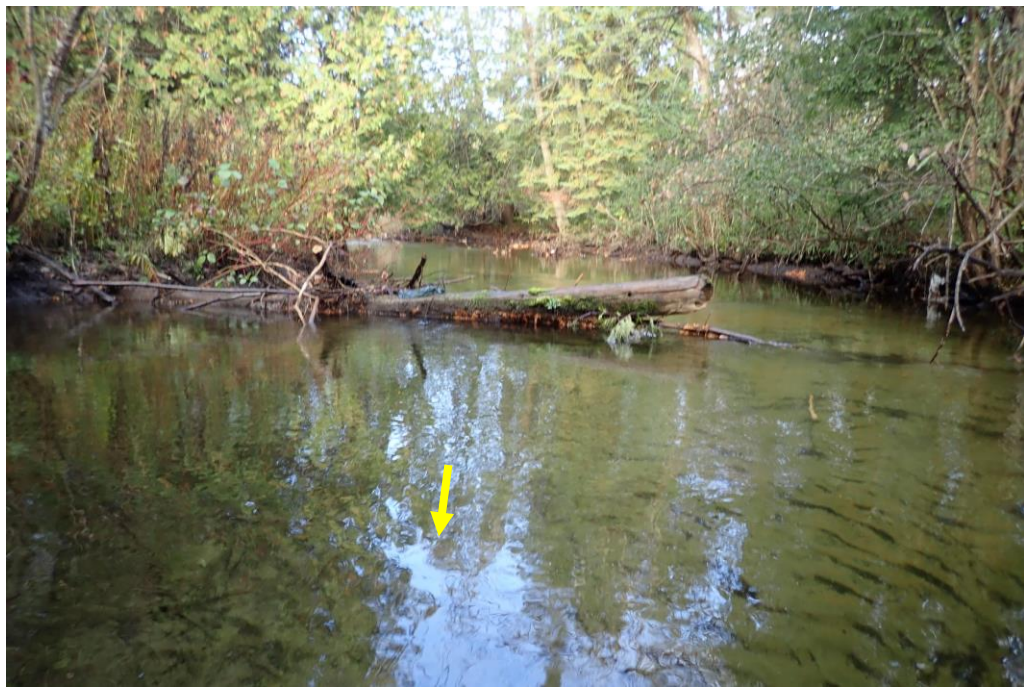
Photo 8
Reach TCR-1

The channel substrate is predominantly sand and silt.

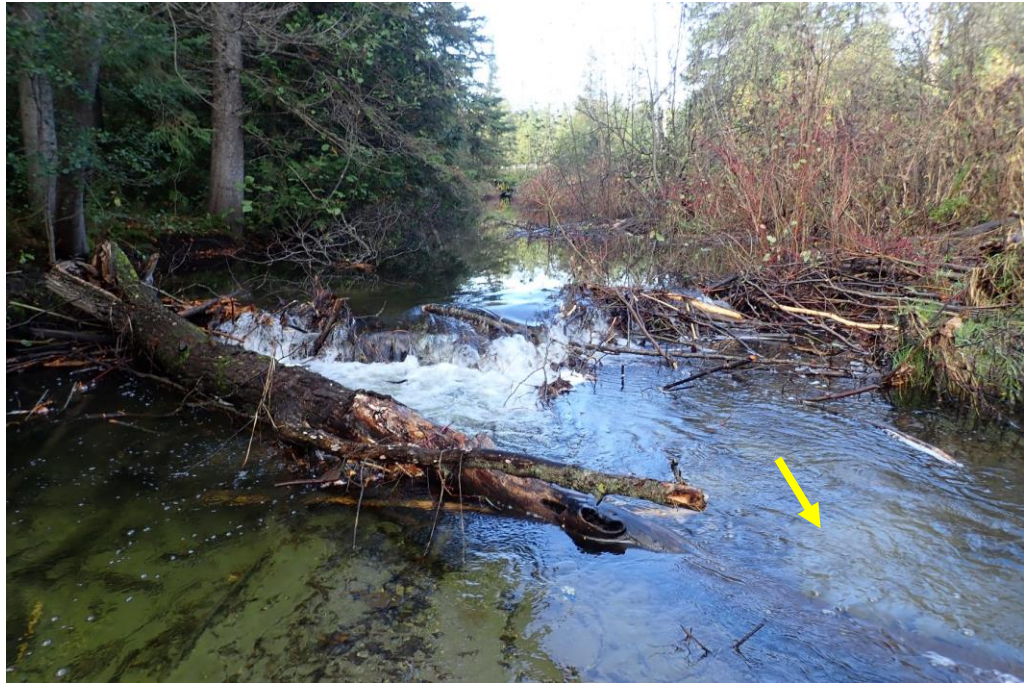
Photo 9
Reach **TCR-1**

A small beaver dam was observed in the upstream portion of the reach.

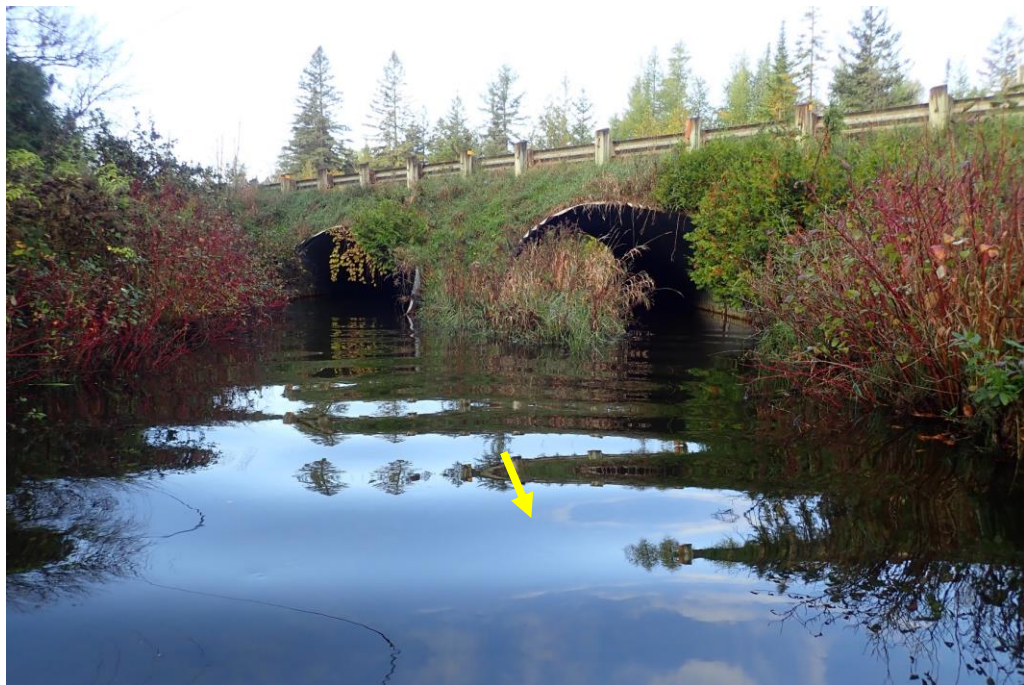
Photo 10
Reach **TCR-1**

The 17th Sideroad crossing defines the upstream extent of Reach **TCR-1**.
