# Erosion Mitigation Assessment West Credit River (Erin Branch)

**Town of Erin, Wellington County**

June 8, 2022  
PN21060

Report Title: Erosion Mitigation Assessment  
Credit River Tributary  
Town of Erin, Wellington County

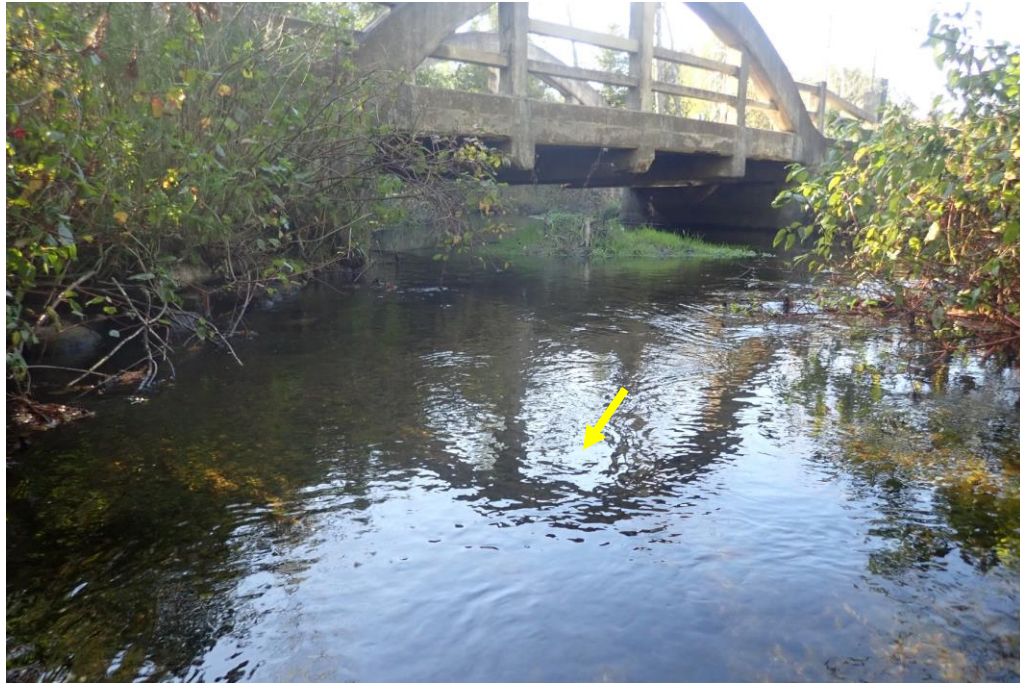
Photo 1  
Reach **TCR-1**

Photo taken facing upstream at the 8<sup>th</sup> Line bridge crossing. The yellow arrow denotes flow direction.

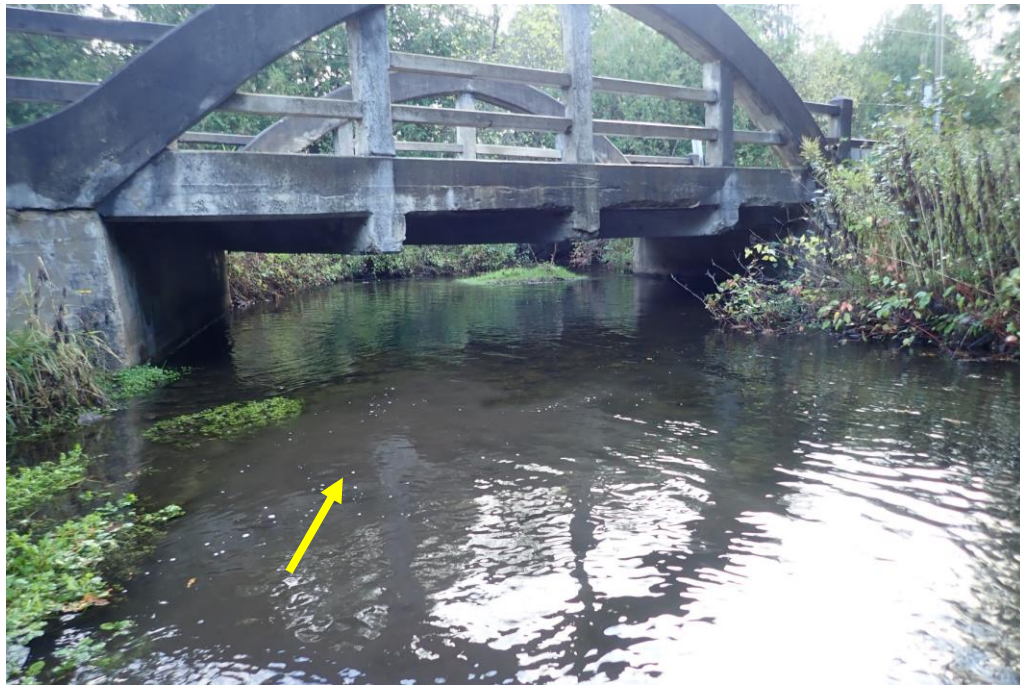
Photo 2  
Reach **TCR-1**

Despite the wetted width of the channel extending to both footings, no significant evidence of instability was observed for the 8<sup>th</sup> Line bridge crossing.

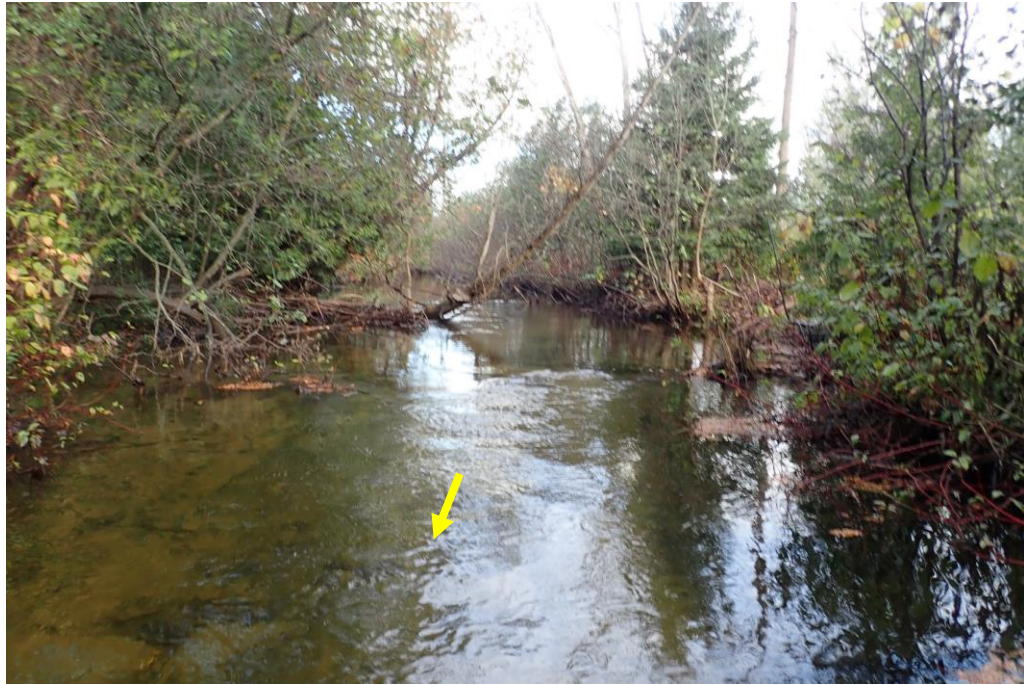
Photo 5  
Reach **TCR-1**

Shallow, run-type sections with rippled flow are intermittent throughout the reach.

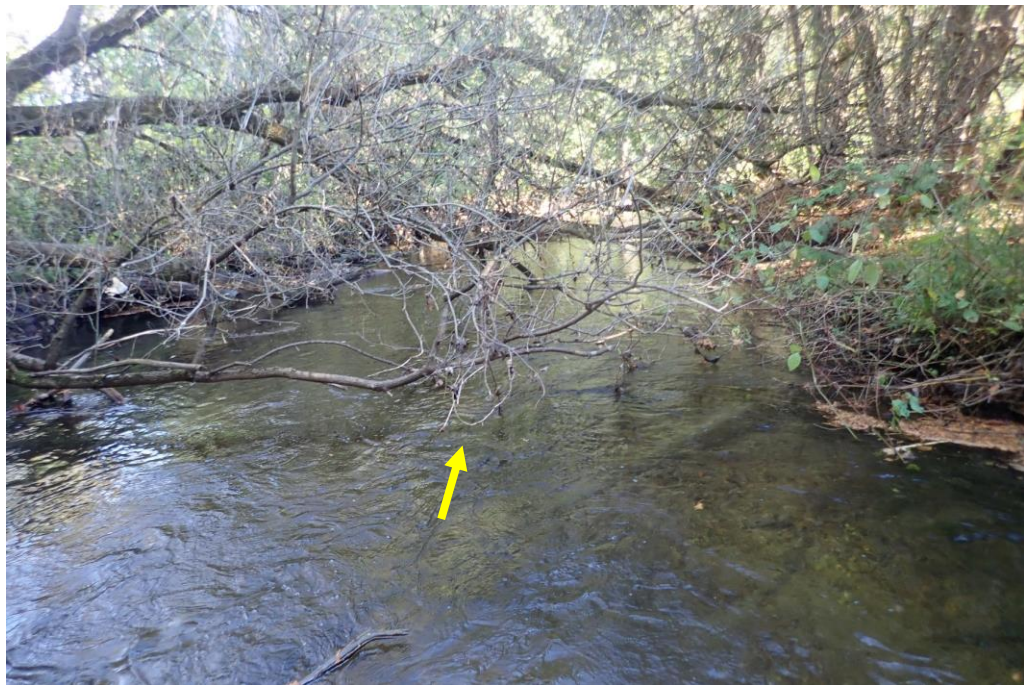
Photo 6  
Reach **TCR-1**

Overhanging mature trees, large woody debris, and exposed roots are common.

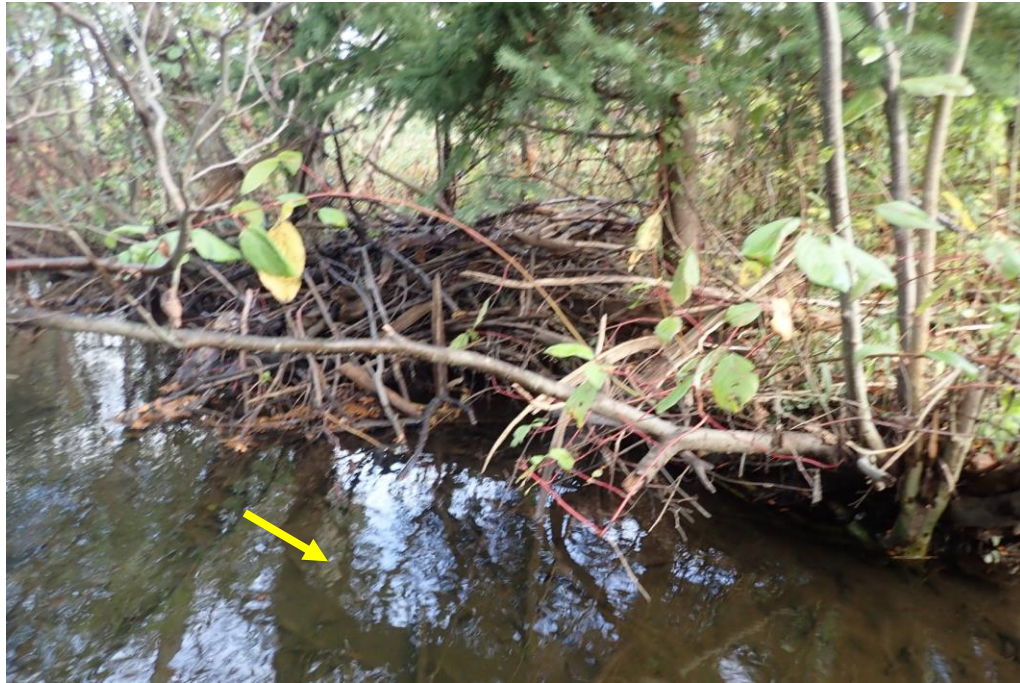
Photo 7  
Reach **TCR-1**

Exposed roots were predominantly from mature trees. Minor bank undercutting was observed in several locations.

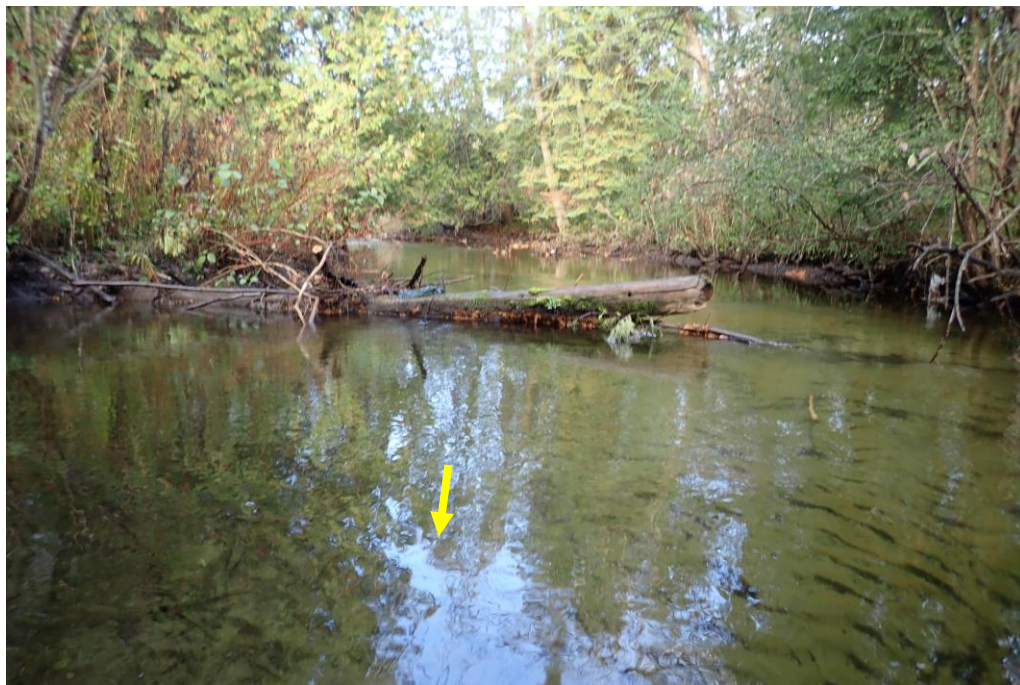
Photo 8  
Reach **TCR-1**

The channel substrate is predominantly sand and silt.
