**Reference Number: T20828**

**Subject: Test Pit Investigation  
Proposed Residential Development  
Erin Property  
5520 8<sup>th</sup> Line, Erin, Ontario**

Test Pit Investigation

Erin Property

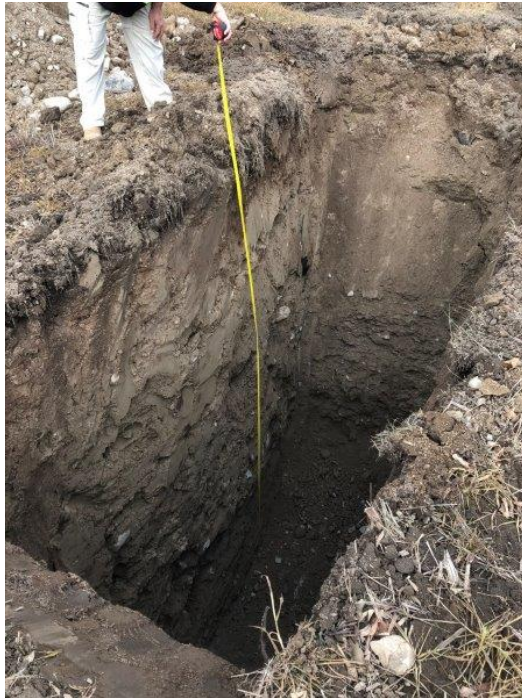
| Test Pit No. | Elevation (m) | Approx. Depth (m) | Soil Description |
|---|---|---|---|
| 1 | 454.60 | 0 - 0.2<br>0.2 - 0.5<br>0.5 - 5.0 | <p>Topsoil<br/>Organic Stained Silty Sand with some gravel, damp<br/>Brown Silty Sand Till, with some silt seams, cobbles and boulders, damp to moist.</p> <p>Bulk Unit Weight@ -2.1 m: 2074 kN/m<sup>3</sup><br/>Natural Moisture Content: 10%<br/>Hard excavating from 2.5 m to completion depth.<br/>Test pit dry upon completion and open for 3.0 hours.<br/>No cave-in of the sides and no water seepage observed.</p> |

Photograph 1- View of excavation for TP1.

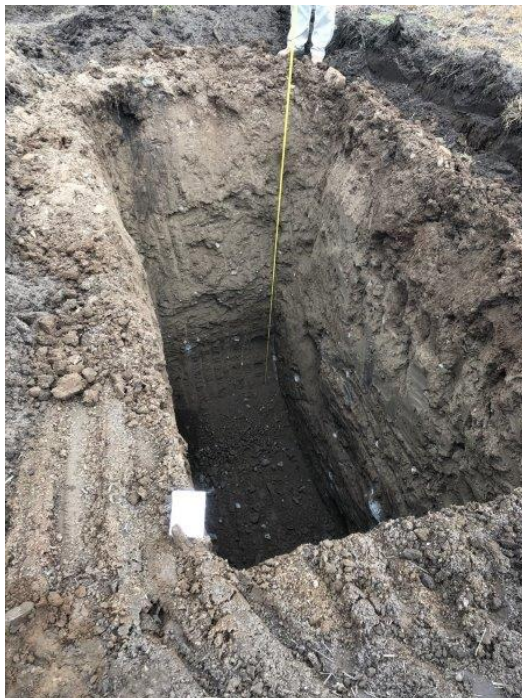
| Test Pit No. | Elevation (m) | Approx. Depth (m) | Soil Description |
|---|---|---|---|
| 2 | 447.30 | 0 - 0.2<br>0.2 - 0.5<br>0.5 - 5.0 | <p>Topsoil<br/>Organic Stained Silty Sand with some gravel and rootlets, damp to moist<br/>Brown Silty Sand Till, with some silt seams, cobbles and boulders, damp.</p> <p>Bulk Unit Weight@ -1.0 m: 2092 kN/m<sup>3</sup><br/>Natural Moisture Content: 11%<br/>Hard excavating from 2.0 m to completion depth.<br/>Test pit dry upon completion and open for 3.0 hours.<br/>No cave-in of the sides and no water seepage observed.</p> |

Photograph 2 – View of excavation for TP2.

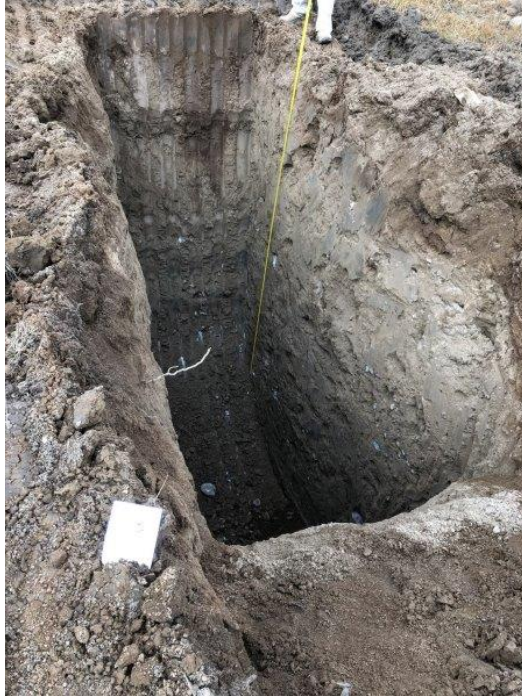
| Test Pit No. | Elevation (m) | Approx. Depth (m) | Soil Description |
|---|---|---|---|
| 3 | 435.47 | 0 - 0.3<br>0.3 - 0.8<br>0.8 - 5.3 | <p>Topsoil<br/>Organic Stained Silty Sand with some gravel, damp to moist<br/>Brown Silty Sand Till, with some cobbles and boulders, damp.</p> <p>Bulk Unit Weight@ -1.2 m: 1944 kN/m<sup>3</sup><br/>Natural Moisture Content: 13.0%<br/>Hard excavating from 2.5 m to completion depth.<br/>Test pit dry upon completion and open for 2.5 hours.<br/>No cave-in of the sides and no water seepage observed.</p> |

Photograph 3- View of excavation for TP3.

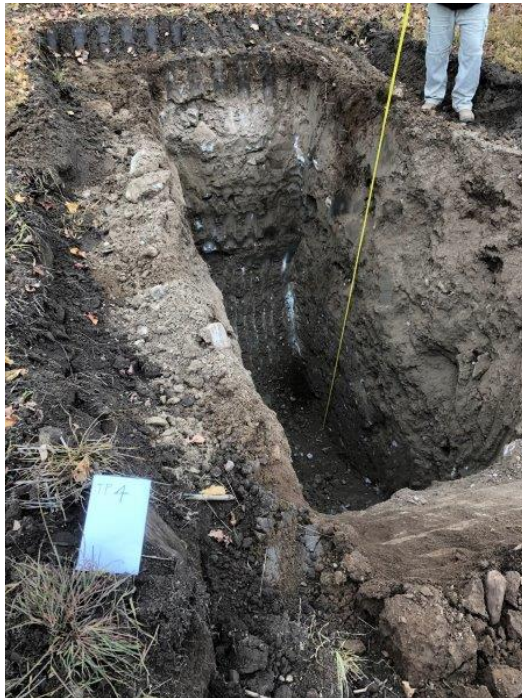
| Test Pit No. | Elevation (m) | Approx. Depth (m) | Soil Description |
|---|---|---|---|
| 4<br><br>(TP location moved ~10 m south due to existing trees). | 455.4 | 0 - 0.25<br>0.25 - 0.6<br>0.6 - 4.7 | <p>Topsoil<br/>Organic Stained Silty Sand with some grave and rootlets, damp<br/>Brown Silty Sand Till, with some silt seams, cobbles and boulders, damp.</p> <p>Hard excavating from 2.0 m to completion depth.<br/>Test pit dry upon completion and open for 2.5 hours.<br/>No cave-in of the sides and no water seepage observed.</p> |

Photograph 4 – View of excavation for TP4.

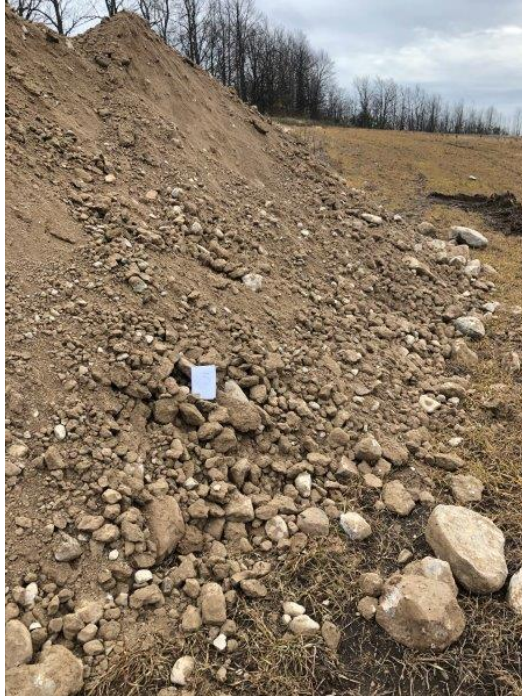
| 5 | 442.72 | 0 - 0.25<br>0.25 - 0.5<br><br>0.5 - 5.3 | Topsoil<br>Organic Stained Silty Sand with some gravel and rootlets, damp to moist<br>Brown Silty Sand Till, with some cobbles and boulders, damp.<br><br>Hard excavating from 2.5 m to completion depth.<br>Test pit dry upon completion and open for 3.0 hours.<br>No cave-in of the sides and no water seepage observed. |

Photograph 5- Excavated soils from TP5. Note large boulders in soil pile.

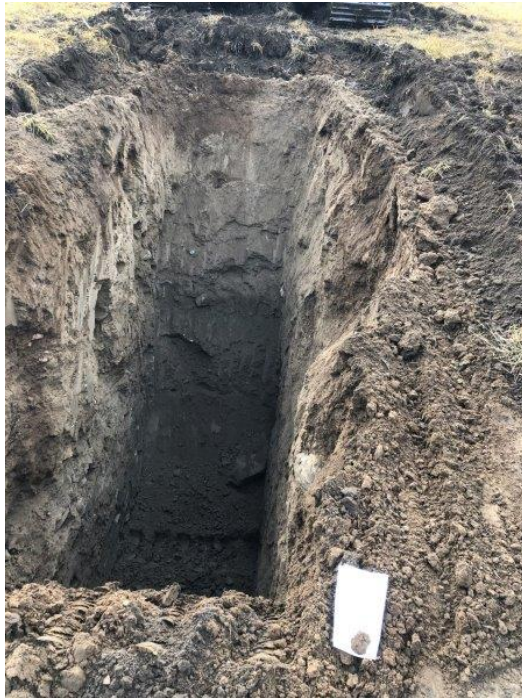
| 6 | 440.77 | 0 - 0.3<br>0.3 - 0.8<br>0.8 - 5.0 | Topsoil<br>Organic Stained Silty Sand with some gravel and rootlets, damp<br>Brown Silty Sand Till, with some silt seams, cobbles and boulders, damp.<br><br>Bulk Unit Weight@ -1.5 m: 2058 kN/m <sup>3</sup><br>Natural Moisture Content: 8%<br>Hard excavating from 4.0 m to completion depth.<br>Test pit dry upon completion and open for 2.0 hours.<br>No cave-in of the sides and no water seepage observed. |

Photograph 6- View of excavation for TP6.

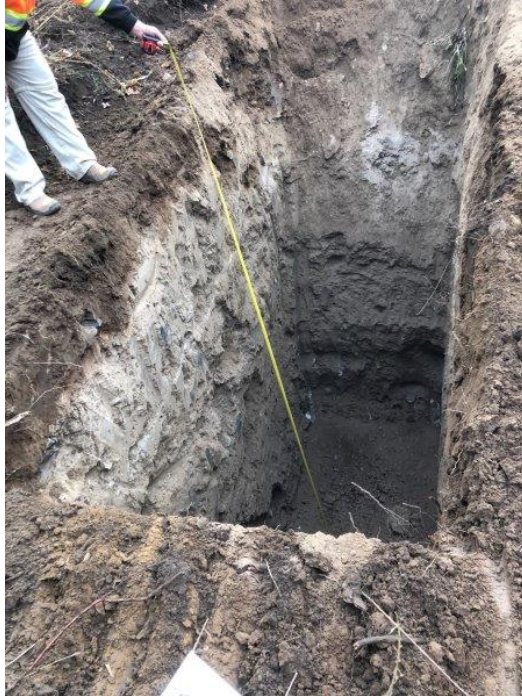
| 7 | 435.96 | 0 - 0.3<br>0.3 - 0.7<br><br>0.7 - 5.1 | Topsoil<br>Organic Stained Silty Sand with some gravel and rootlets, damp to moist<br>Brown Silty Sand Till, with some silt seams, cobbles and boulders, damp.<br><br>Hard excavating from 3.0 m to completion depth.<br>Test pit dry upon completion.<br>No cave-in of the sides and no water seepage observed. |

Photograph 7- View of excavation for TP7.

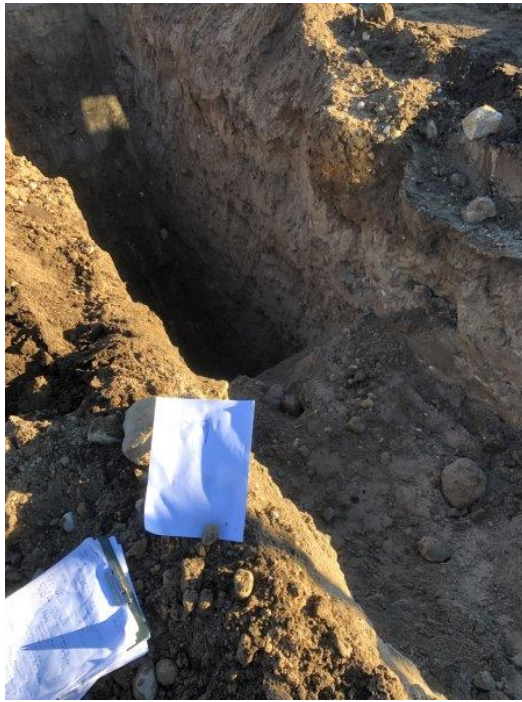
| 9<br><br>(TP location moved ~7 m south due to proximity to the existing manure pile and fence). | 435.36 | 0 - 0.3<br>0.3 - 0.7<br>0.7 - 5.3 | Topsoil<br>Organic Stained Silty Sand with some gravel, damp to moist<br>Brown Silty Sand Till, cobbles and boulders, damp.<br><br>Bulk Unit Weight@ - 1.0 m: 1916 kN/m <sup>3</sup><br>Natural Moisture Content: 10%<br>Hard excavating from 2.5 m to completion depth.<br>Test pit dry upon completion.<br>No cave-in of the sides and no water seepage observed. |

Photograph 9- View of excavation for TP9.

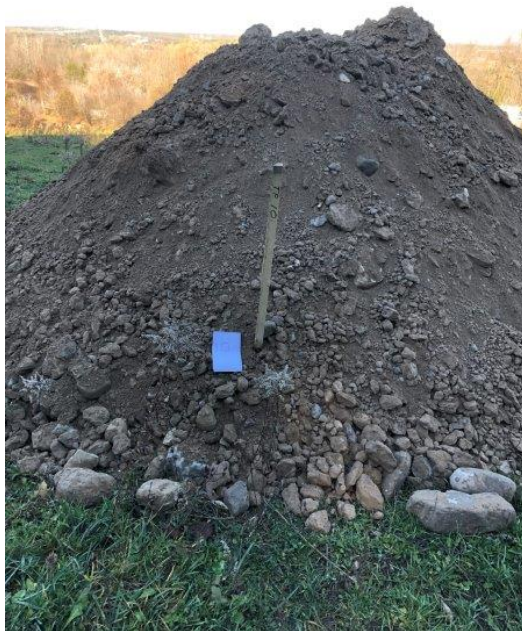
| 10 | 445.70 | 0 - 0.2<br>0.2 - 0.5<br>0.5 - 5.0 | Topsoil<br>Organic Stained Silty Sand with some gravel and rootlets, damp<br>Brown Silty Sand Till, with some cobbles and boulders, damp. |

| | | | Hard excavating from 2.5 m to completion depth.<br>Test pit dry upon completion and open for 1.5 hours.<br>No cave-in of the sides and no water seepage observed. |

Photograph 10- View of excavated soil from TP10. Note large boulders in soil pile.
