# Fluvial Geomorphology Assessment and Erosion Mitigation Analysis

**Nichol Drain**  
Elora, Ontario

Submitted:  
October 31, 2025

GEO Morphix Project No. 25002

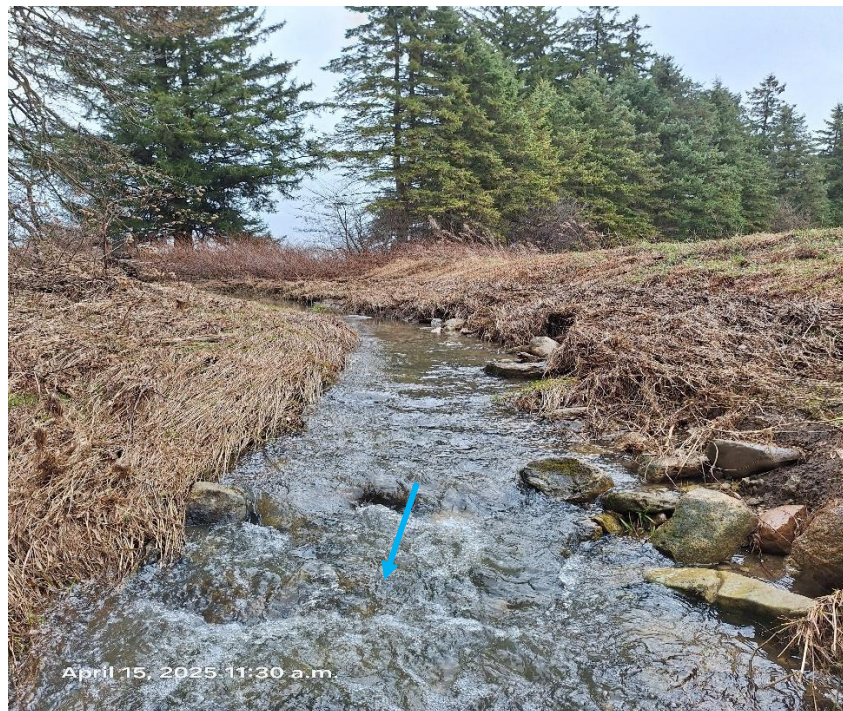
**Photo 1**

Photograph taken facing upstream from culvert at Sideroad 15. Note coarse, cobble substrate. Arrow denotes direction of flow.

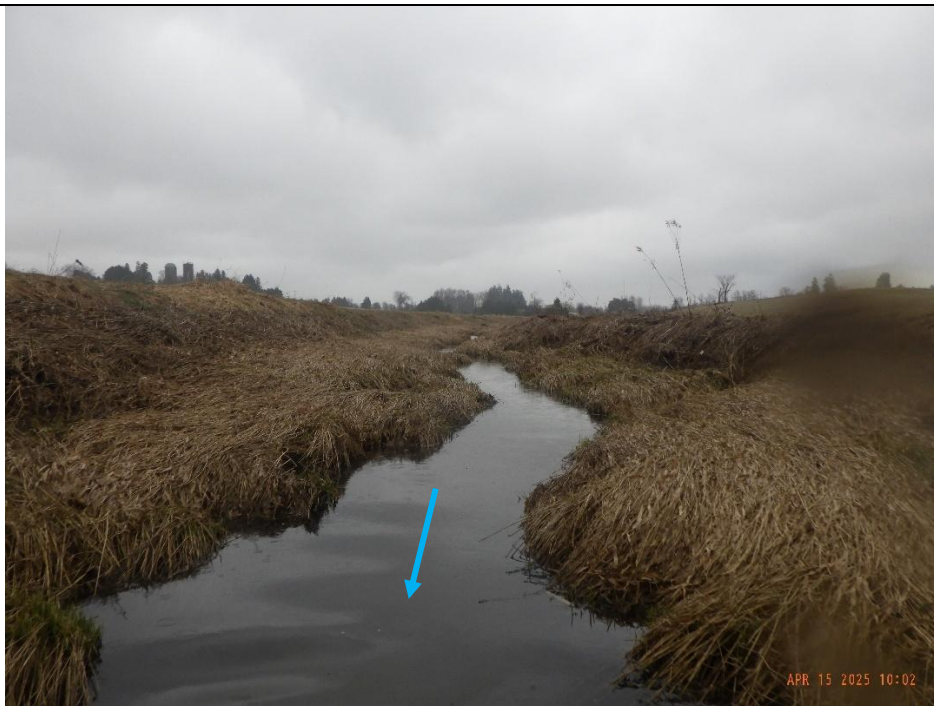
**Photo 2**

Photograph taken facing upstream. Agriculture fields extend close to channel edge on both sides of stream corridor. Arrow denotes direction of flow.

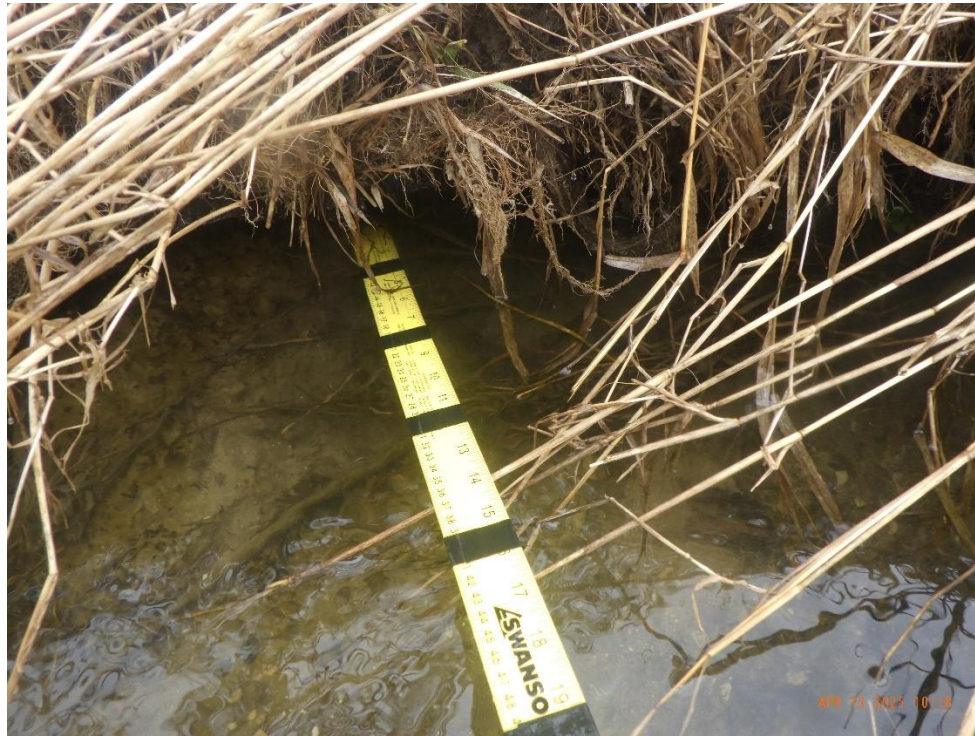
**Photo 3**

Photograph taken of the edge of channel. Slight undercutting of 0.23m. Meterstick for scale.

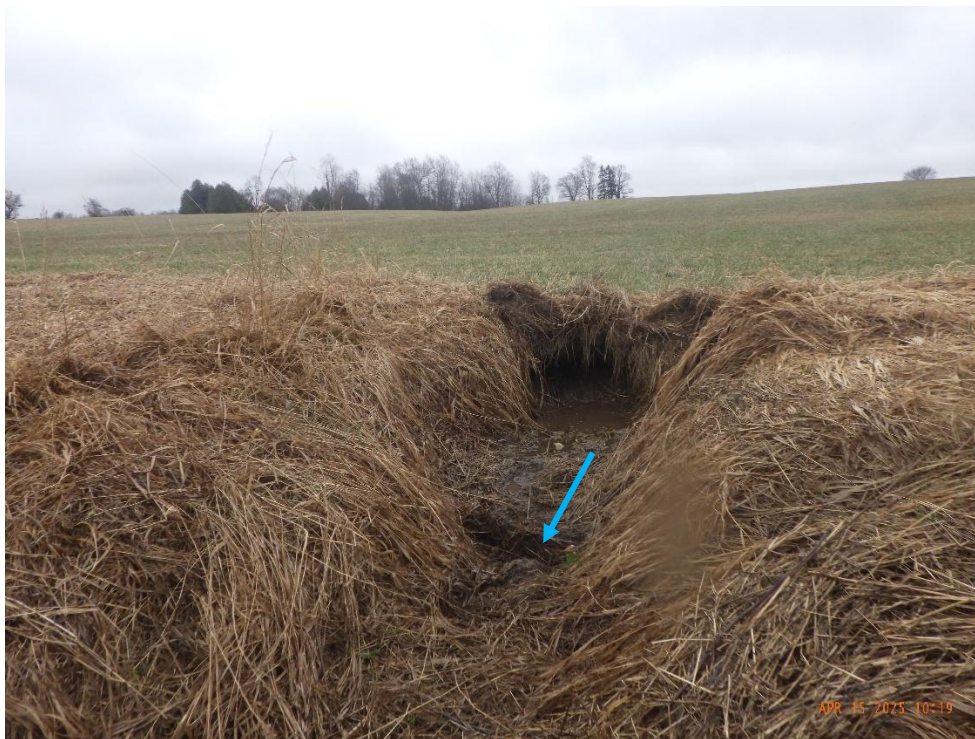
**Photo 4**

Photograph facing above the right bank highlighting a tile drain from adjacent agriculture field. The tile drain diameter was 0.14m.

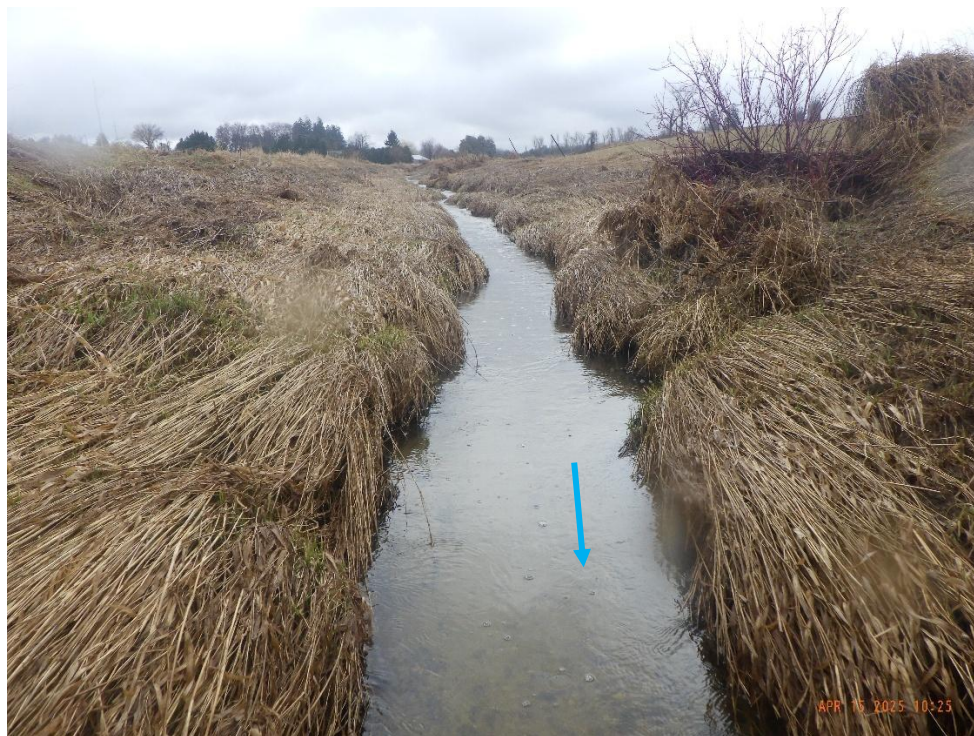
**Photo 5**

Photograph taken facing upstream. Note straight, uniform channel condition with dense grass vegetation adjacent to the channel.

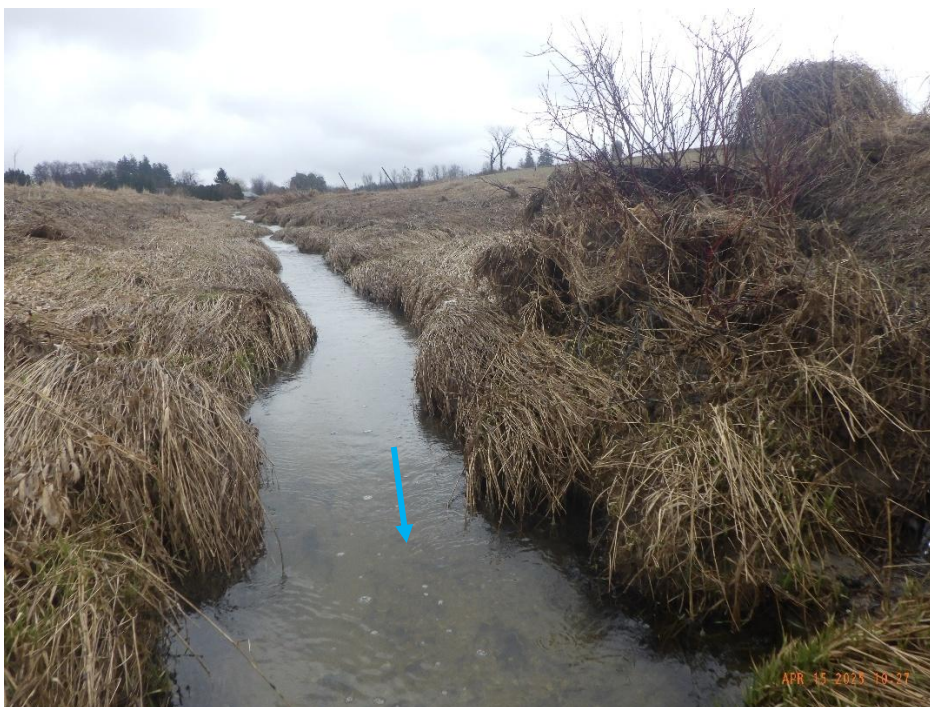
**Photo 6**

Photograph taken facing upstream as R2A transitions to R2B. Heavy vegetation along the banks. Straight channel with open canopy. Arrow denotes direction of flow.

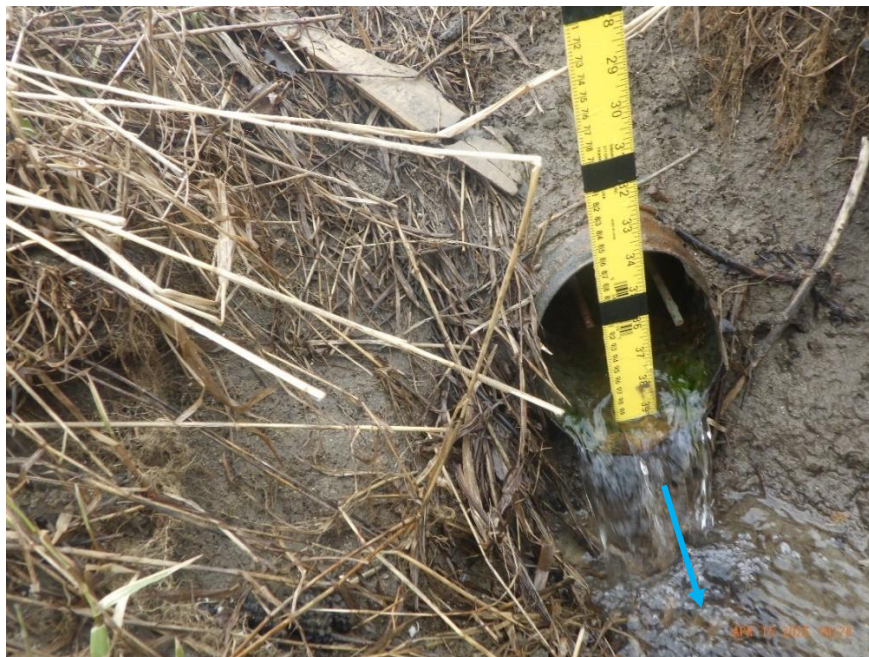
**Photo 7**

Photograph facing the right bank flow from tile drain into channel. Tile drain diameter was 0.14m.

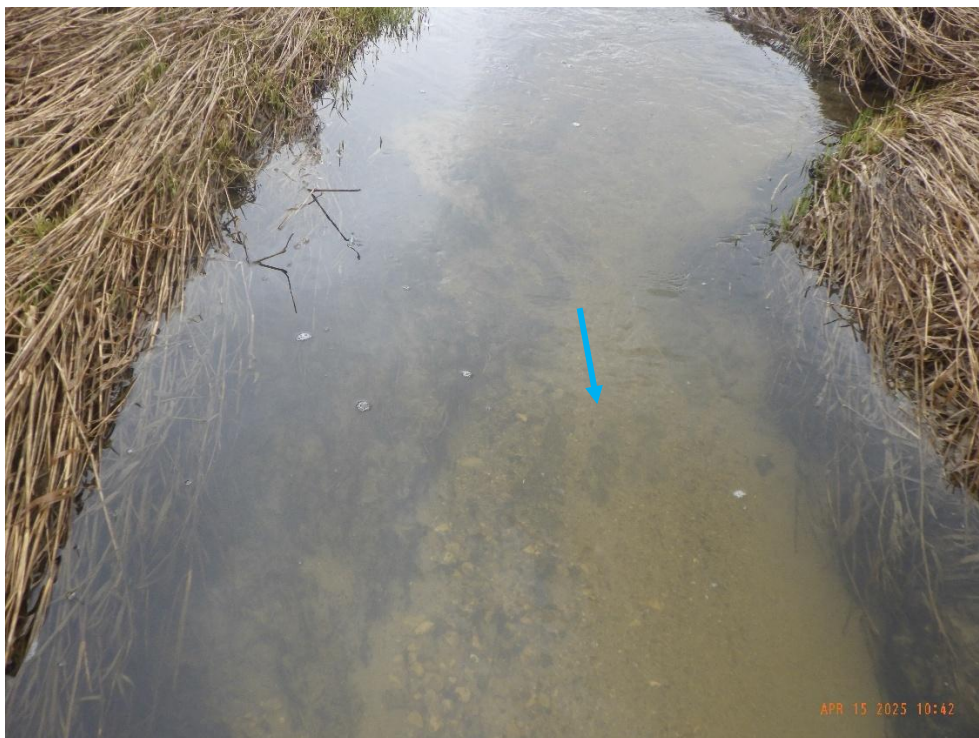
**Photo 8**

Photograph taken of bed substrate. Substrate ranges from sand, gravel and cobbles. Water has limited turbidity.
