# WELLINGTON COUNTY

**Blatchford Bridge**  
**B032085**  
**2025 OSIM Inspection**  
Wellington Road 32  
0.80 km S of Wellington Road 124

Structure\_ID: B032085  
 MTO Site Number: 35-343  
 BCI: 61.67

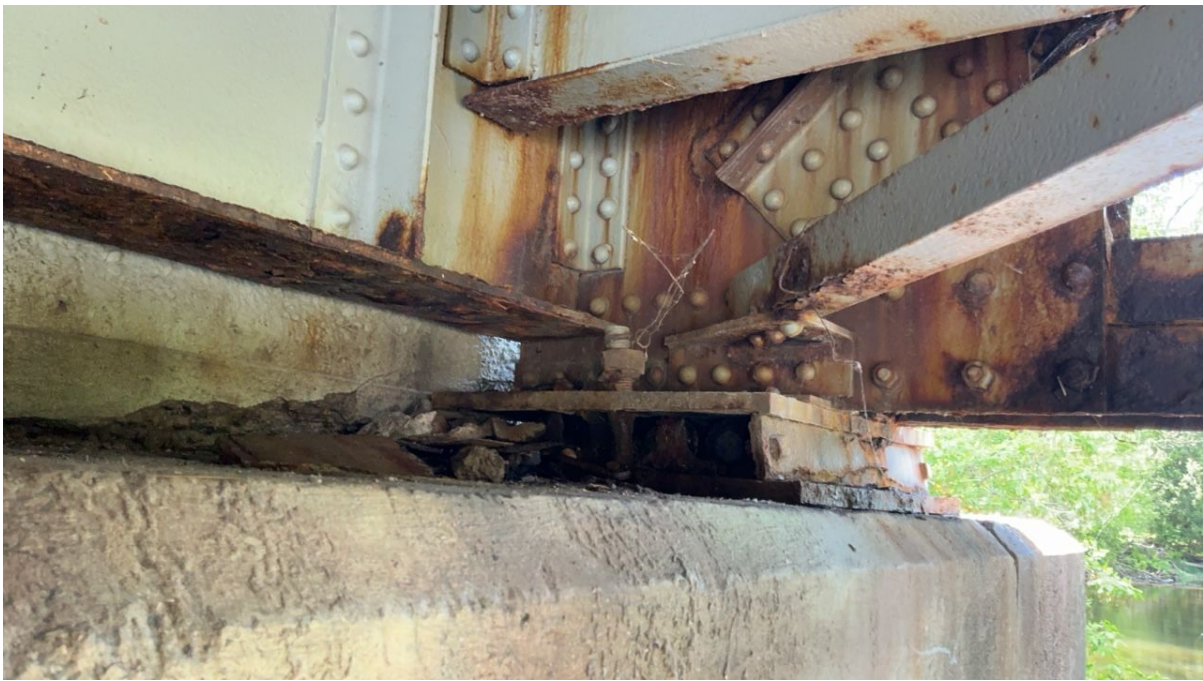
| Comments: | | Light to medium corrosion, spall near NE bearing, SW bearing in poor condition. | | | | |

*SW bearing.*

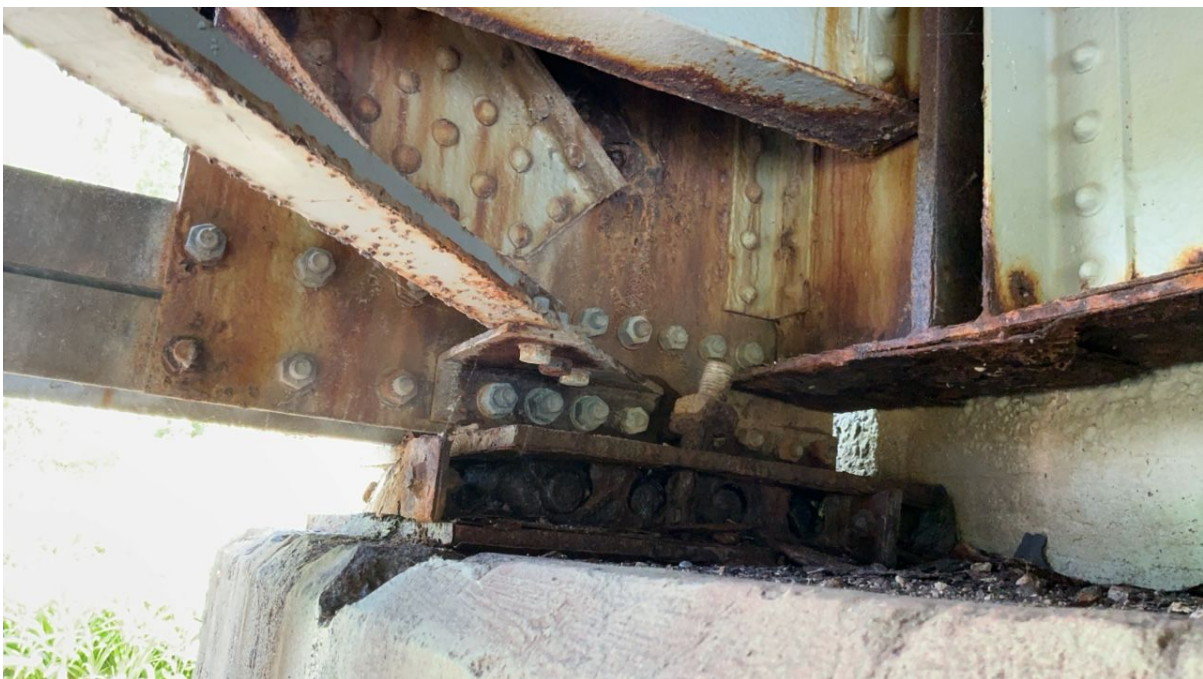
*SE bearing.*

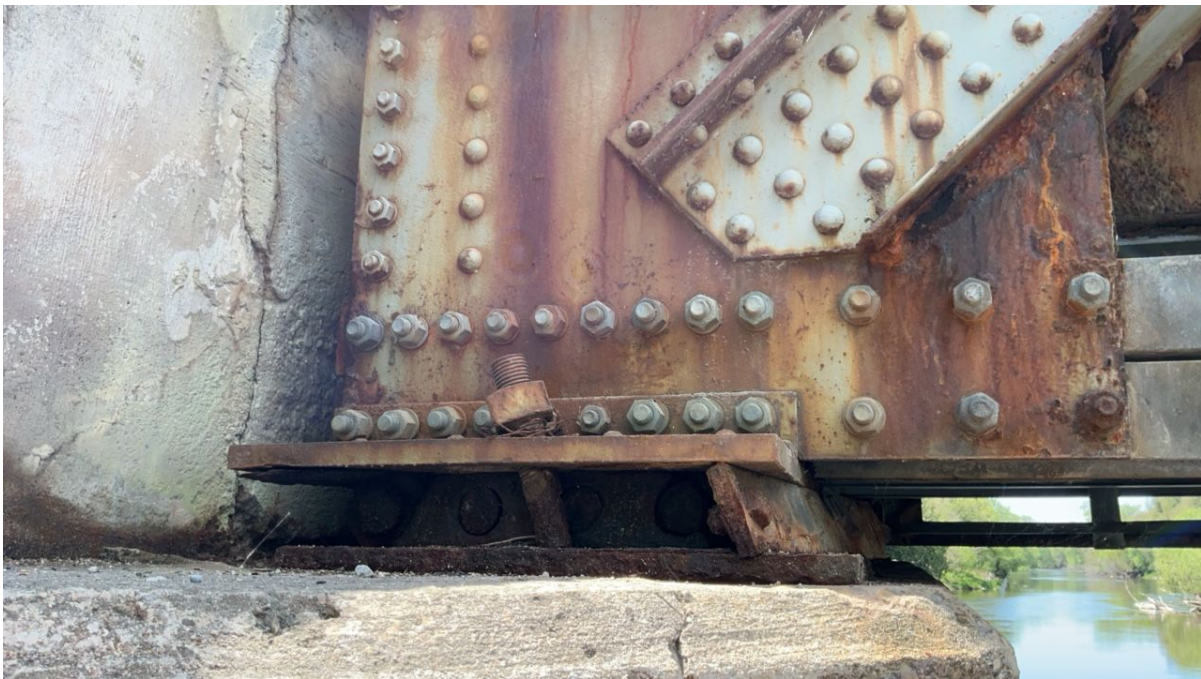
*SE bearing plate.*

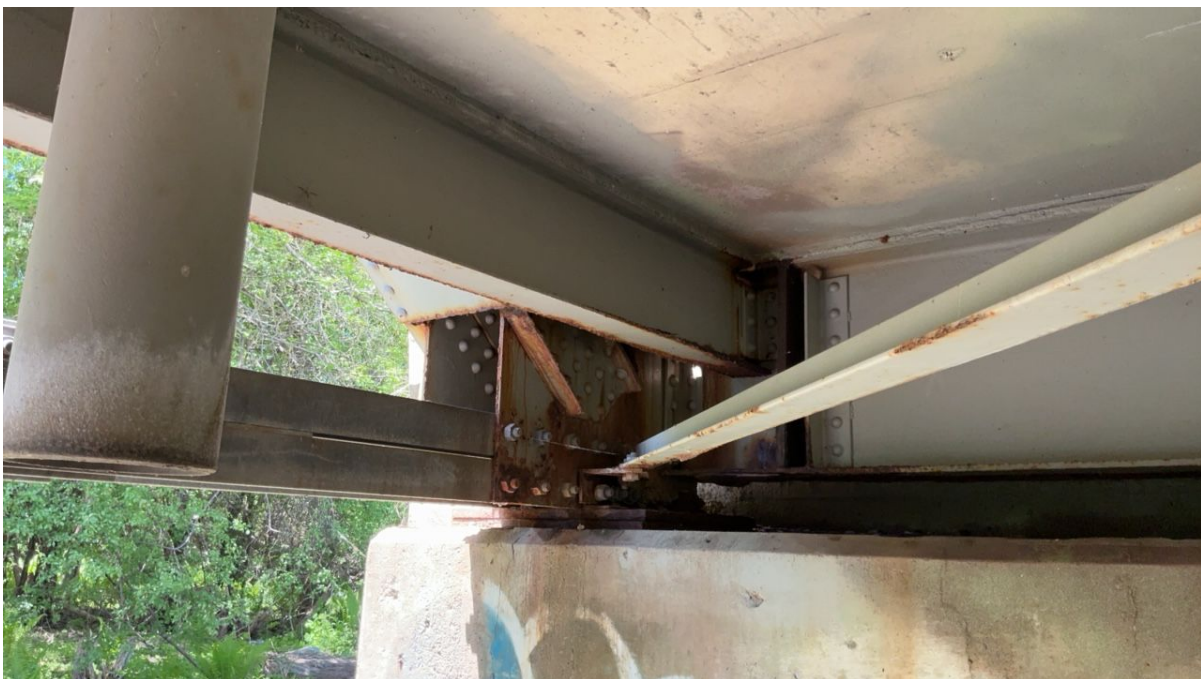
*NW bearing.*

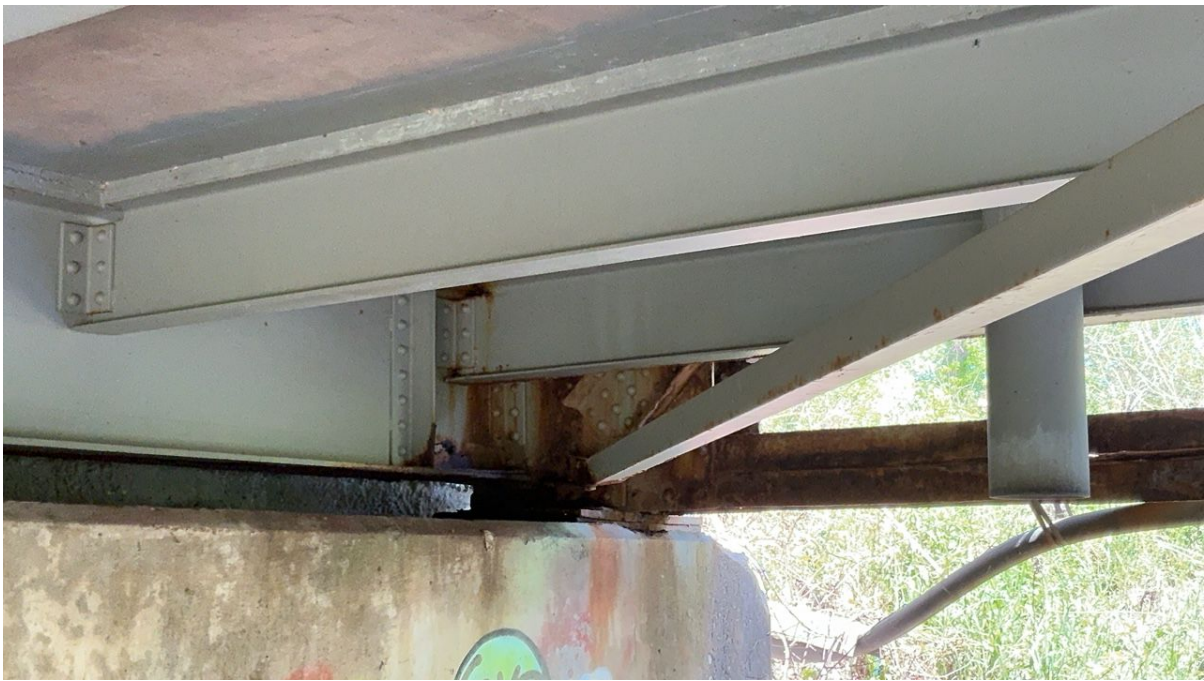
*NE bearing with minor spall.*

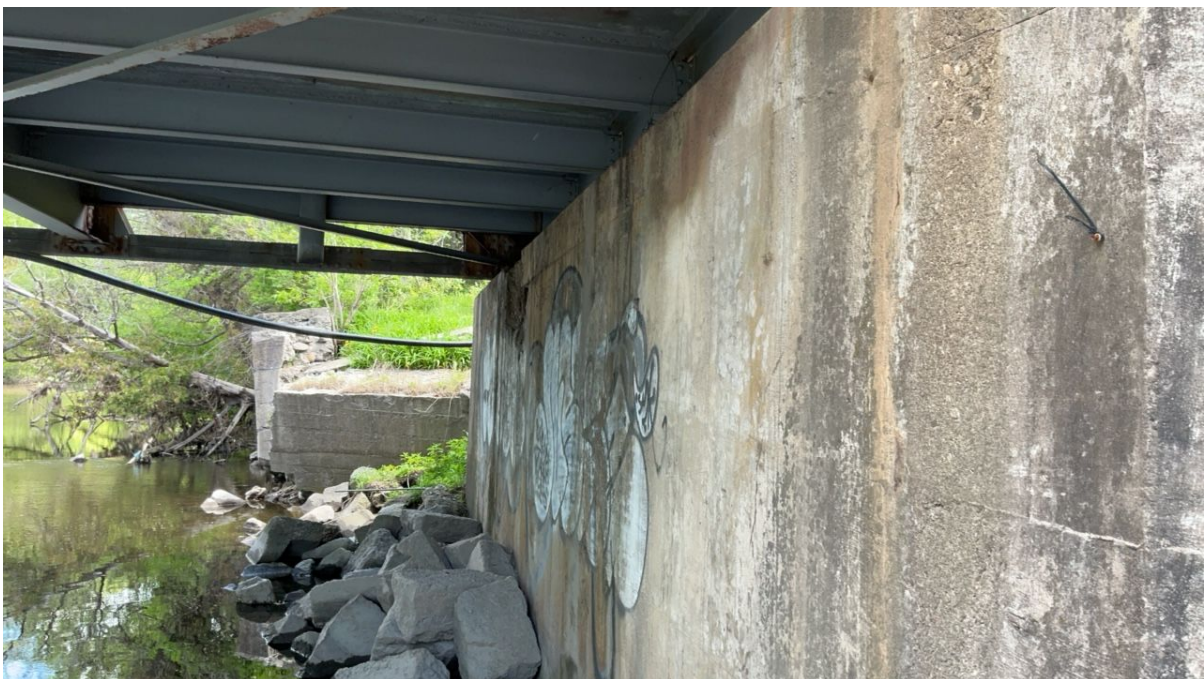
*South abutment.*

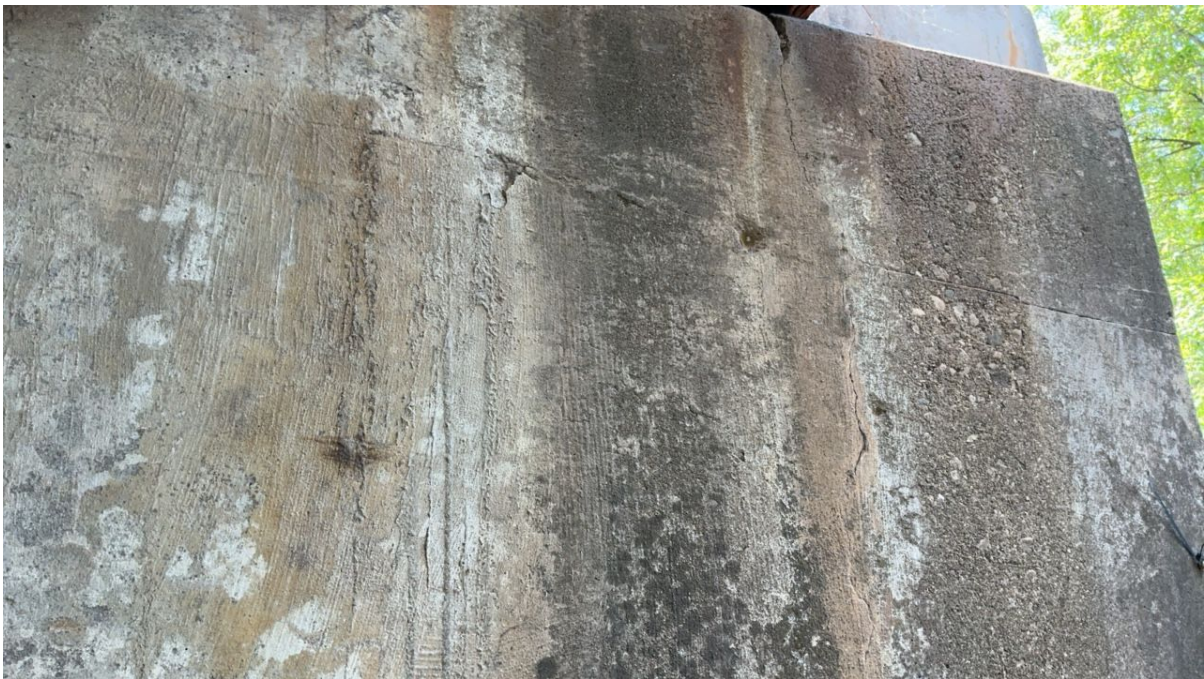
*Narrow vertical cracking on South abutment.*

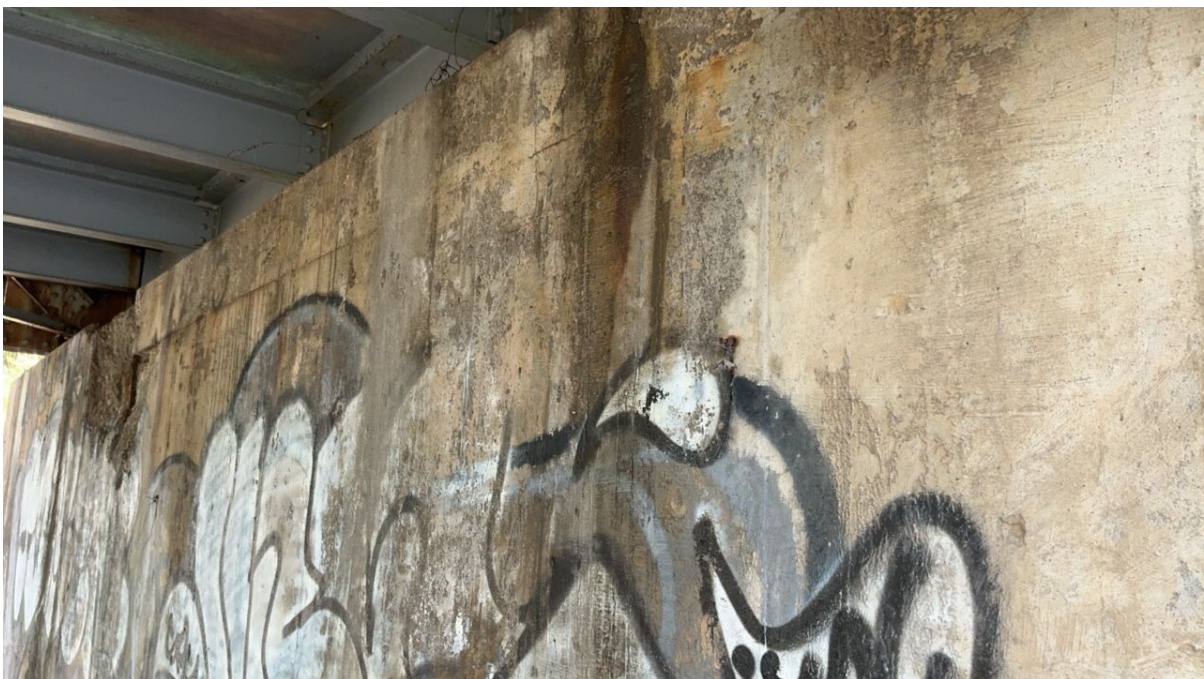
*Concrete staining on South abutment.*

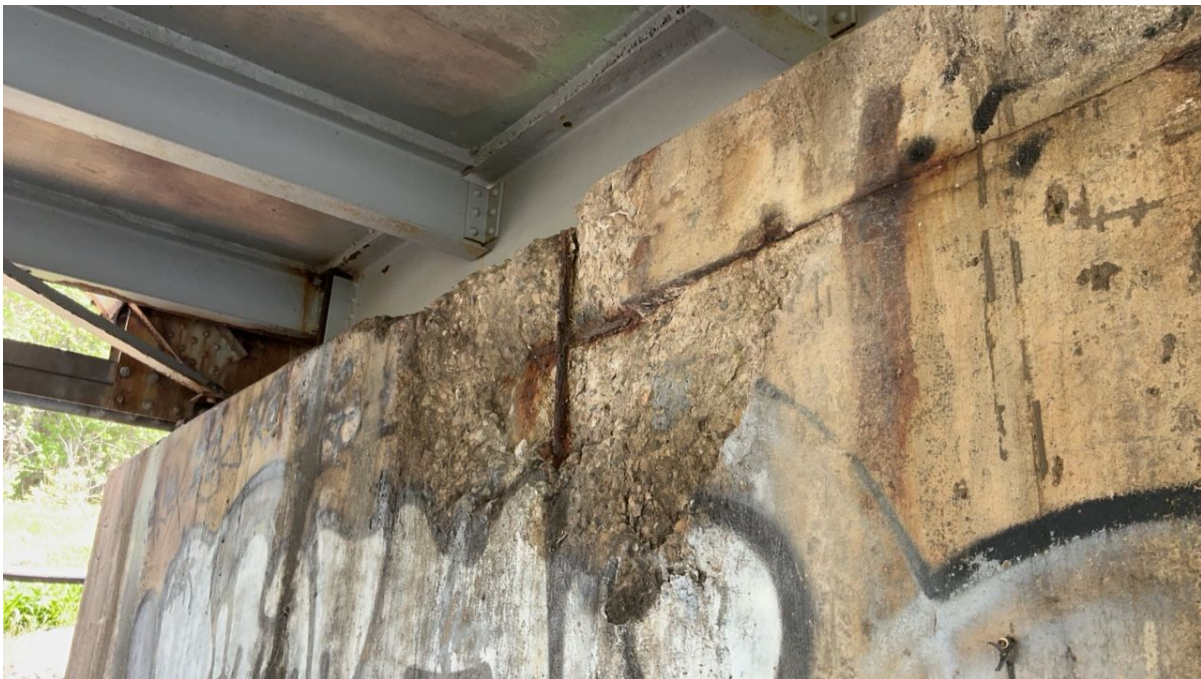
| Comments: | | Large spall with exposed rebars at South abutment, spall with exposed rebar at East end of South ballast wall, light scaling on North abutment, spall near NE bearing, narrow horizontal crack along North abutment. | | | | |

*Large spall on South abutment.*

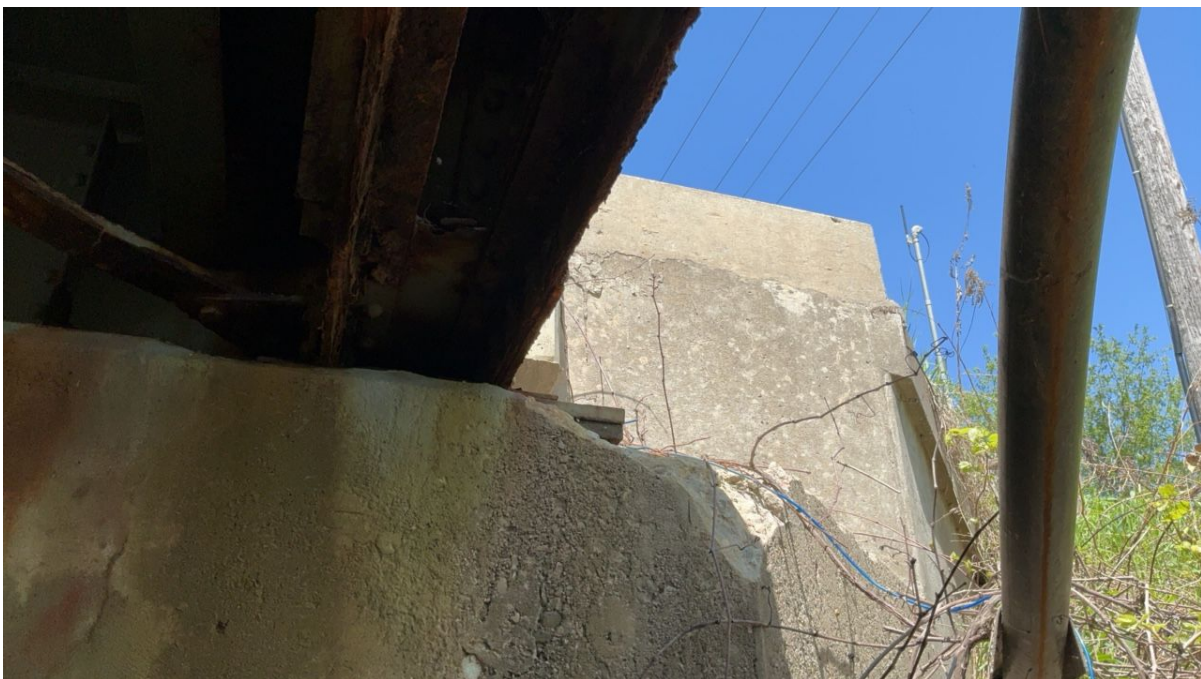
*Spall at NE.*

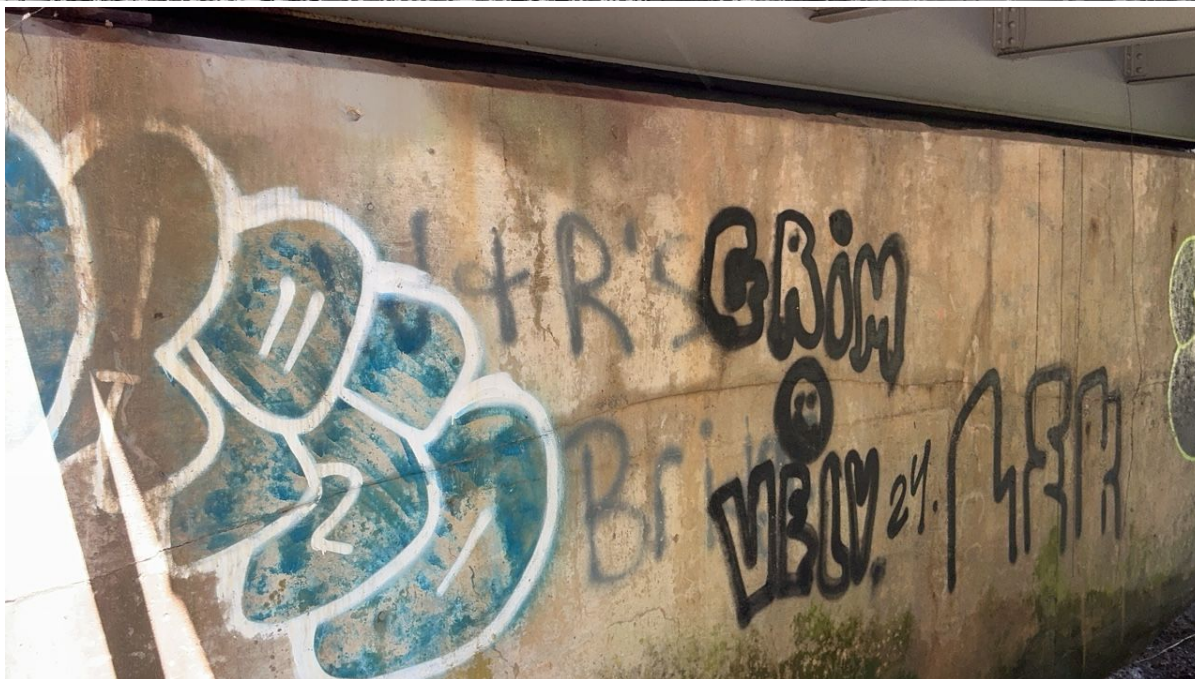
*Horizontal crack along North abutment.*

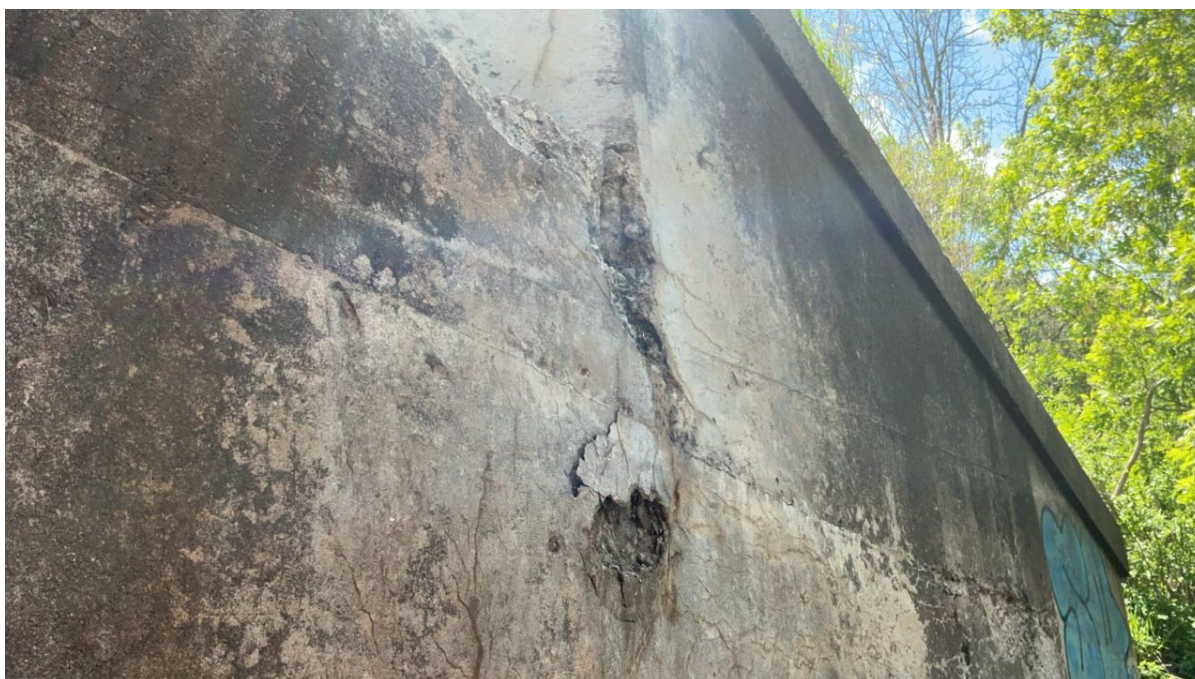
| Comments: | | Medium scaling, spalling, delamination and map cracks with efflorescence at SW, spalling, delamination and cracks with efflorescence at NW, horizontal cracking and scaling at SW, scaling and spall at NE. | | | | |

*SW wingwall spalls with delamination.*

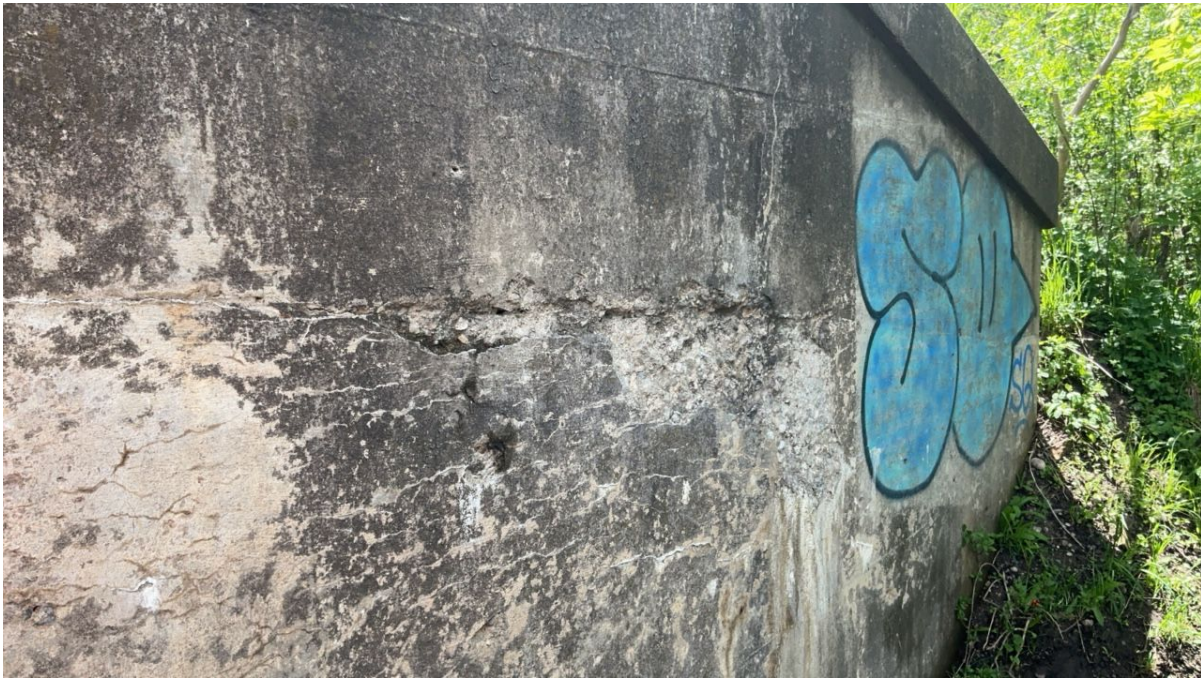
*SW wingwall scaling and delamination.*

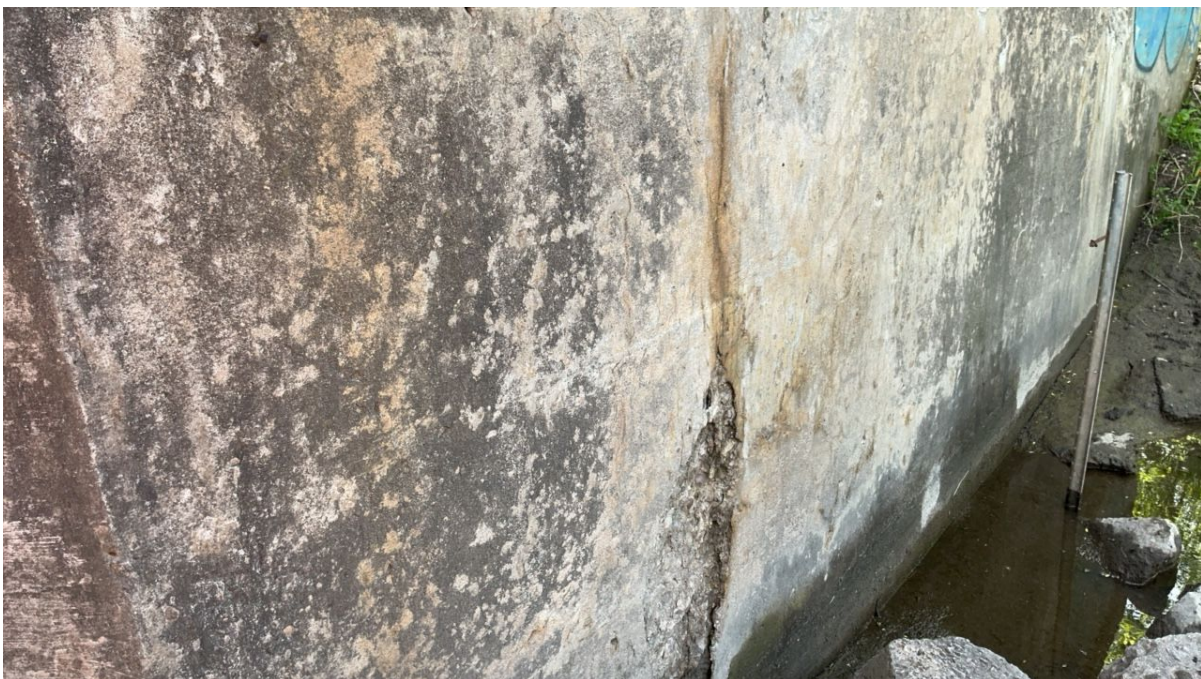
*SW wingwall vertical stained cracking.*

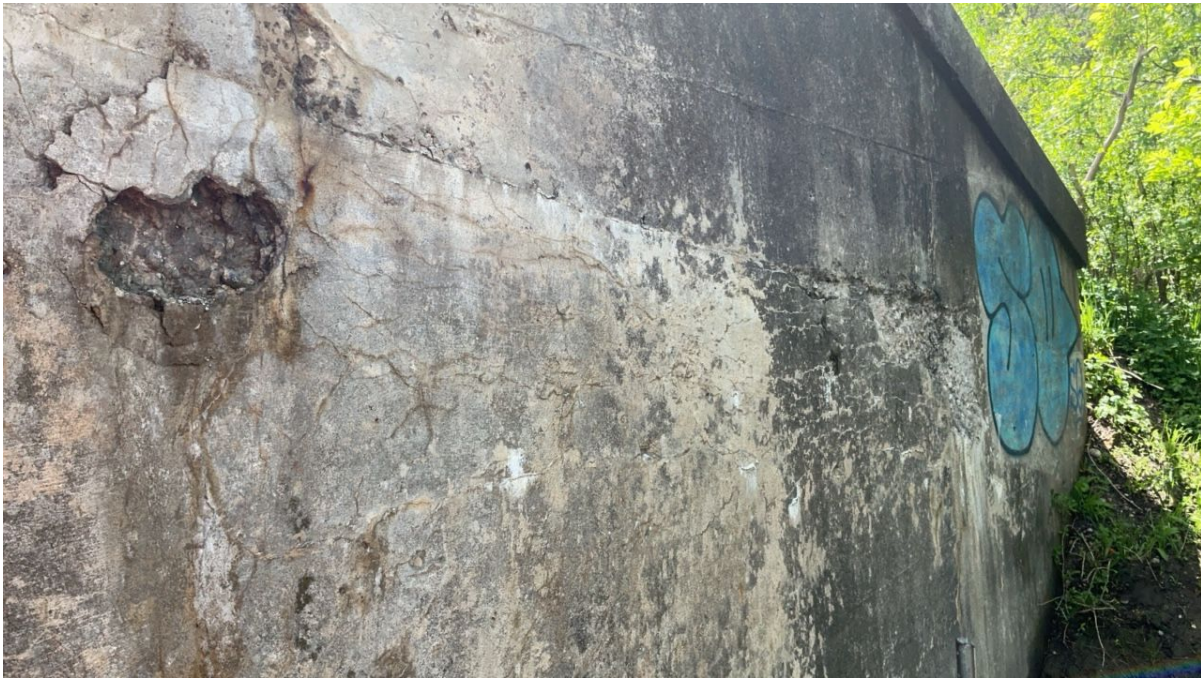
*Typical cracking on wingwalls.*

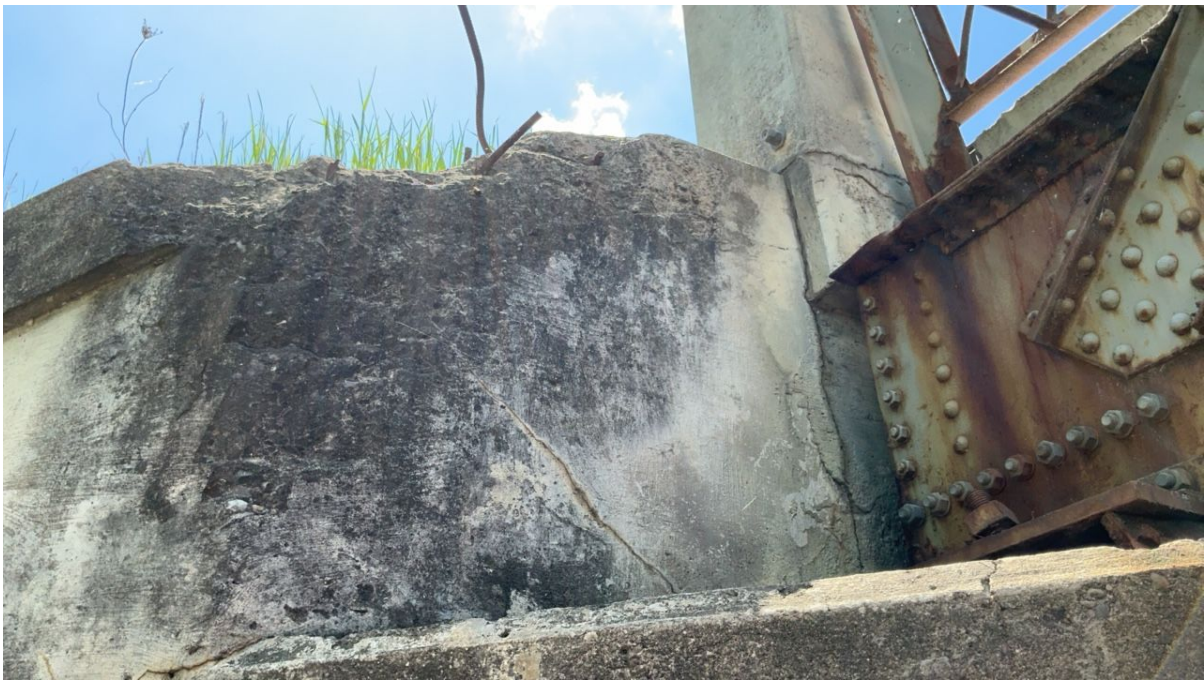
*SW cracking.*

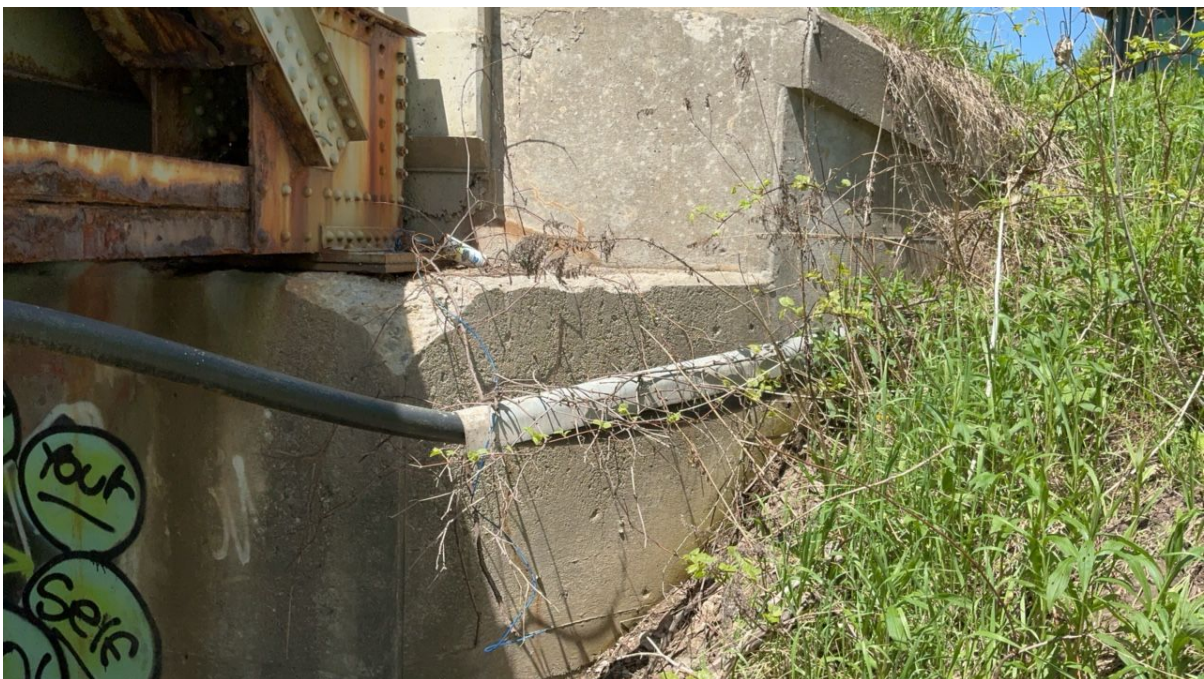
*NE wingwall spall and scaling.*

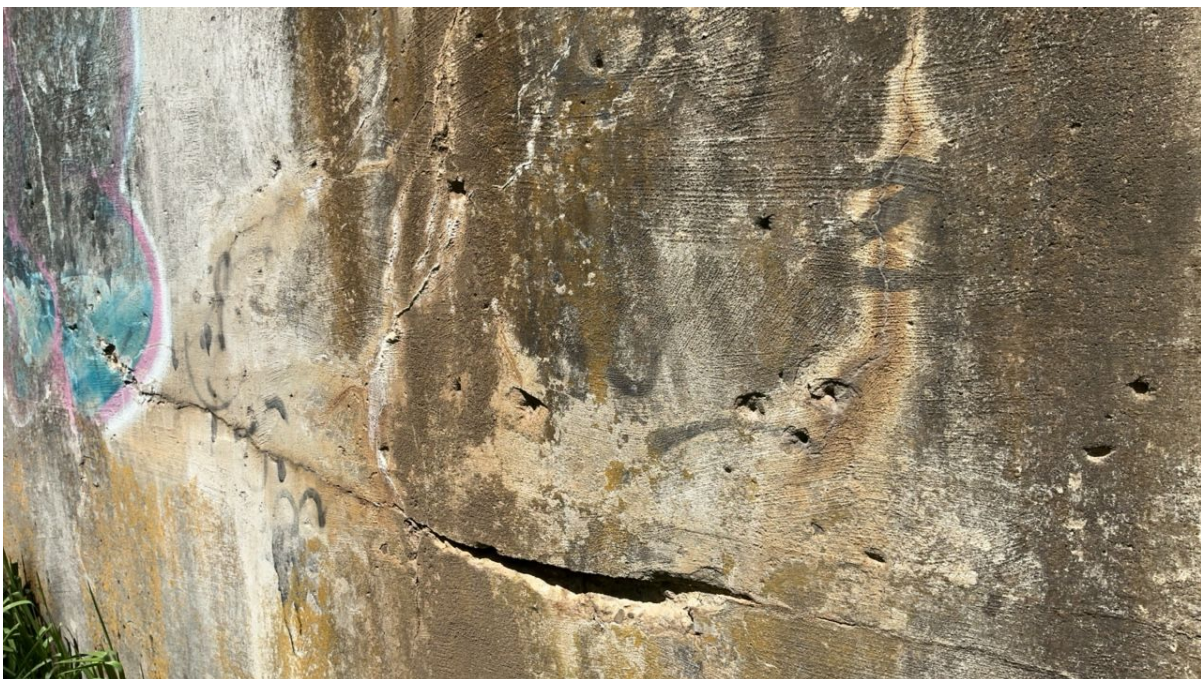
*NW wingwall spall and cracking.*

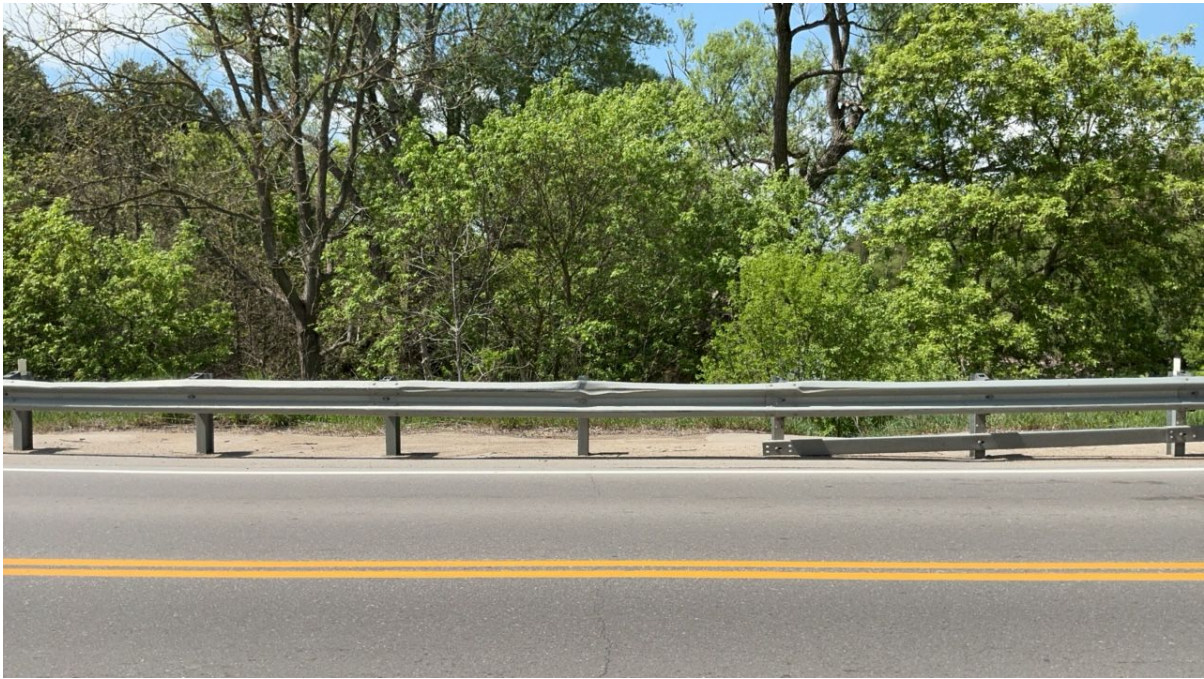
| Comments: | | Light to medium corrosion, disconnected and missing panels at SE, impact damage at SW. | | | | |

*Impact damage on SW guide rail.*

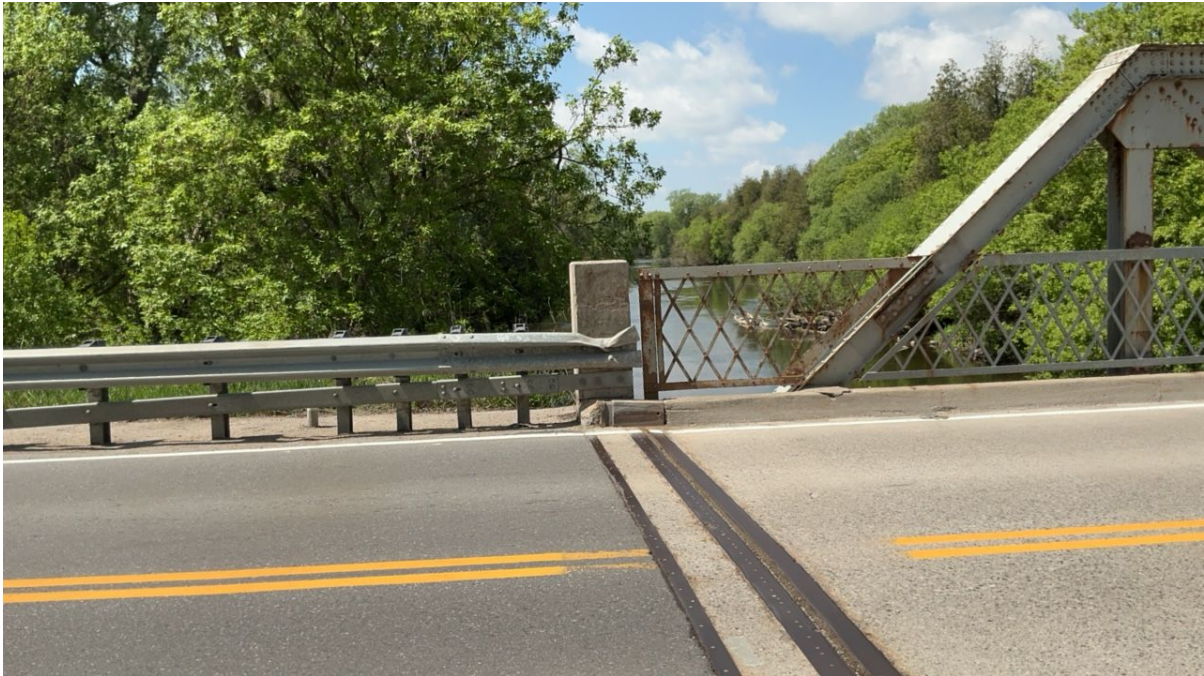
*Impact damage at SE guide rail end.*

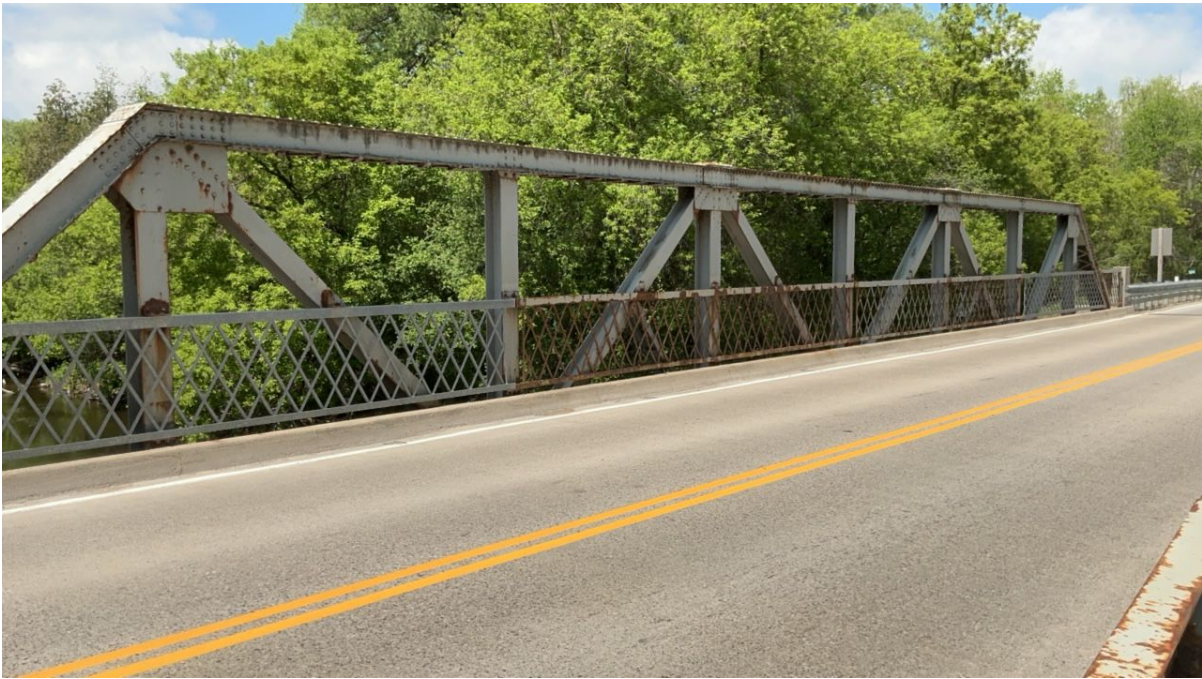
| Comments: | | Corrosion in railings over approximately 50% of the area, numerous areas of impact damage (~30% replaced) Traffic impact damage to railing at Northeast and Northwest corners. | | | | |

*West railing with rust and impact damage.*

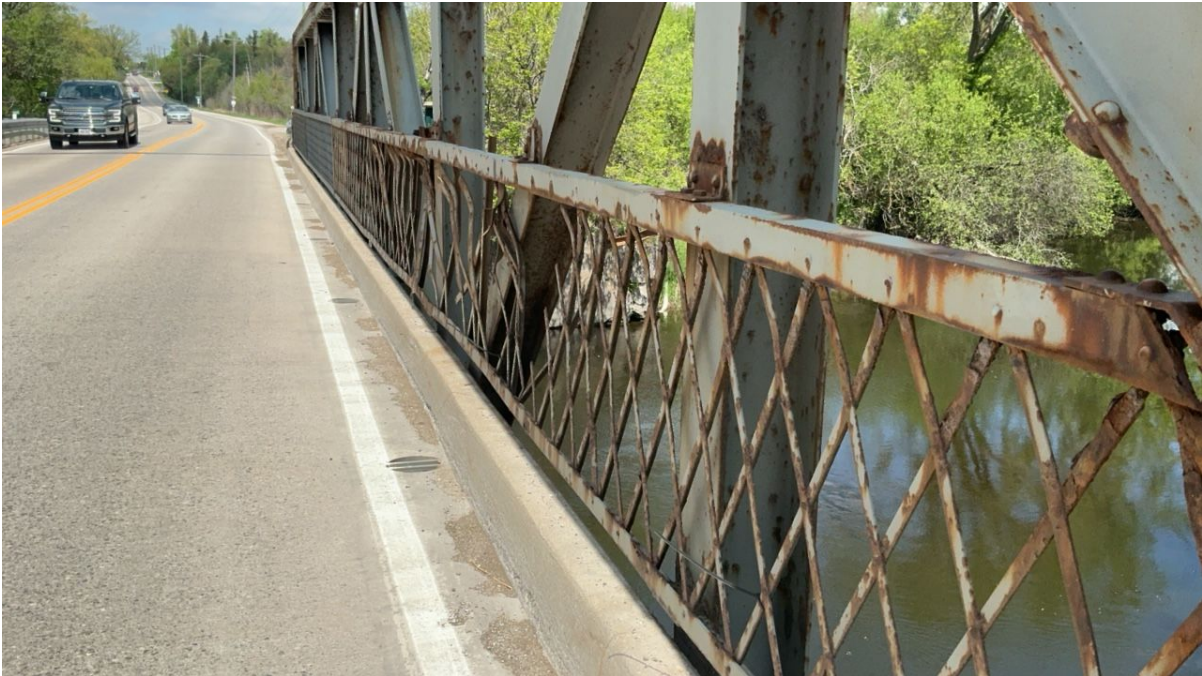
*East railing with rust and impact damage.*

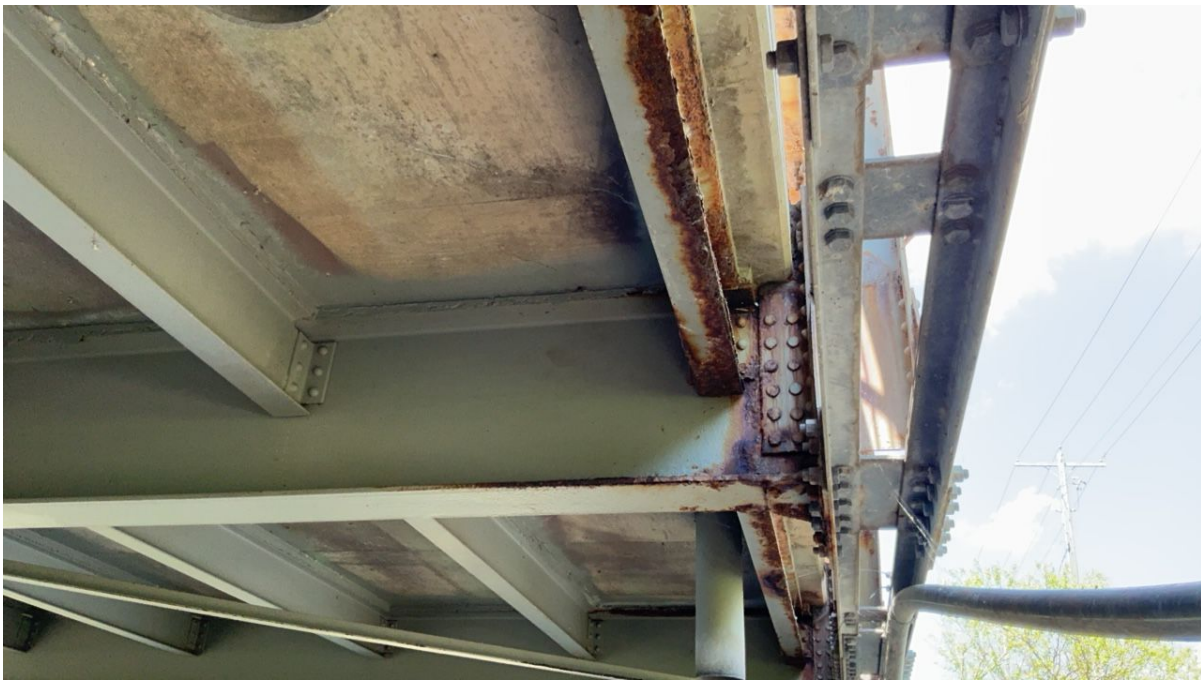
| Comments: | | Rust staining at connection plates, light to medium corrosion at soffit connections, perforation at NE end floor beams,, | | | | | |

*Floor beam rusted connection with bottom and vertical cord (typ).*

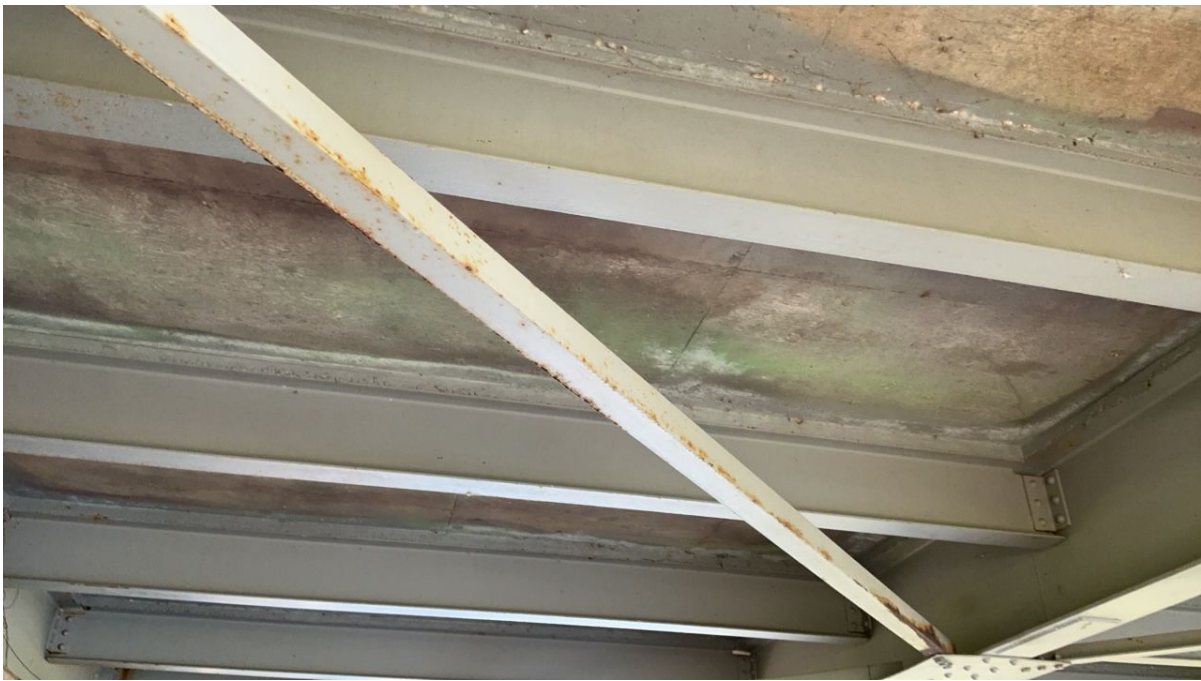
| Comments: | | Corrosion at connections, light rust on bracings. | | | | | |

*Light bracing rust.*

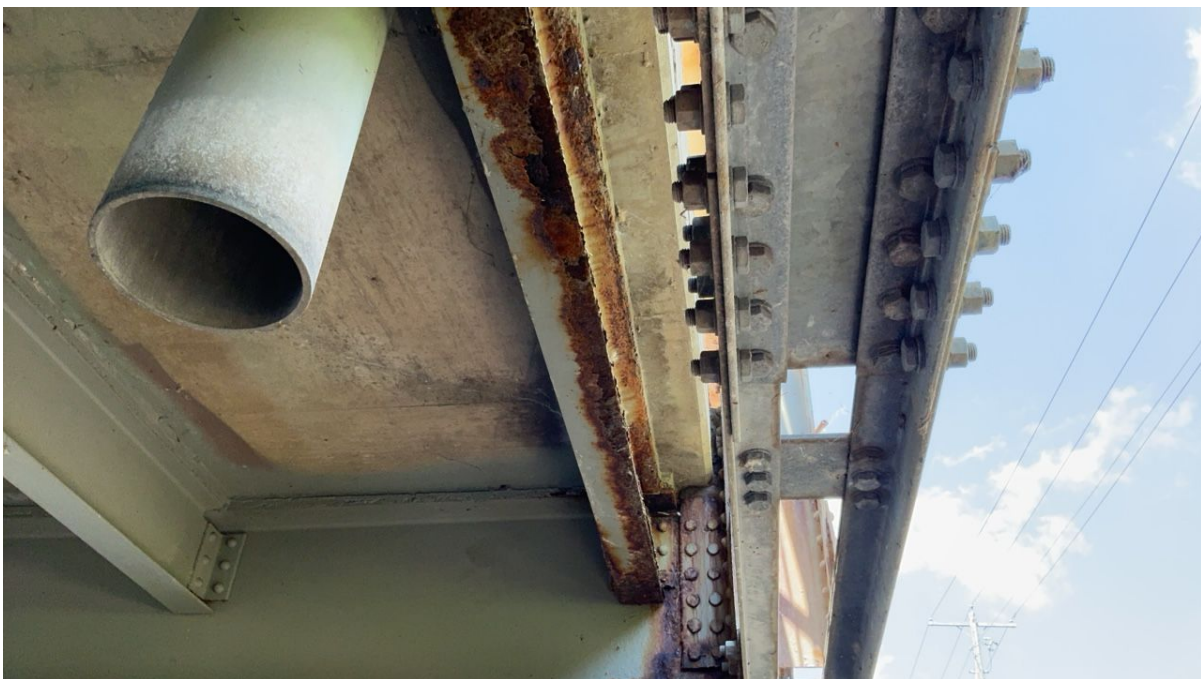
| Comments: | | Flaking of coating at diagonal and bottom chords. | | | | | |

*Flaking (typ).*

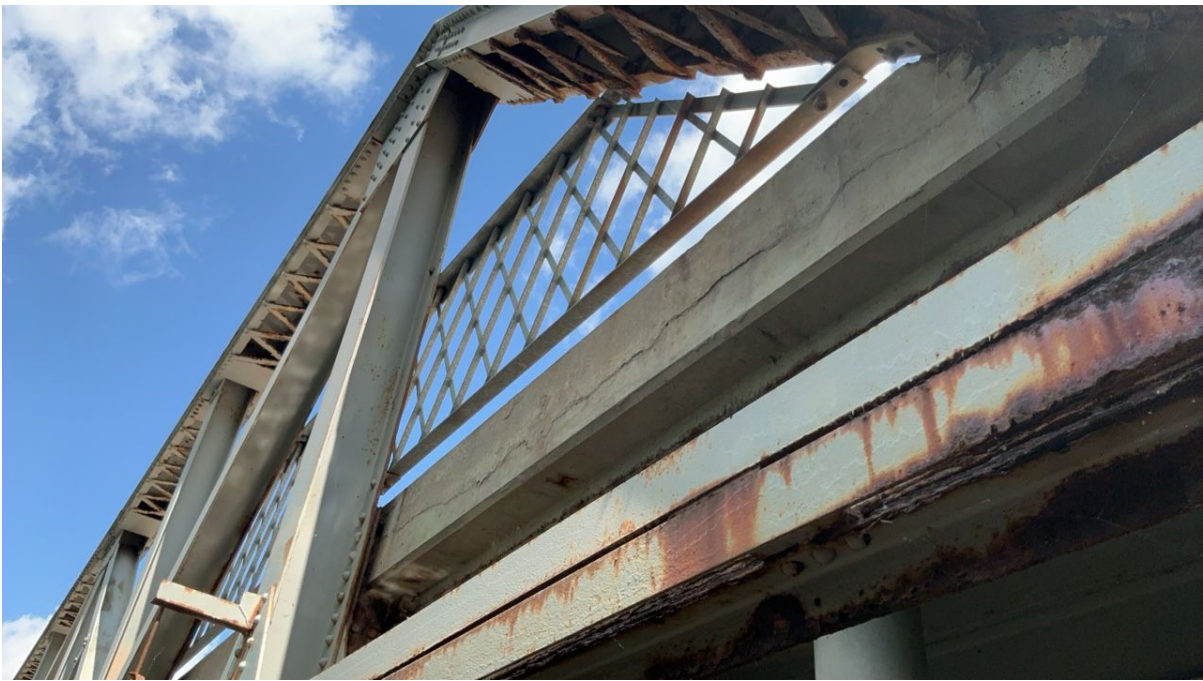
| Comments: | | Cracking with efflorescence at drain (typ), cold joint at West and East. | | | | | |

*Cold joint on West exterior soffit.*

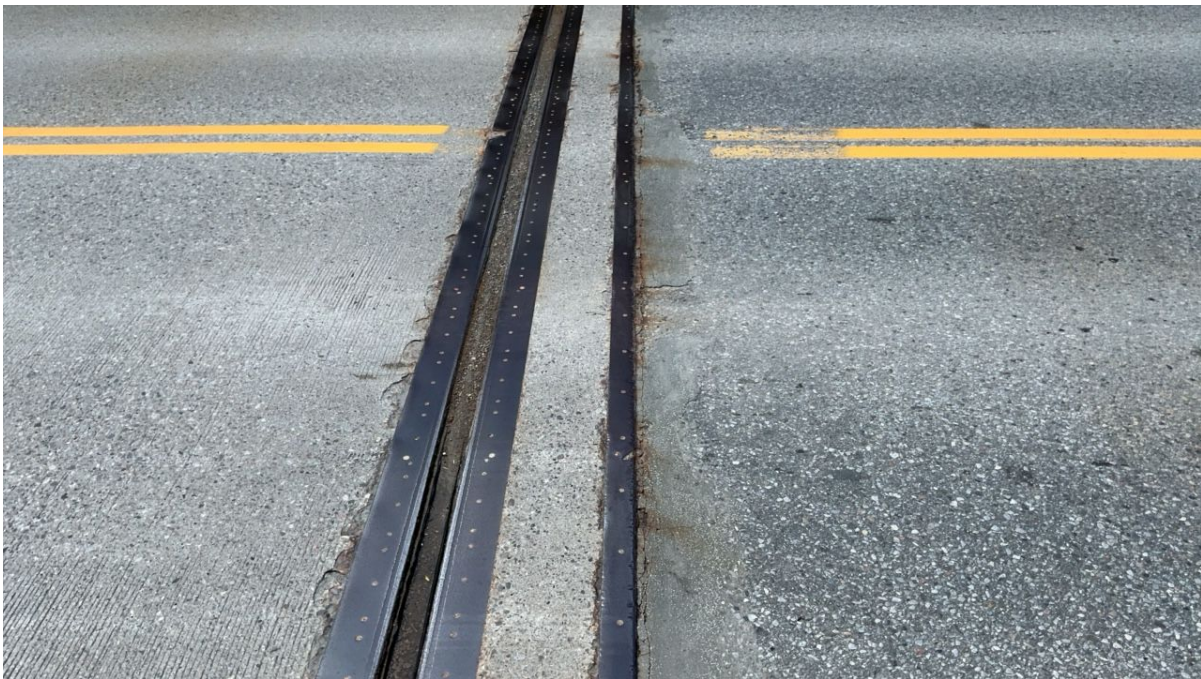
| Comments: | | Localized abrasions, settlement of North steel armorings of South joint on deck, filled with debris, snow plow damage present on South and North joint. | | | | | |

*North armour damage.*
