# WELLINGTON COUNTY

**Blatchford Bridge**  
**B032085**  
**2025 OSIM Inspection**  
Wellington Road 32  
0.80 km S of Wellington Road 124

Structure\_ID: B032085  
 MTO Site Number: 35-343  
 BCI: 61.67

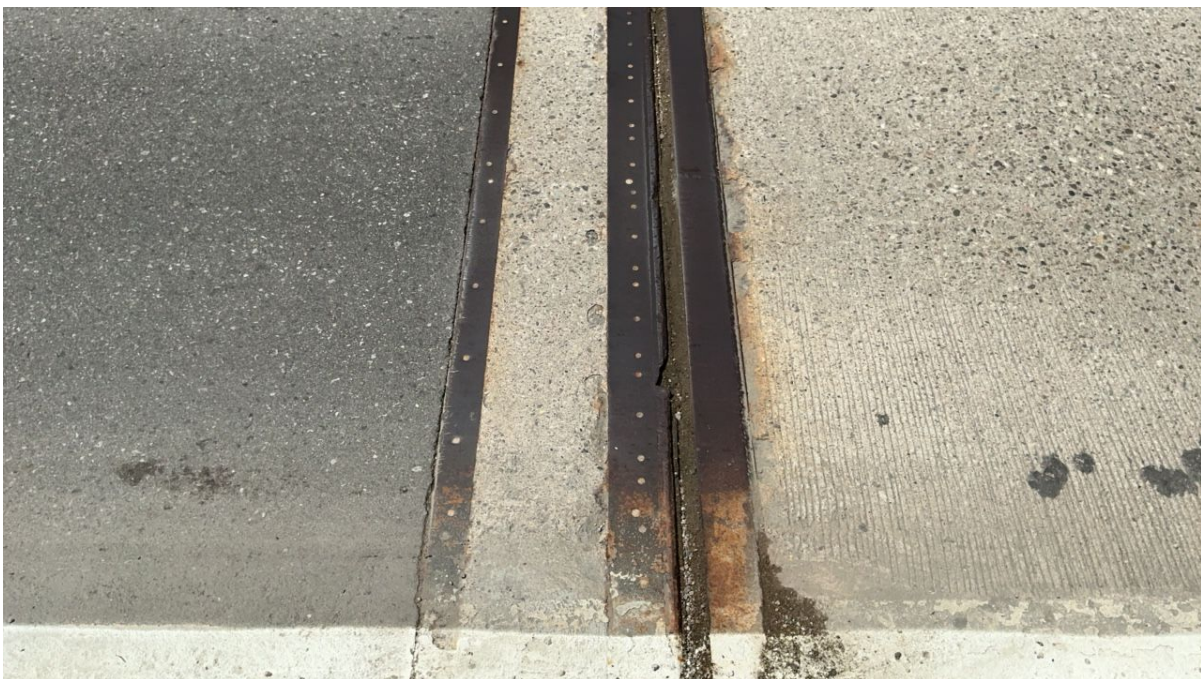
*Scaling on South dam.*

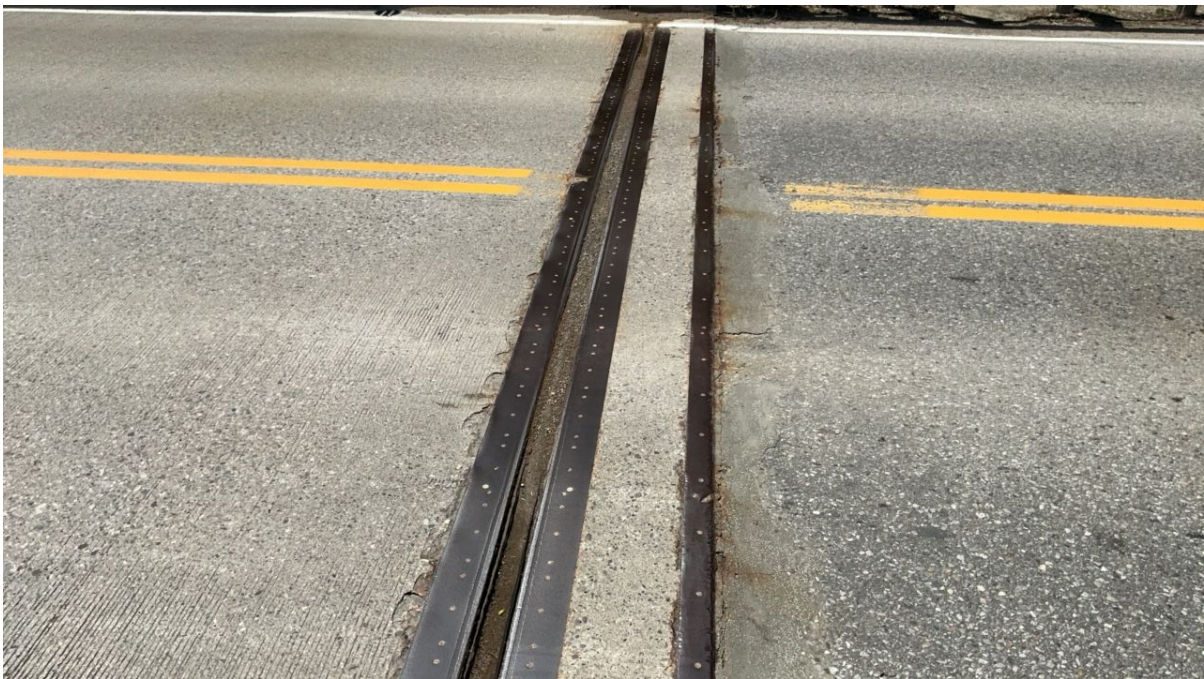
*Concrete spalled from North joint.*

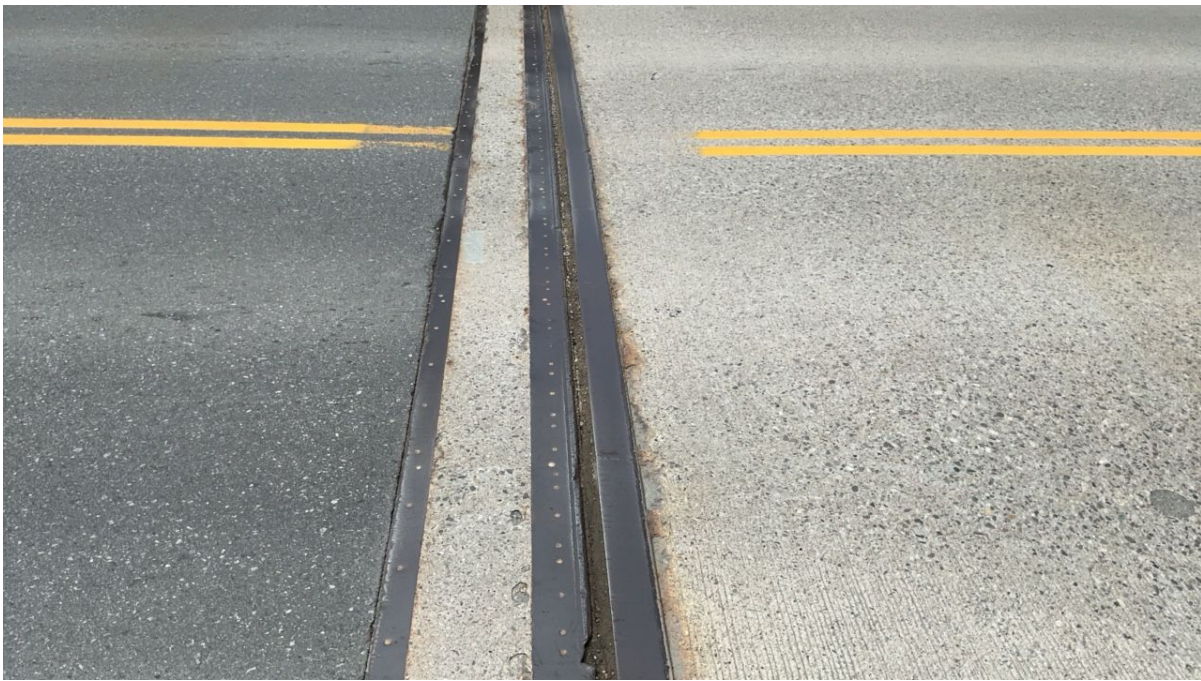
| Comments: | | Joints filled with debris (typ). | | | | | |

*South joint filled with debris.*

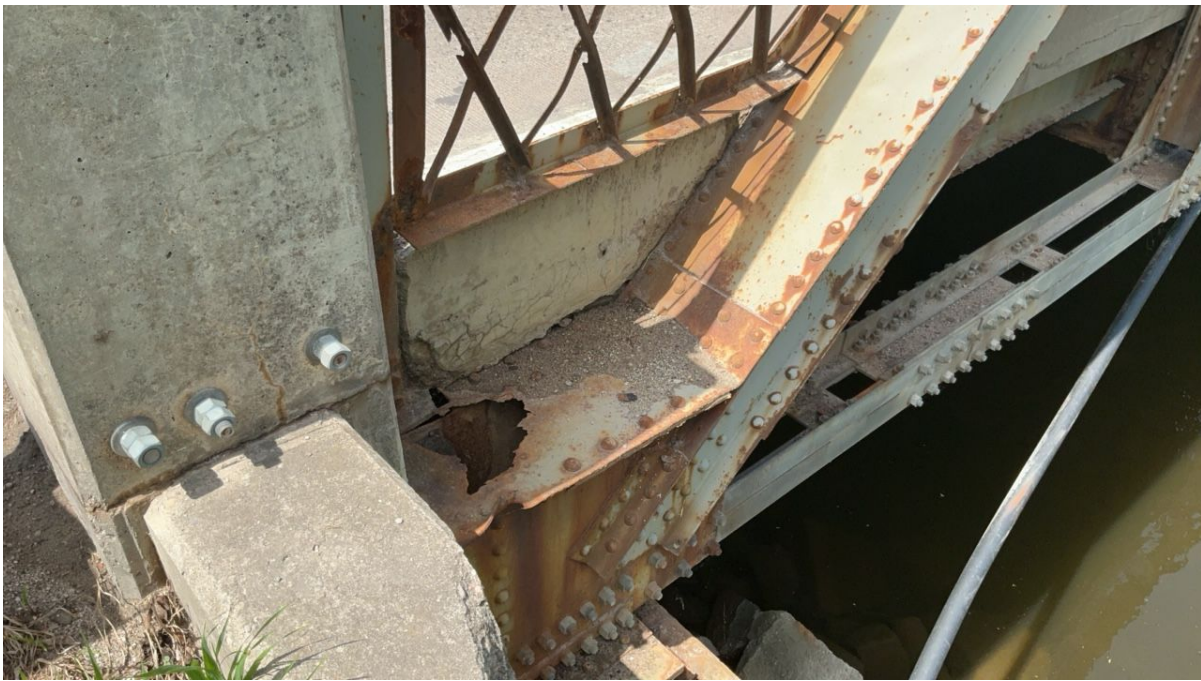
| Comments: | | Perforation at SW, NW & SE corner, light to medium corrosion through-out, severe corrosion with perforation at North end of East chord (Targeted repairs were completed to this section after the inspection). | | | | | |

*SE end perforation.*

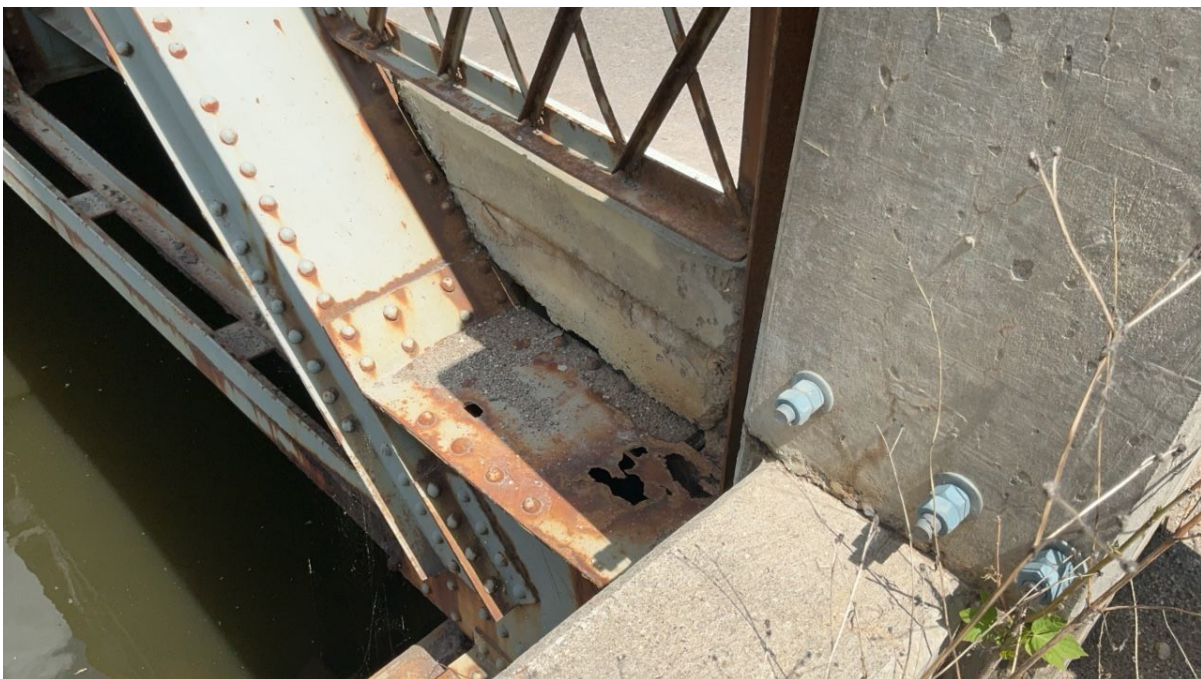
*SW end perforation.*

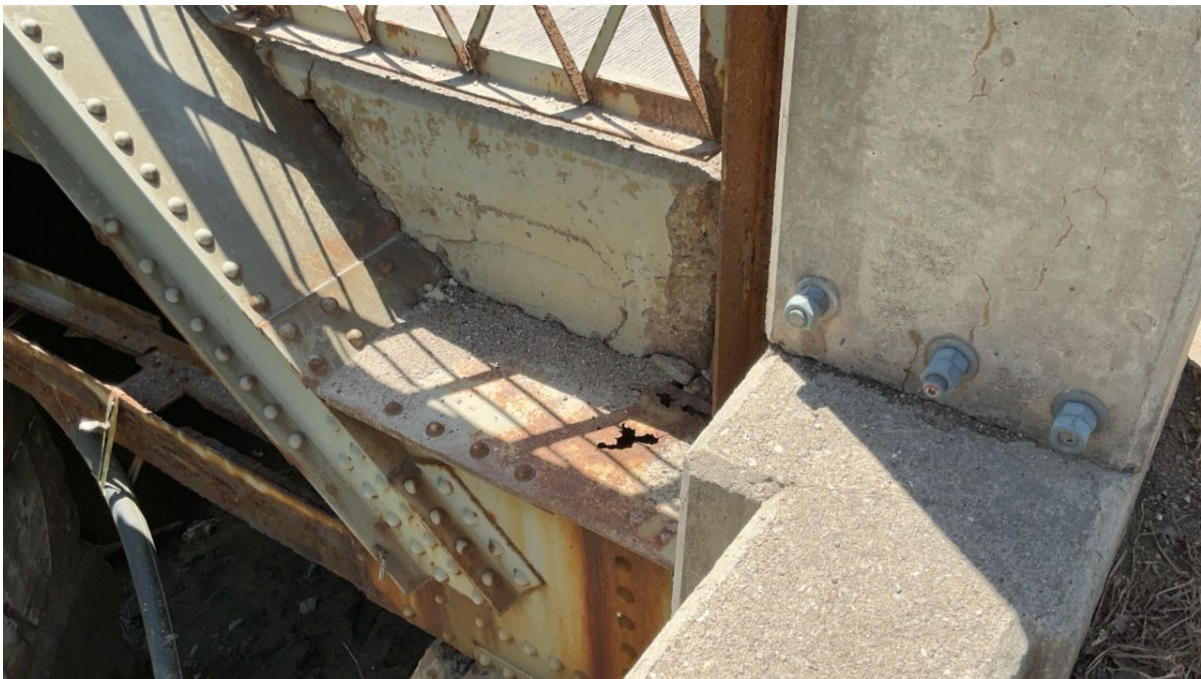
*NE end perforations.*

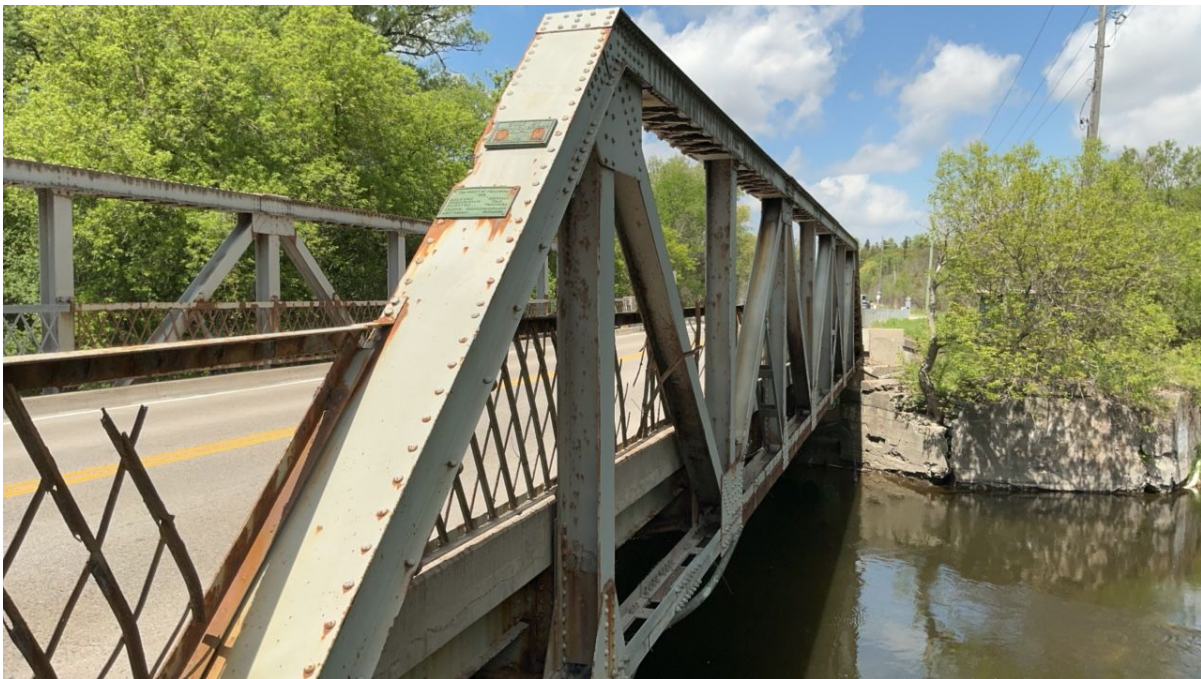
| Comments: | | Corrosion at connection plates of railings, corrosion at bracing panels members, impact damage at NE & S, rusting with perforation at NE. | | | | | |

*East vertical/ diagonals with rust (typ).*

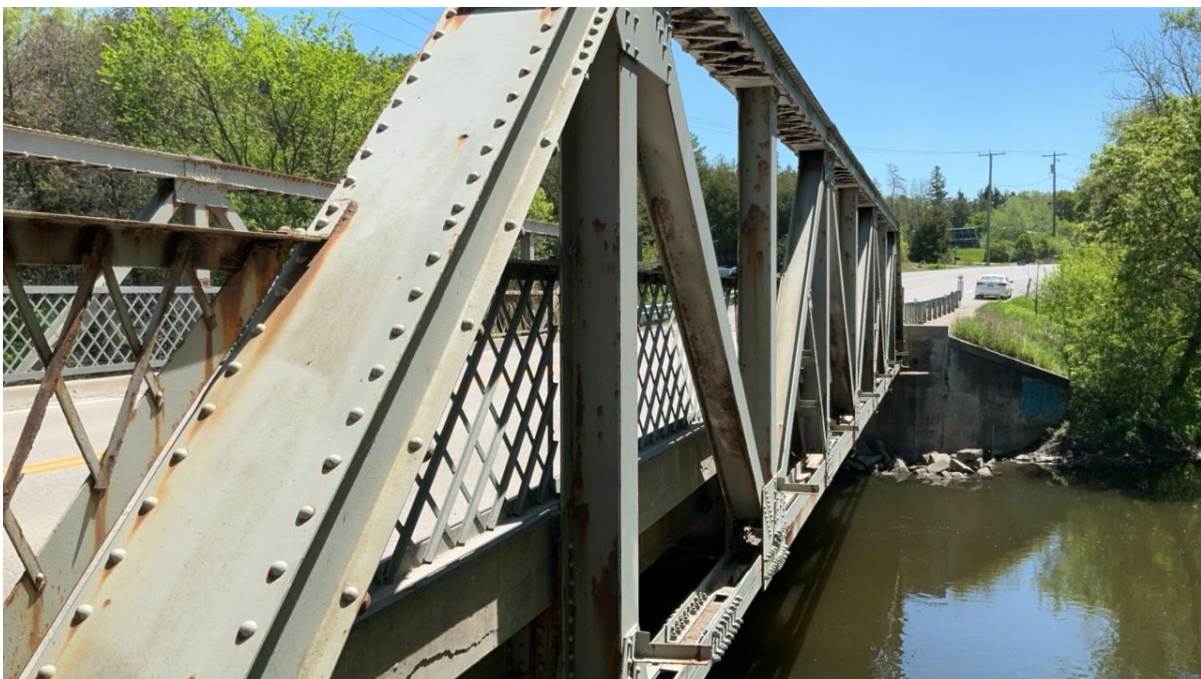
*Rust staining on vertical and diagonals (typ).*

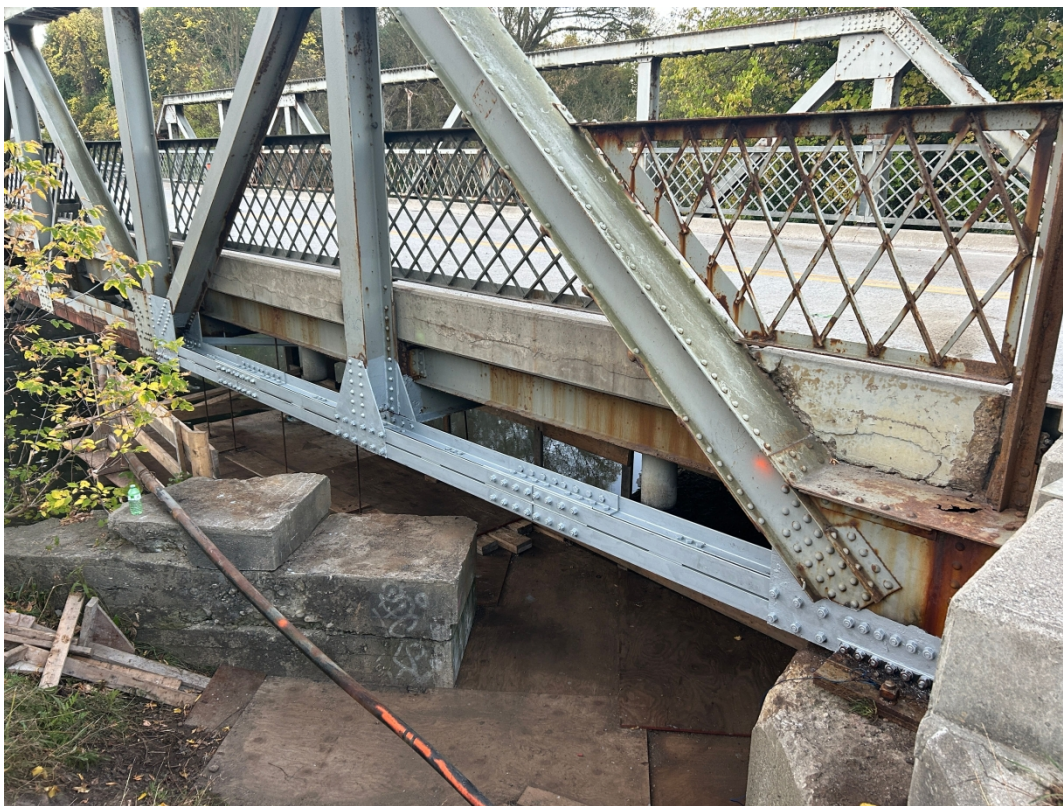
*NE bottom chord repair*
