C STRUCTURAL INVESTIGATION REPORT AND SITE PHOTOGRAPHS

Bosworth Bridge (B007028)

MTO Structure Number 35-104

Municipal Structure Inspection Form

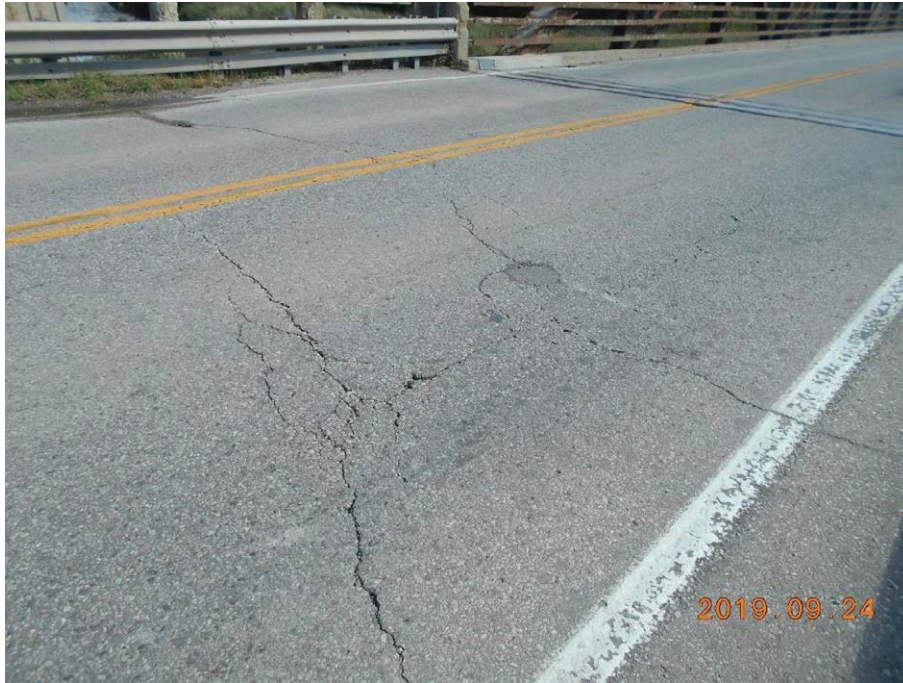
Date	Sept. 24, 2019	Description	West Approach
------	----------------	-------------	---------------

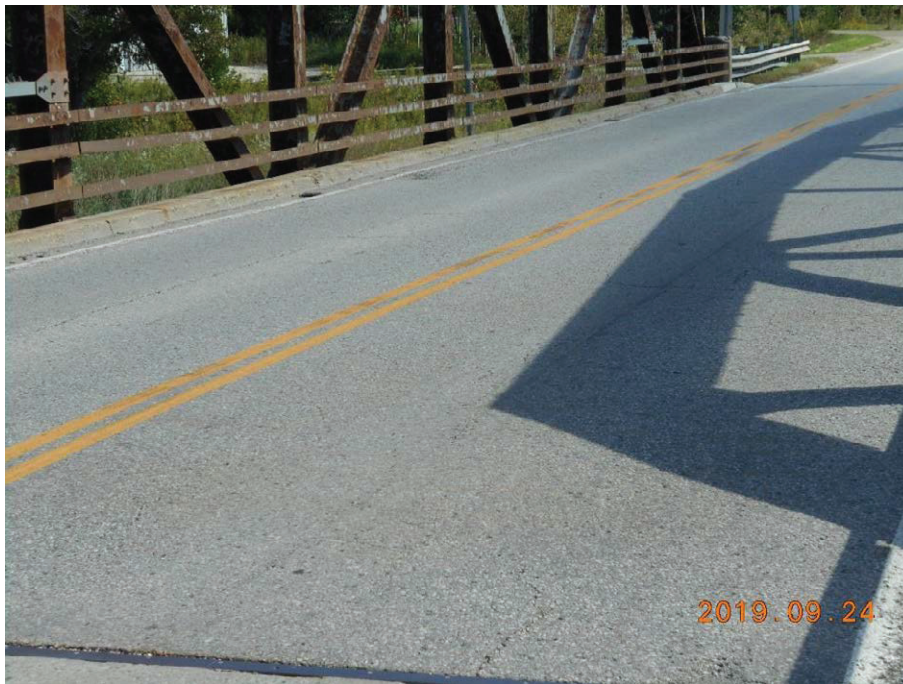
Medium width transverse and longitudinal cracks

Date	Sept. 24, 2019	Description	Asphalt Wearing Surface
------	----------------	-------------	-------------------------

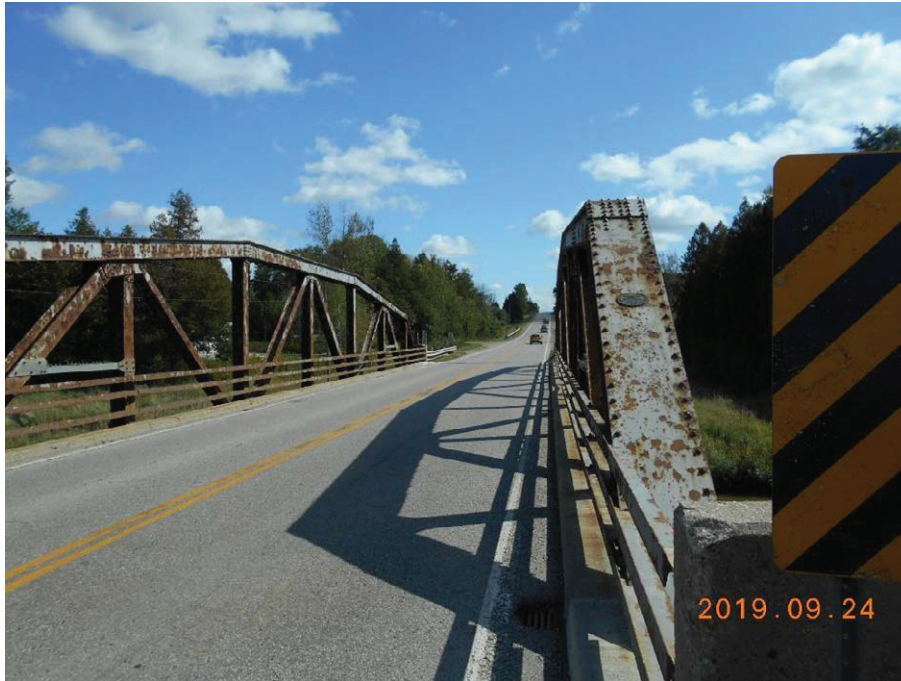
Date	Sept. 24, 2019	Description	General View looking East
------	----------------	-------------	---------------------------

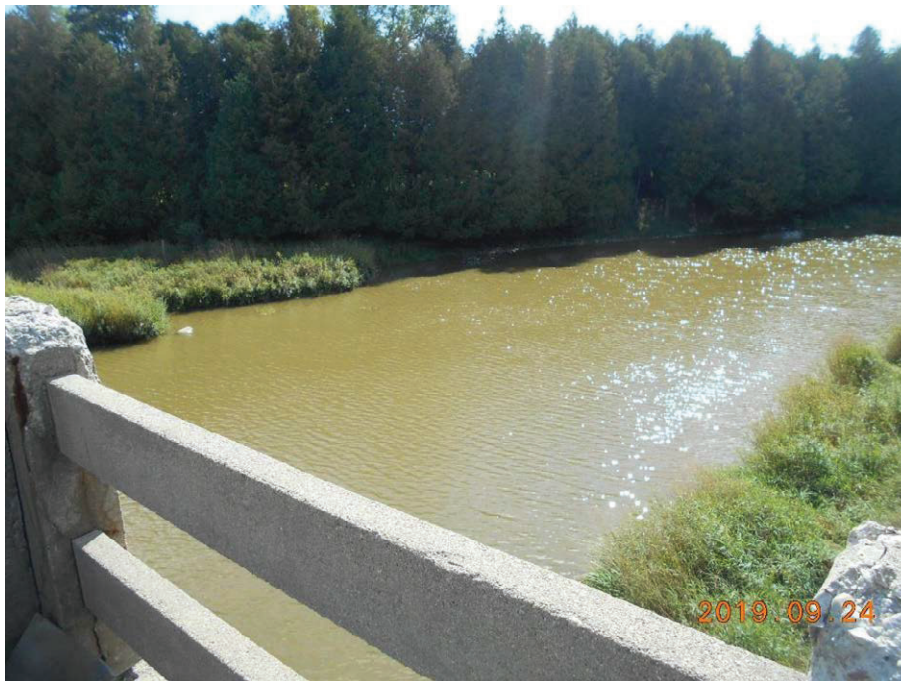
Date	Sept. 24, 2019	Description	General View looking South
------	----------------	-------------	----------------------------

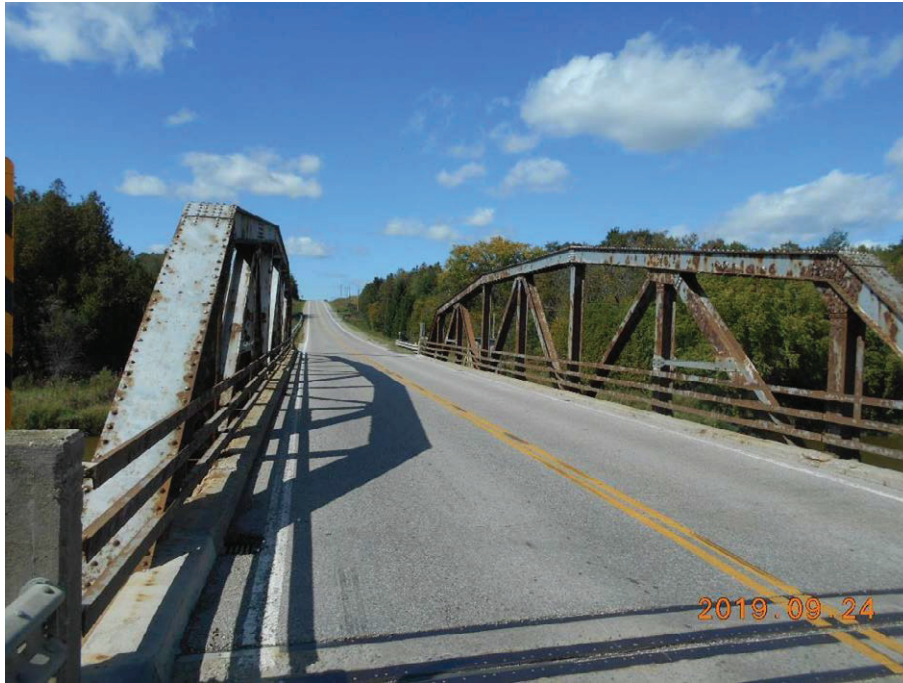
Date	Sept. 24, 2019	Description	General View looking West
------	----------------	-------------	---------------------------

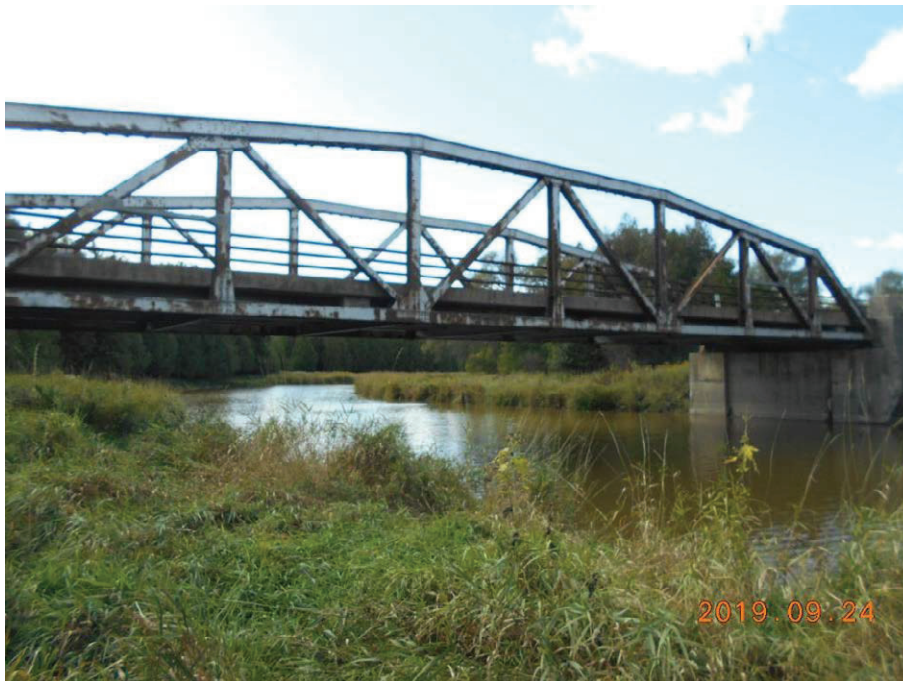
Date	Sept. 24, 2019	Description	North Elevation
------	----------------	-------------	-----------------

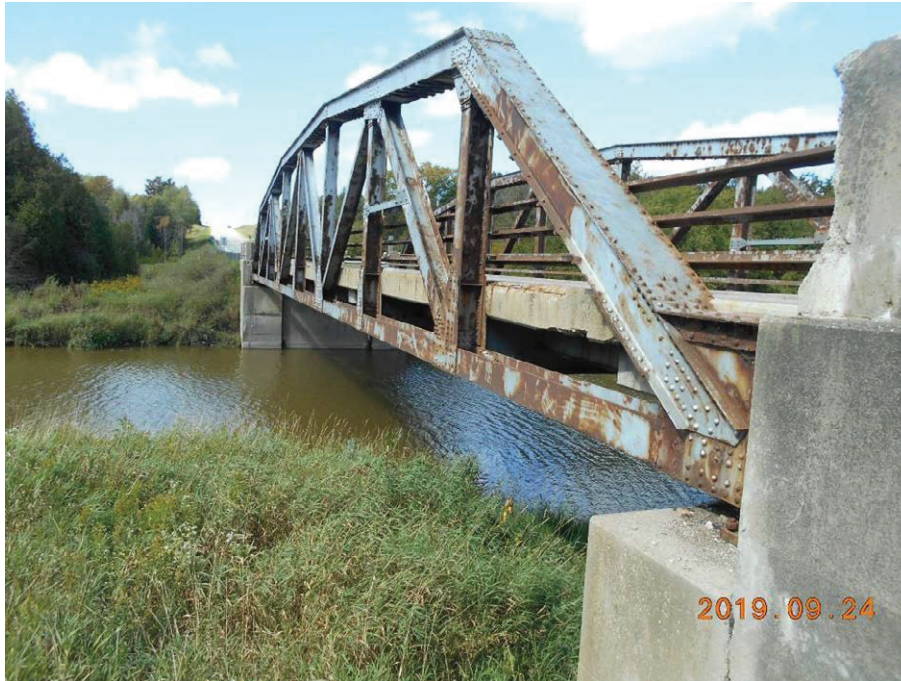
Date	Sept. 24, 2019	Description	South Elevation
------	----------------	-------------	-----------------

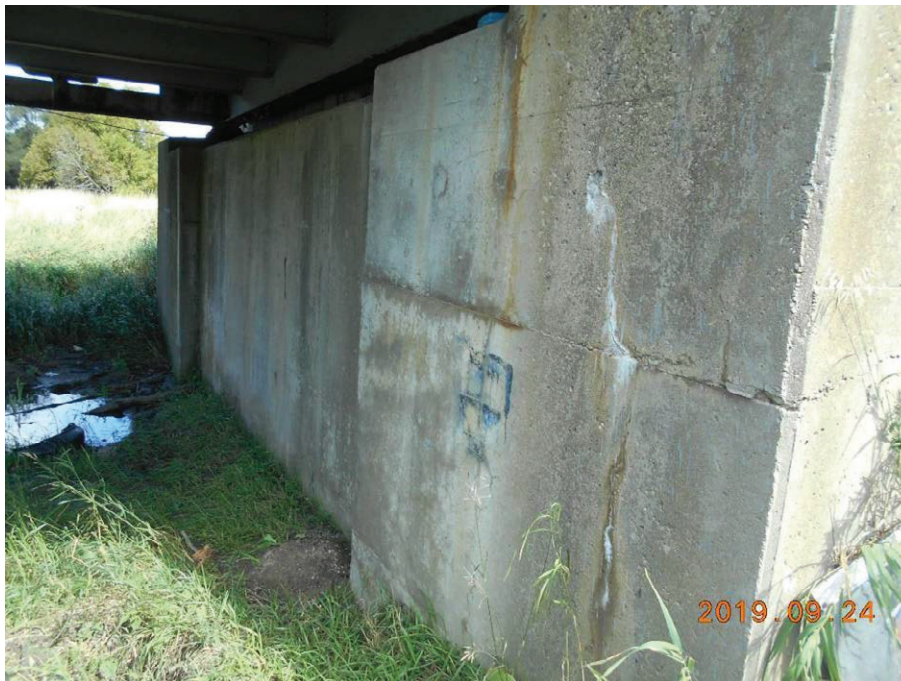
Date	Sept. 24, 2019	Description	East Abutment
------	----------------	-------------	---------------

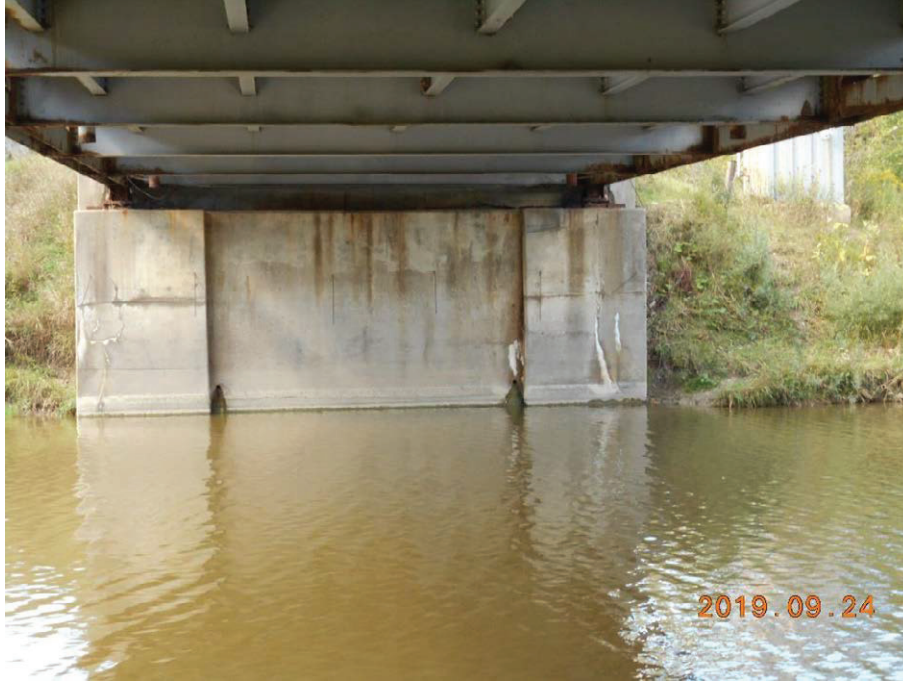
Date	Sept. 24, 2019	Description	West Abutment
------	----------------	-------------	---------------

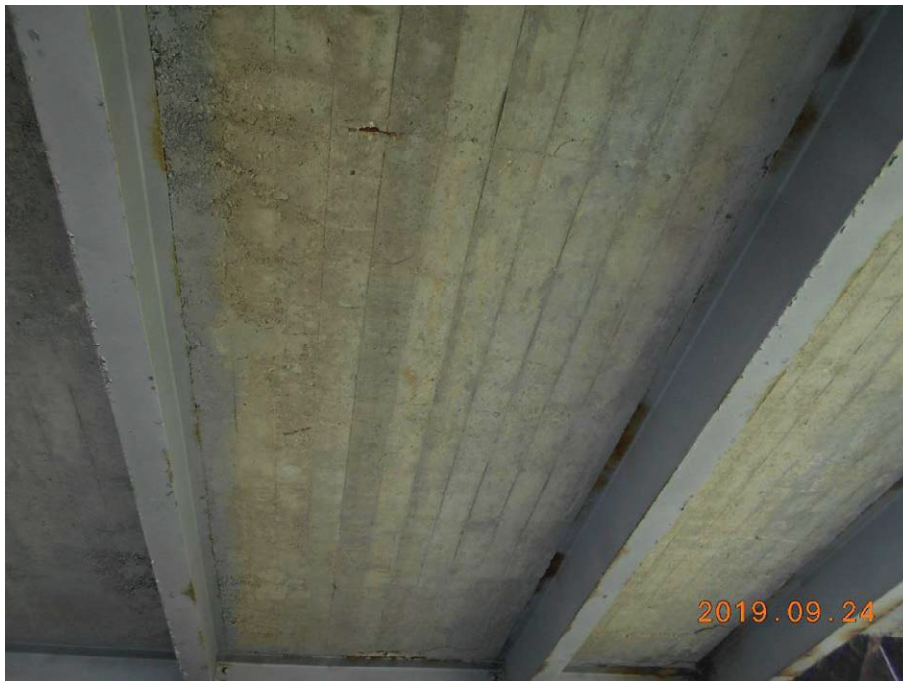
Delaminations with exposed reinforcing at deck ends
 Small delaminations/spalls with exposed reinforcing at midspan

Date	Sept. 24, 2019	Description	Soffit (Typical)
------	----------------	-------------	------------------

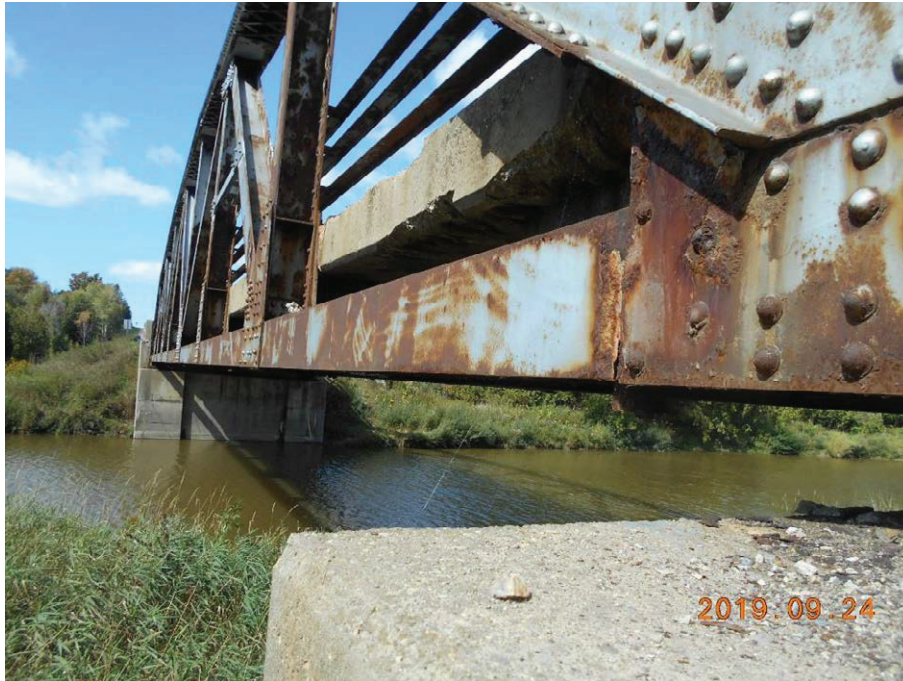
Date	Sept. 24, 2019	Description	Bottom Chord (Typical)
------	----------------	-------------	------------------------

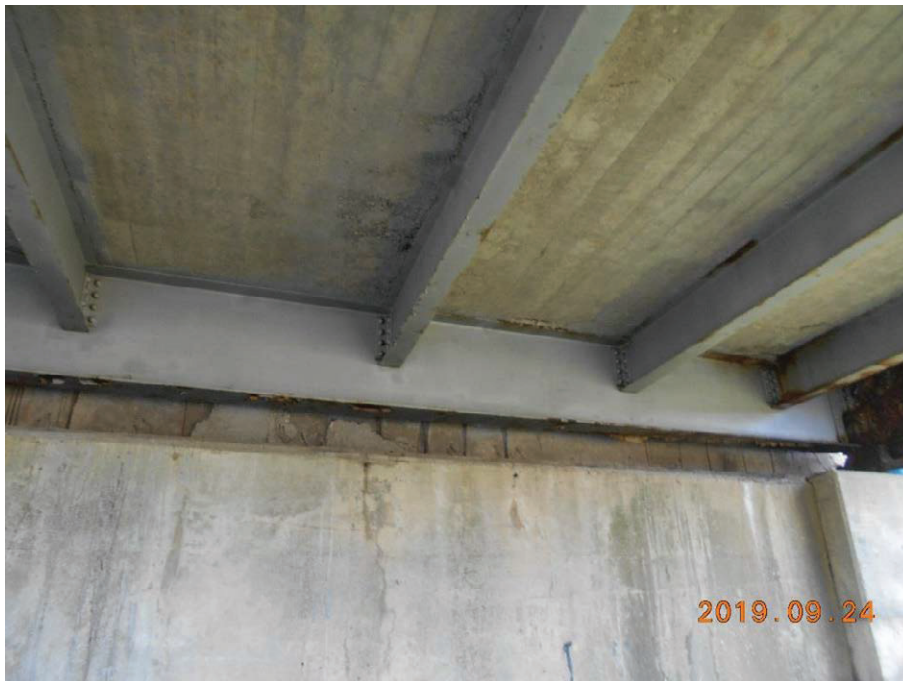
Date	Sept. 24, 2019	Description	Floorbeam and Stringers (Typical)
------	----------------	-------------	-----------------------------------

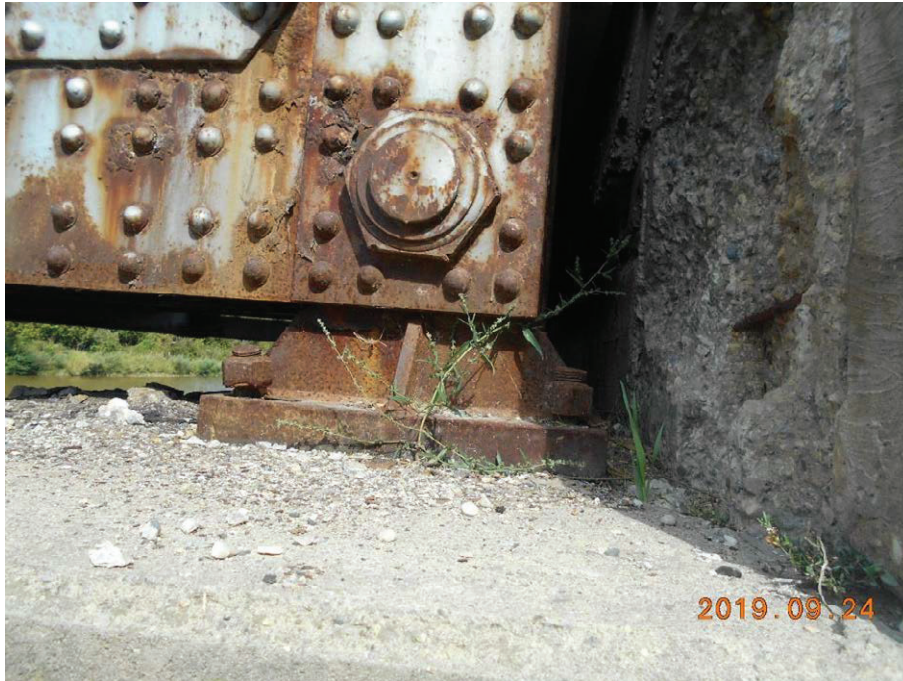
Date	Sept. 24, 2019	Description	East Abutment Bearing
------	----------------	-------------	-----------------------

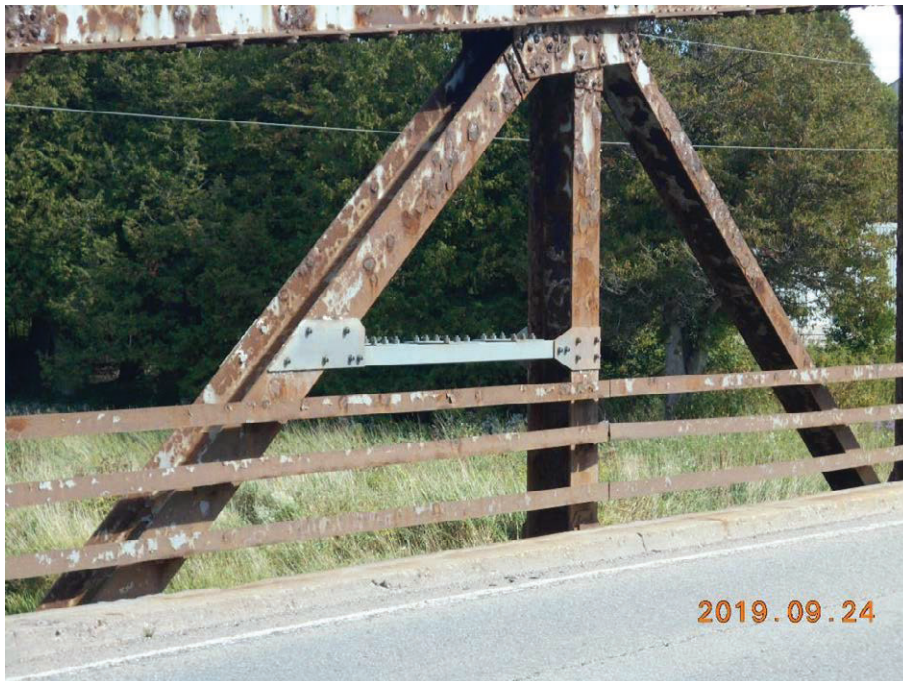
Date	Sept. 24, 2019	Description	Recently Installed Bracing Member
------	----------------	-------------	-----------------------------------

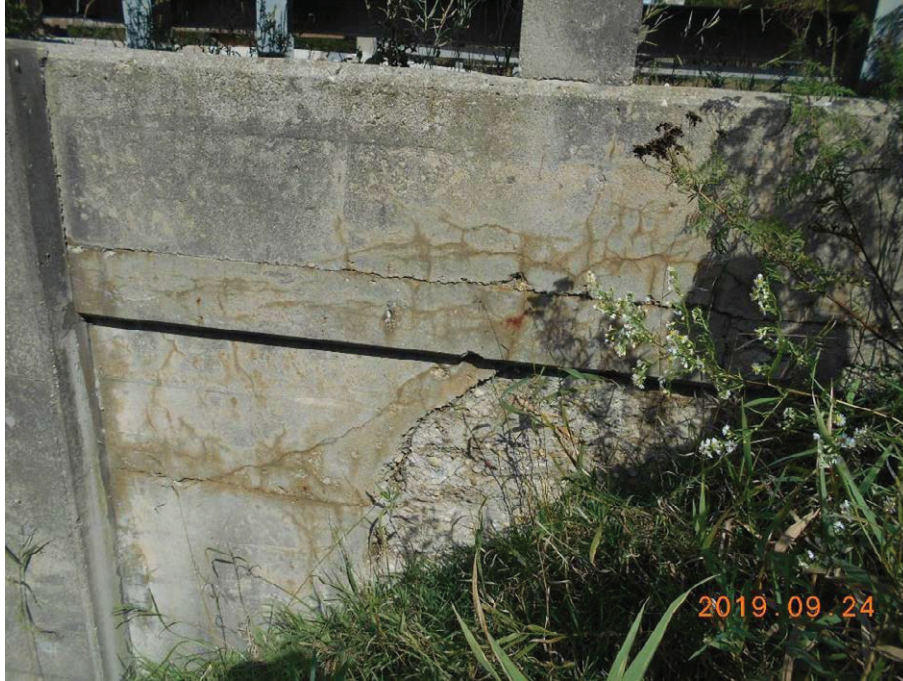
Comments:Southeast wingwall has large crack at abutment
Cracks, patches and light scaling throughout

Date	Sept. 24, 2019	Description	Southeast Wingwall (Note: Spall)
------	----------------	-------------	----------------------------------

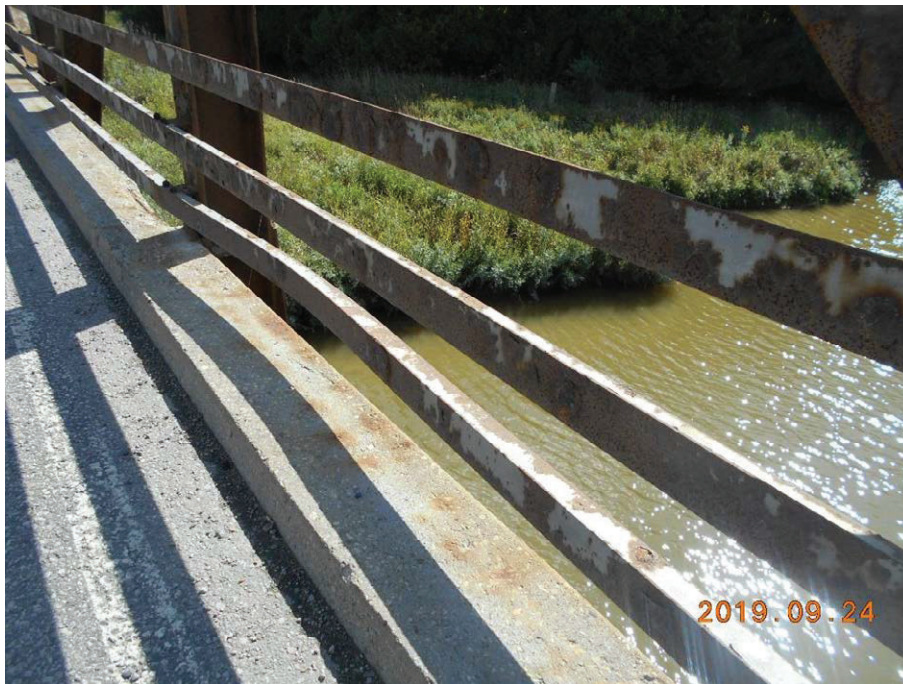
Several broken posts

Date	Sept. 24, 2019	Description	Damaged Barrier
------	----------------	-------------	-----------------

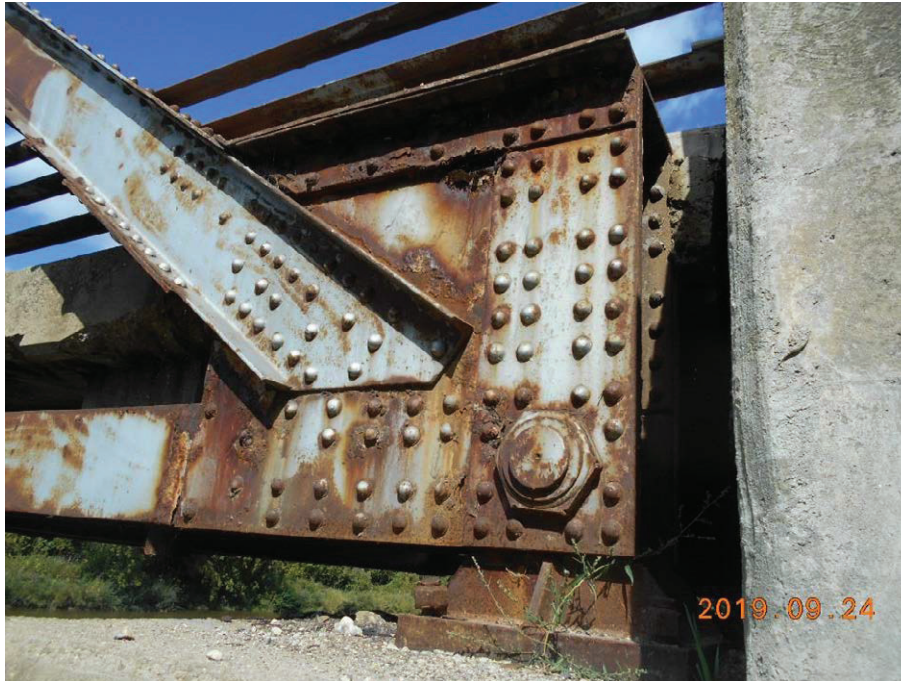
Coating failure on most exposed elements

Date	Sept. 24, 2019	Description	Medium Corrosion at Gusset Connection
------	----------------	-------------	---------------------------------------

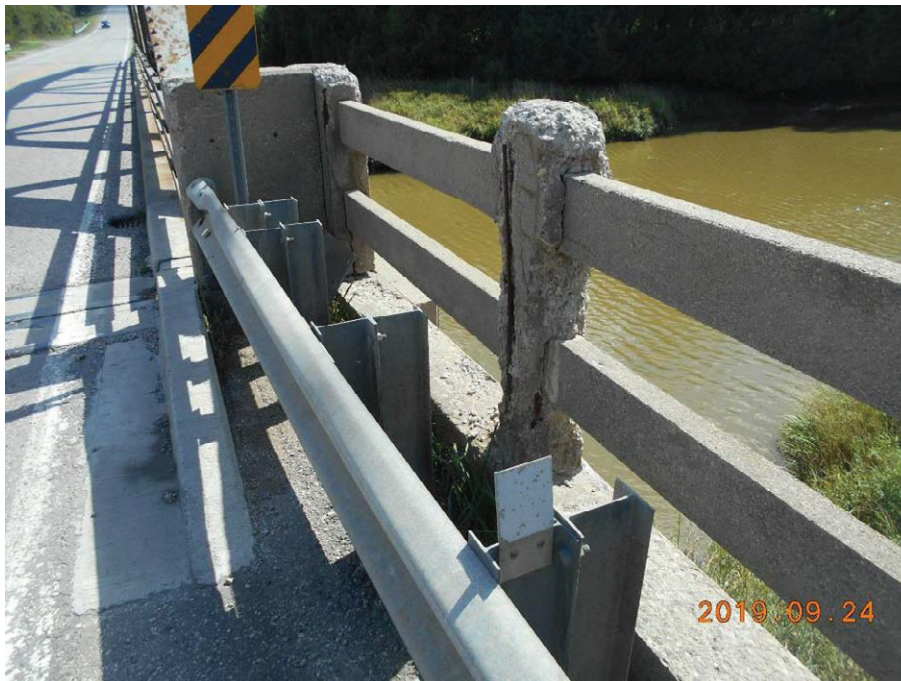
Spalls/delaminations with exposed reinforcing

Date	Sept. 24, 2019	Description	Spall with Exposed Rebar at Concrete Barrier
------	----------------	-------------	--

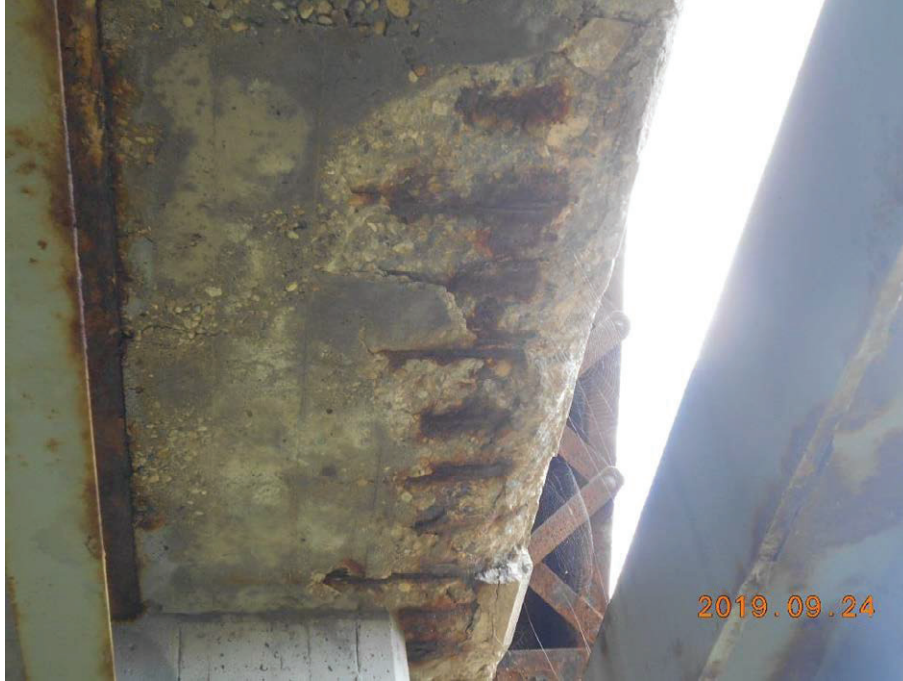
Spalls/delaminations along the exterior soffit with exposed reinforcing and rust staining

Date	Sept. 24, 2019	Description	Spall with Exposed Rebar at Exterior Soffit
------	----------------	-------------	---
