Fluvial Geomorphology

SUBJECT: Wellington Road 109 Schedule C Municipal Class Environmental Assessment – Fluvial Geomorphology Assessment

DATE: June 28, 2023

Project No.: 17M-01271-02

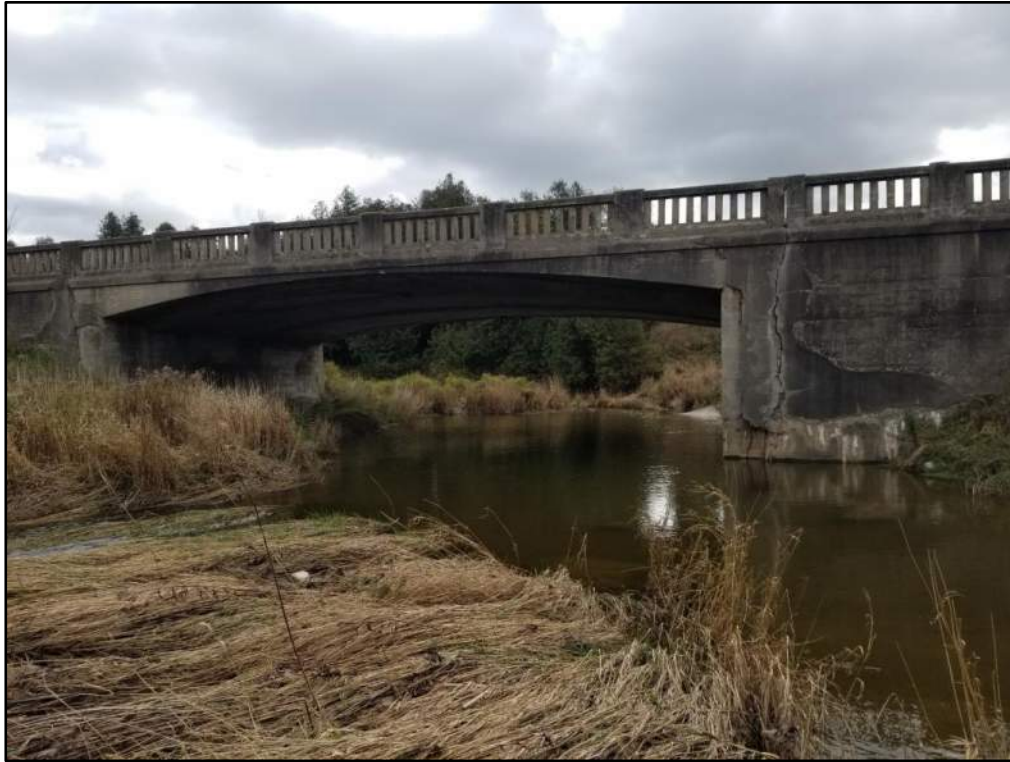
Photo 15: B109132 looking south upstream

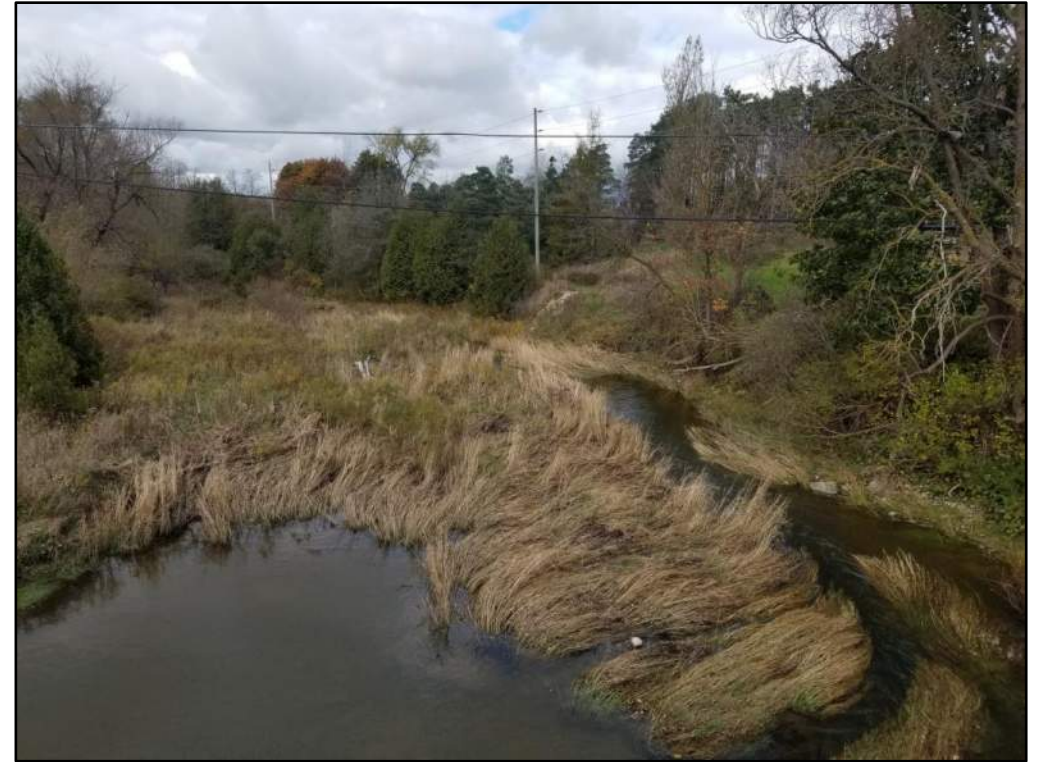
Photo 16: B109132 looking north downstream

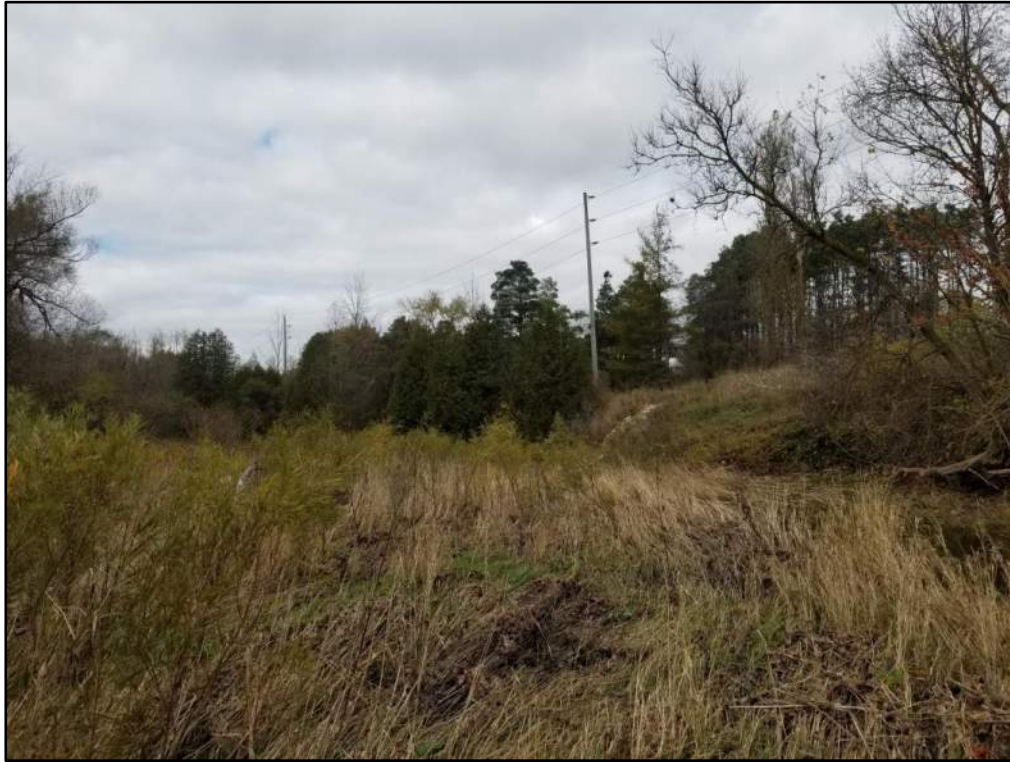
Photo 17: B109132 looking north downstream

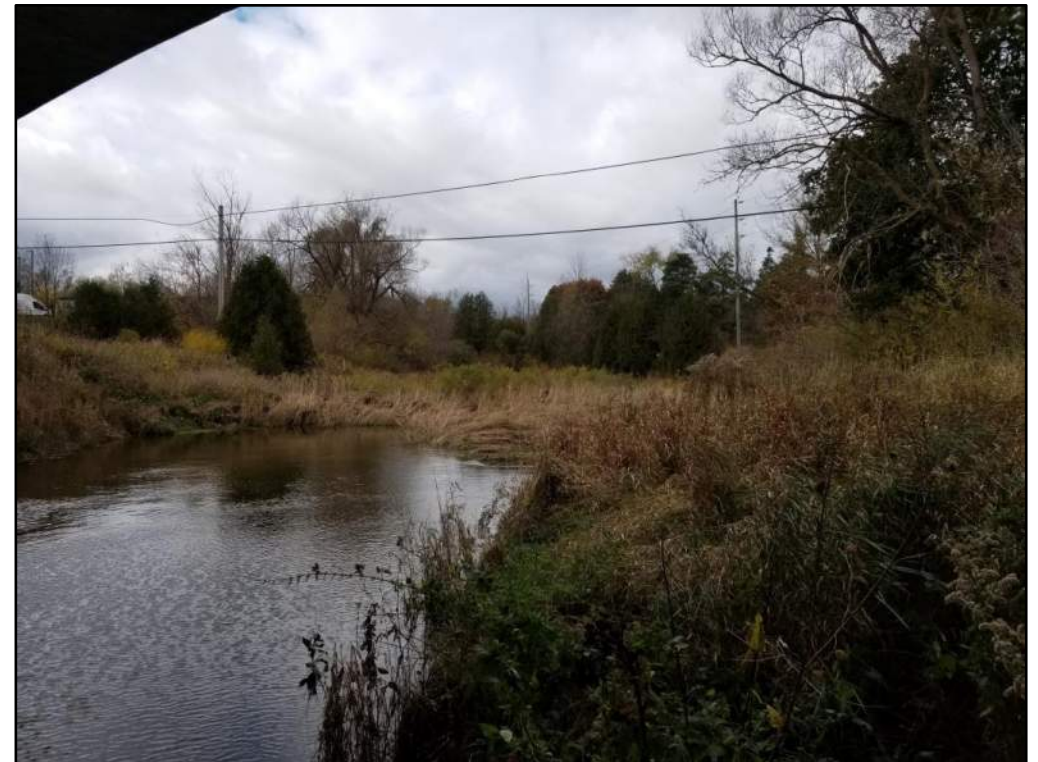
Photo 18: B109132 looking north downstream

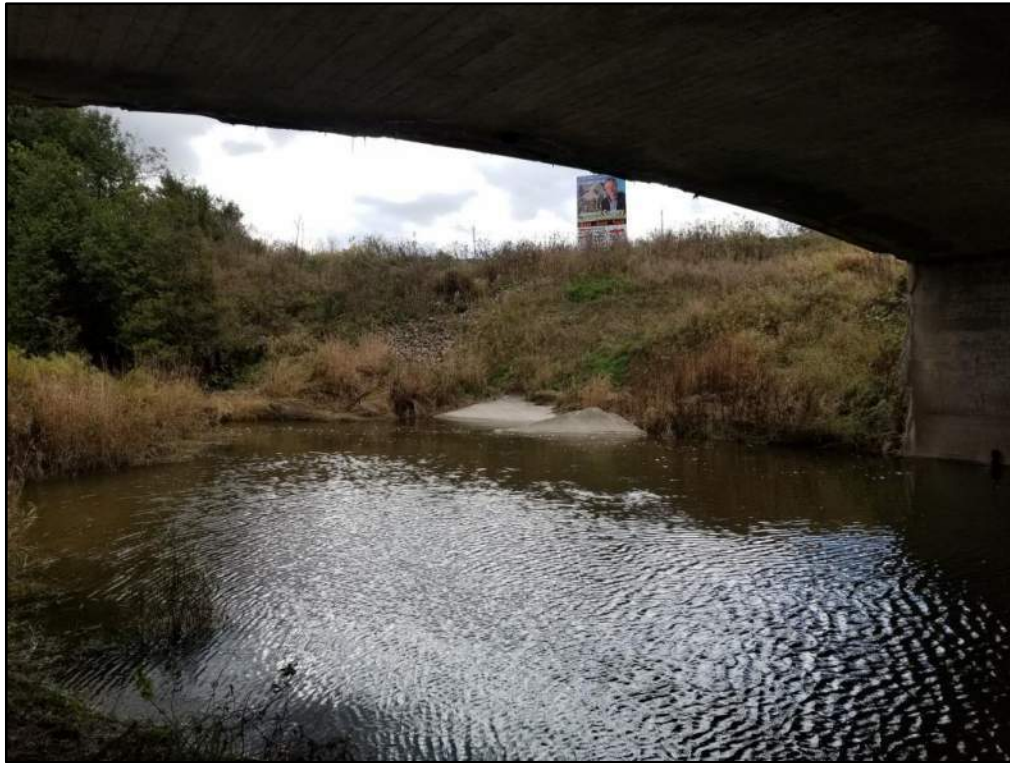
Photo 19: B109132 looking south upstream

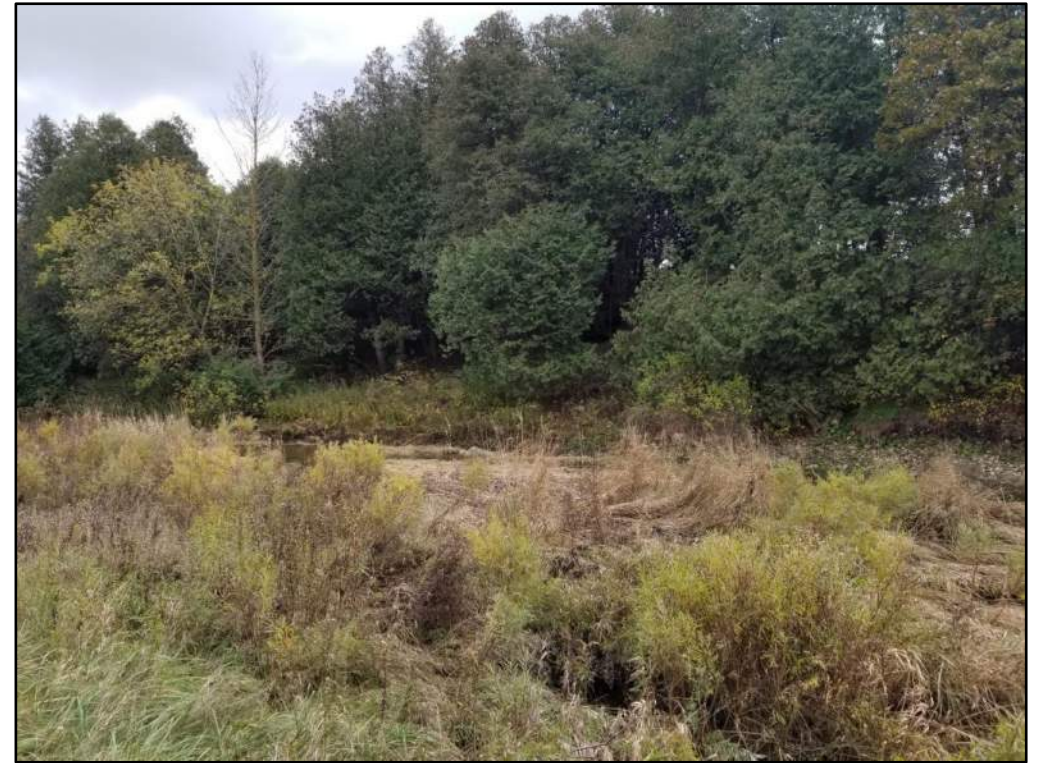
Photo 20: B109132 looking south upstream

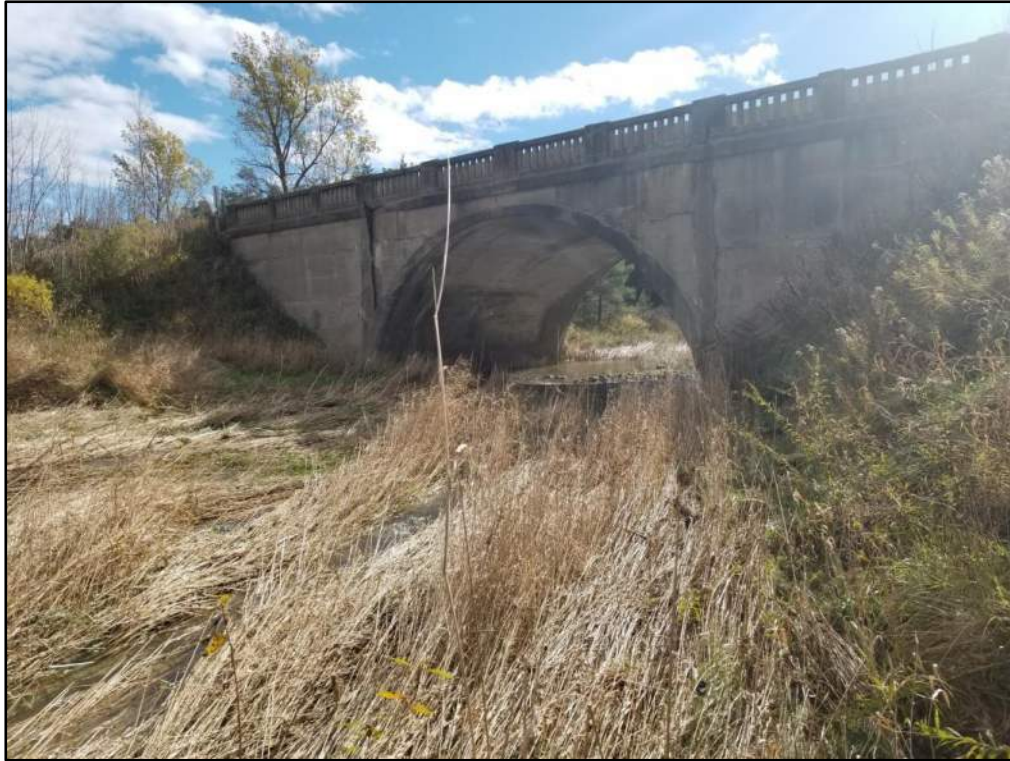
Photo 9: B109123 looking south downstream

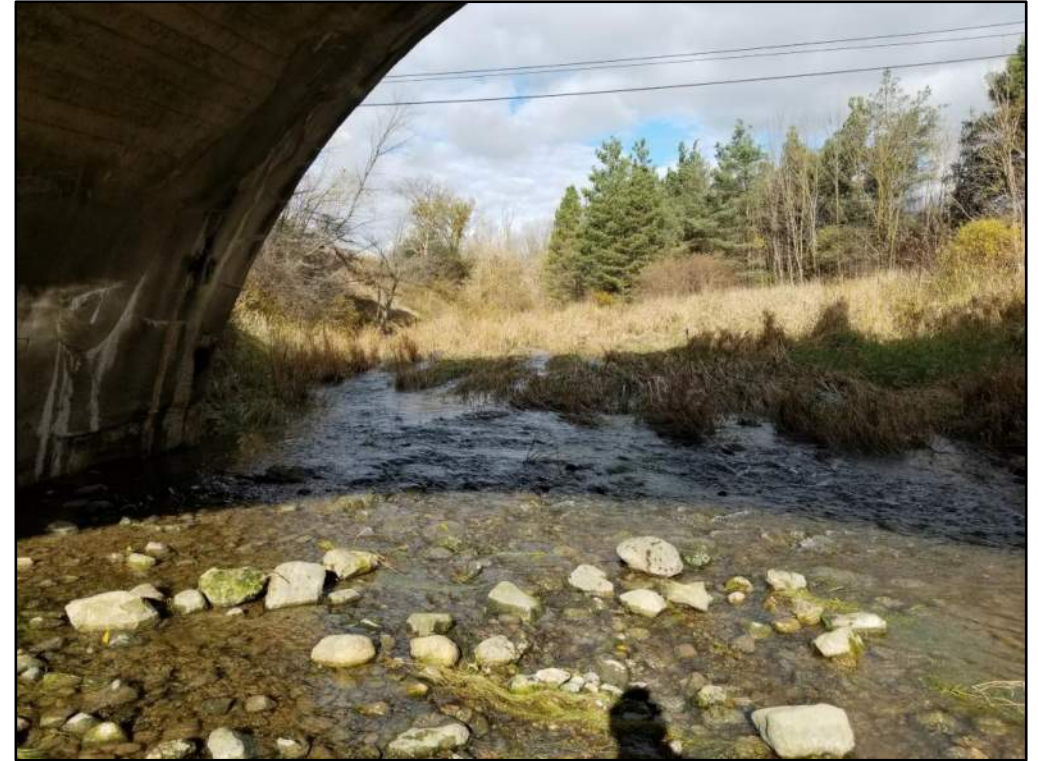
Photo 10: B109123 looking north upstream

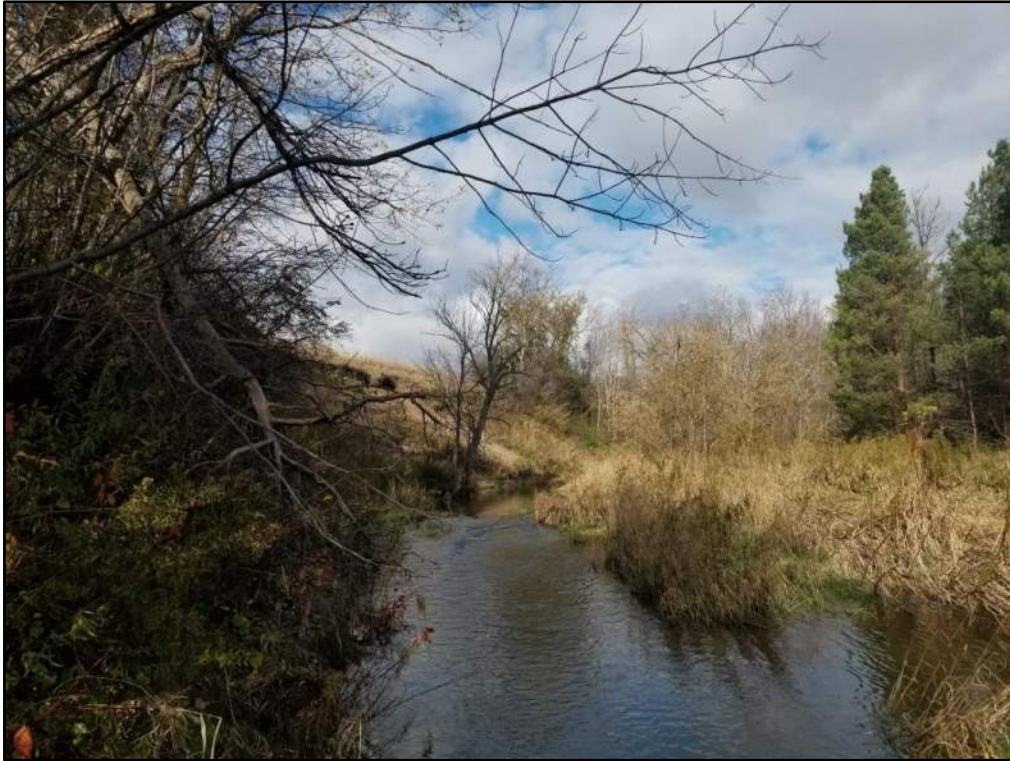
Photo 11: B109123 looking north upstream

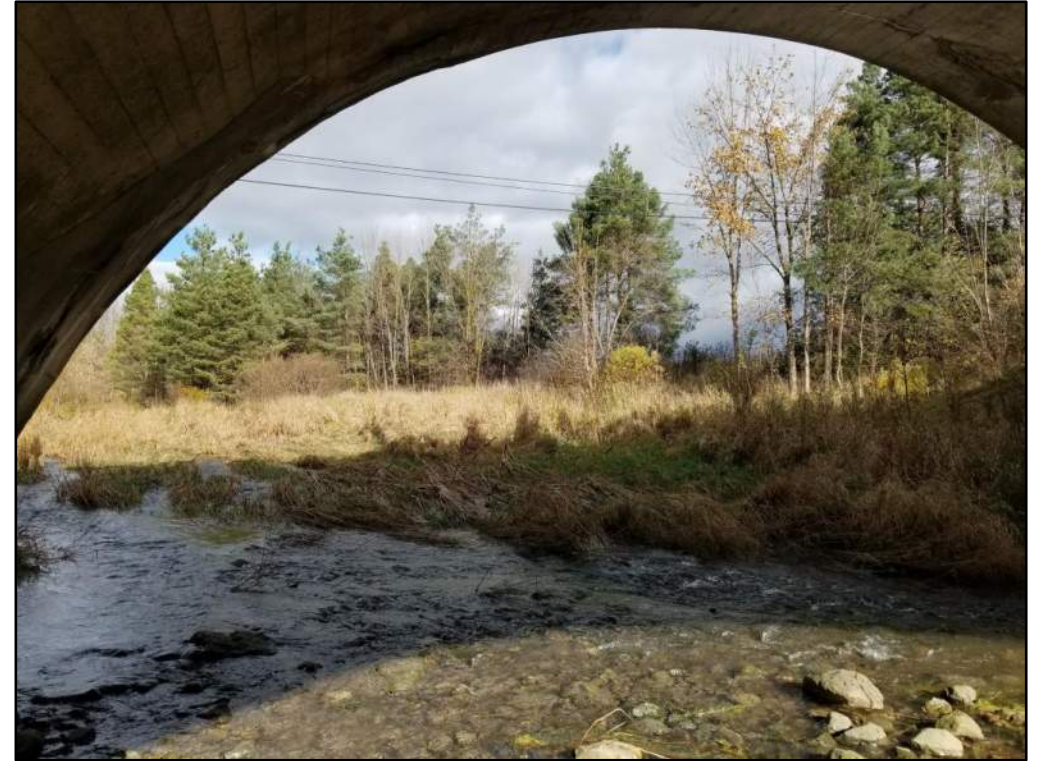
Photo 12: B109123 looking north upstream

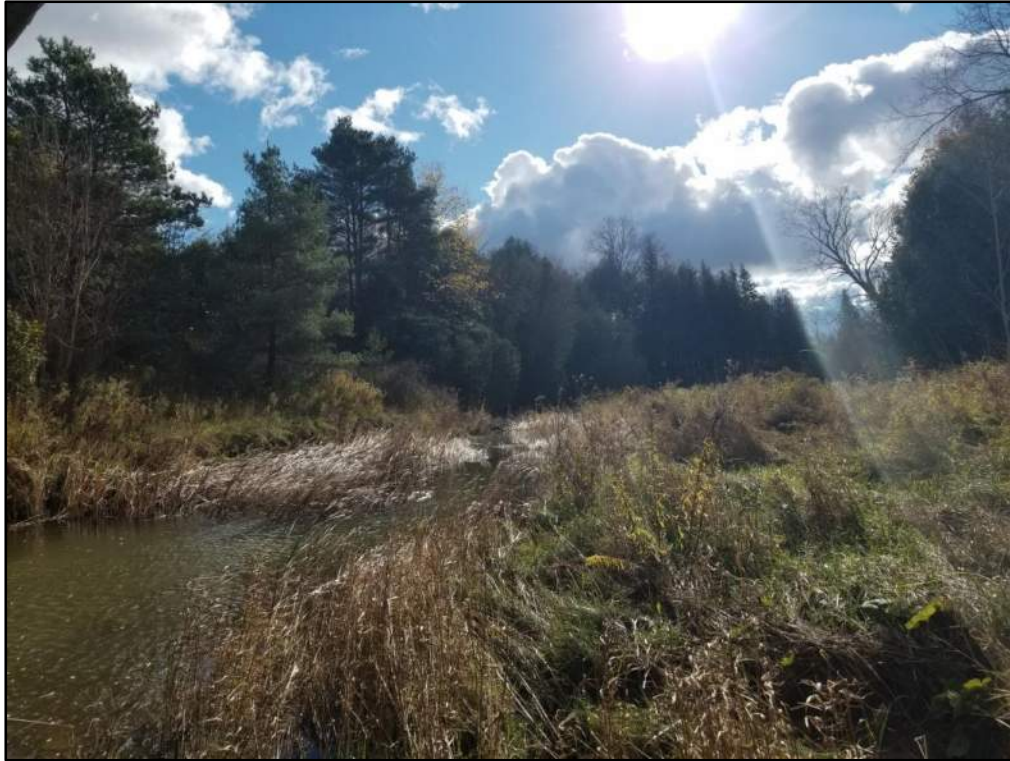
Photo 13: B109123 looking south downstream

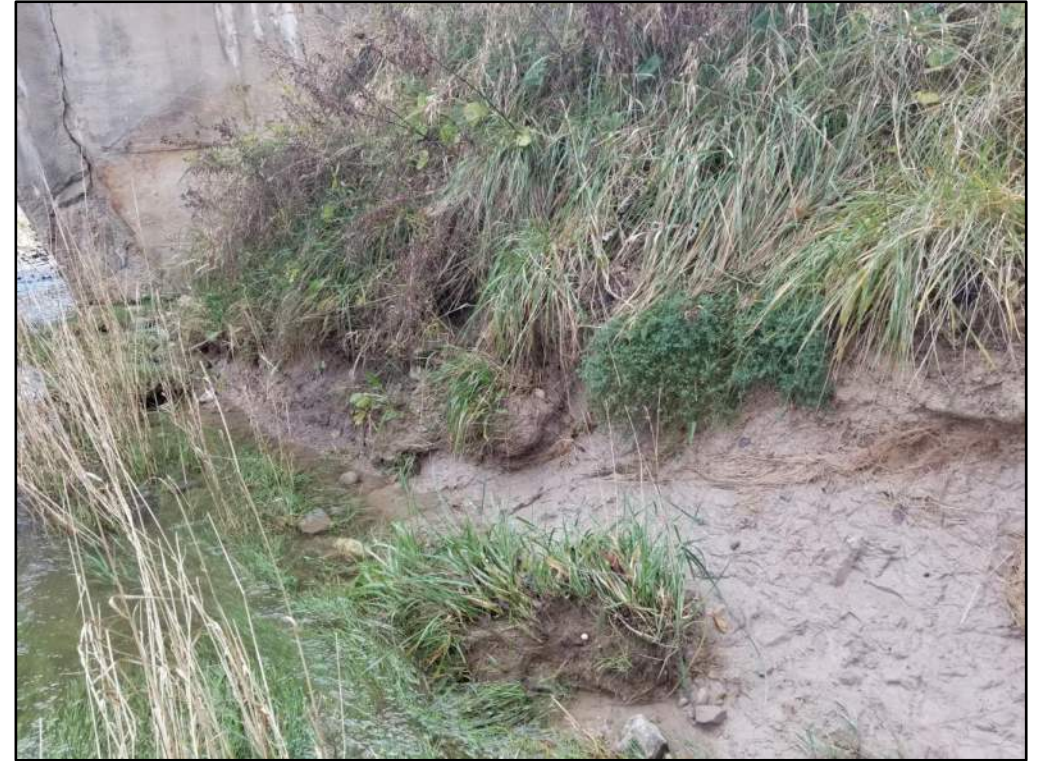
Photo 14: B109123 looking southwest at bank material

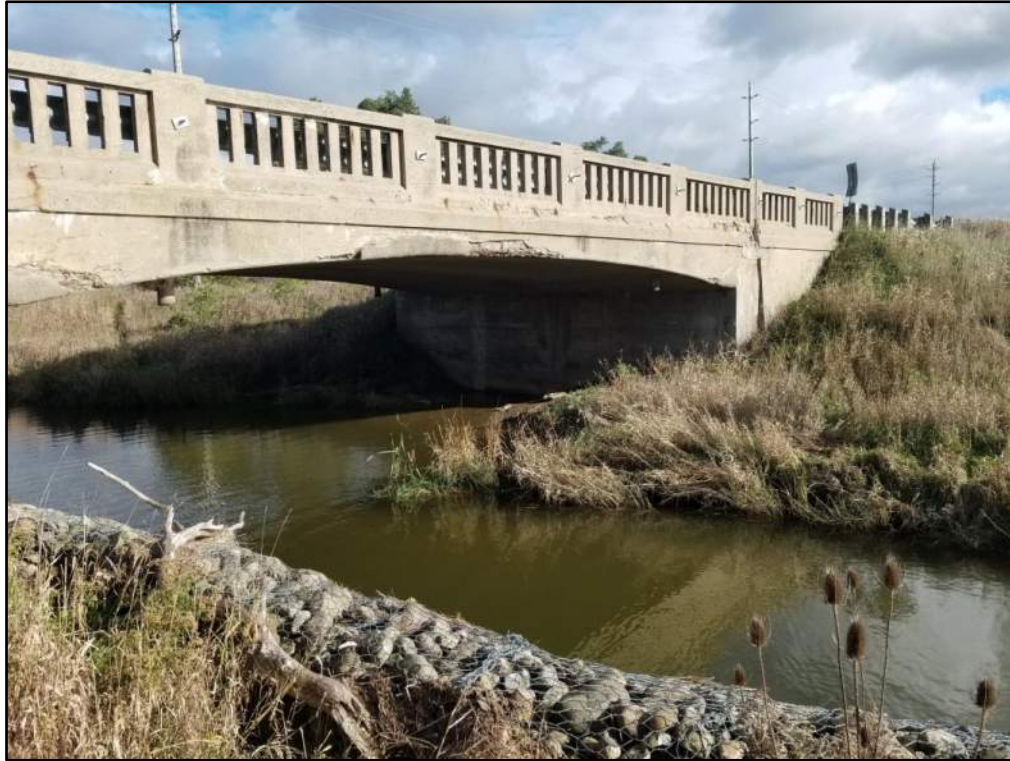
Photo 7: B109133 looking northeast downstream

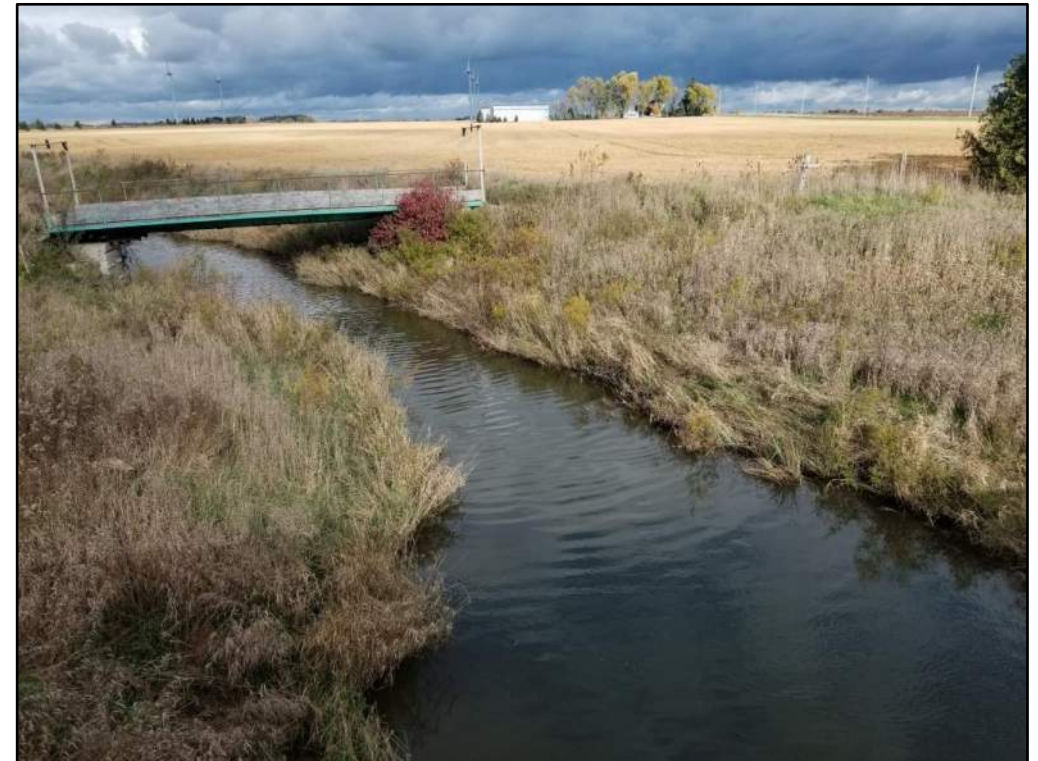
Photo 8: B109133 looking north downstream

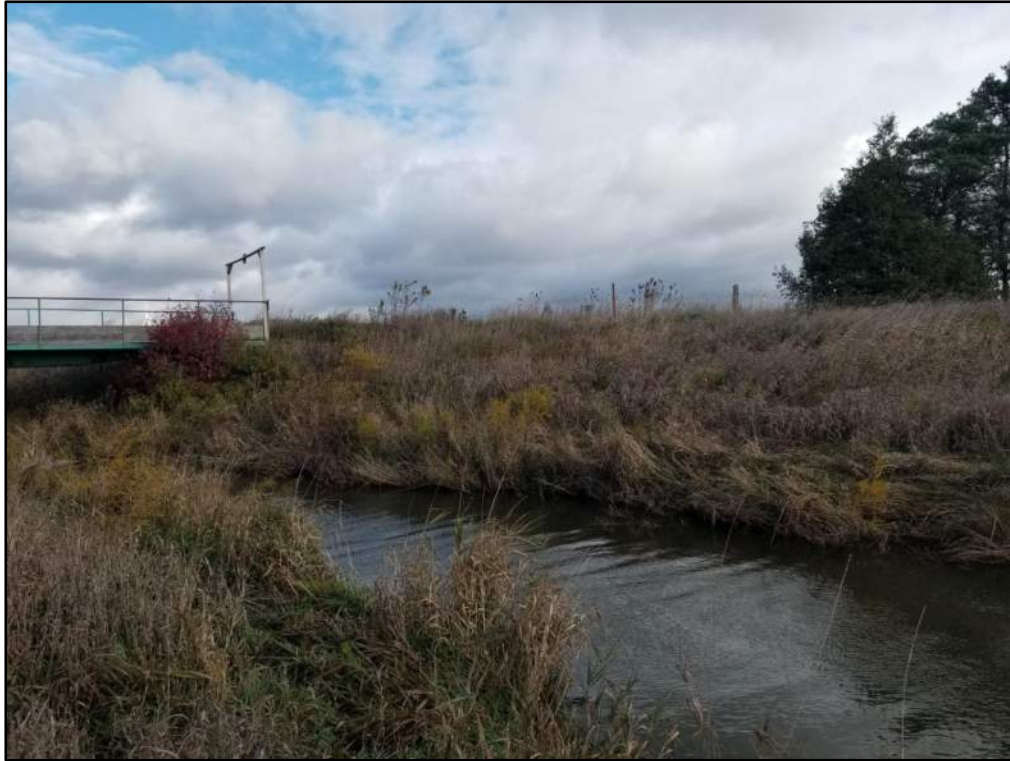
Photo 7: B109133 looking northeast downstream

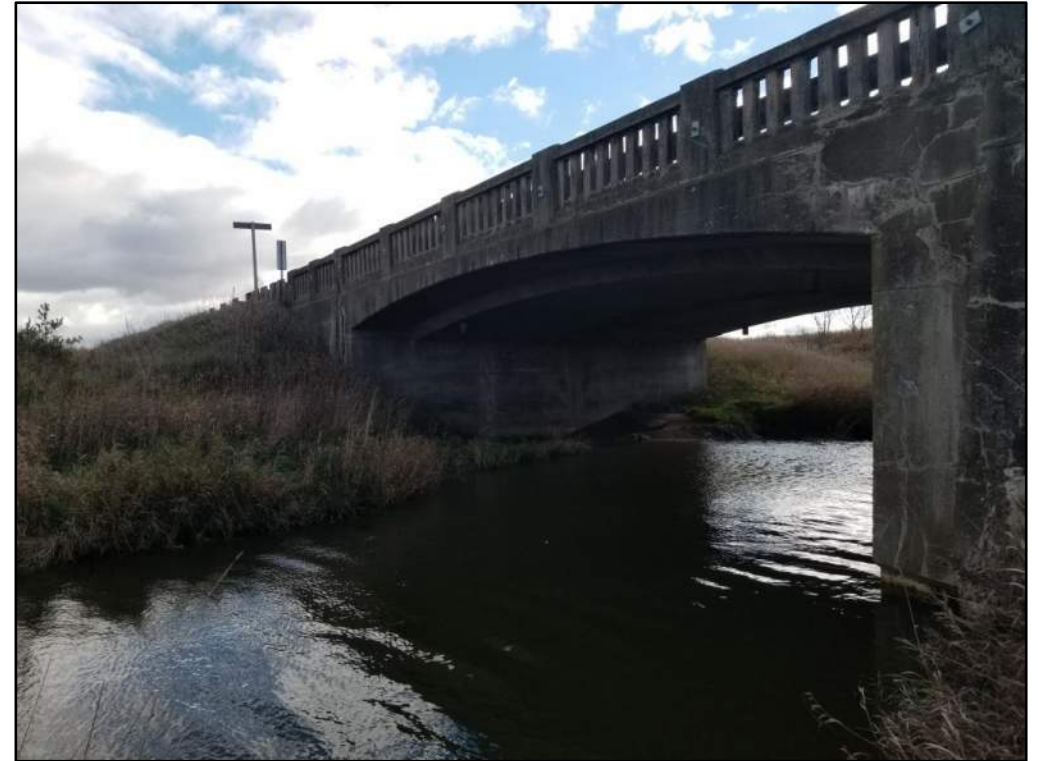
Photo 8: B109133 looking southeast upstream

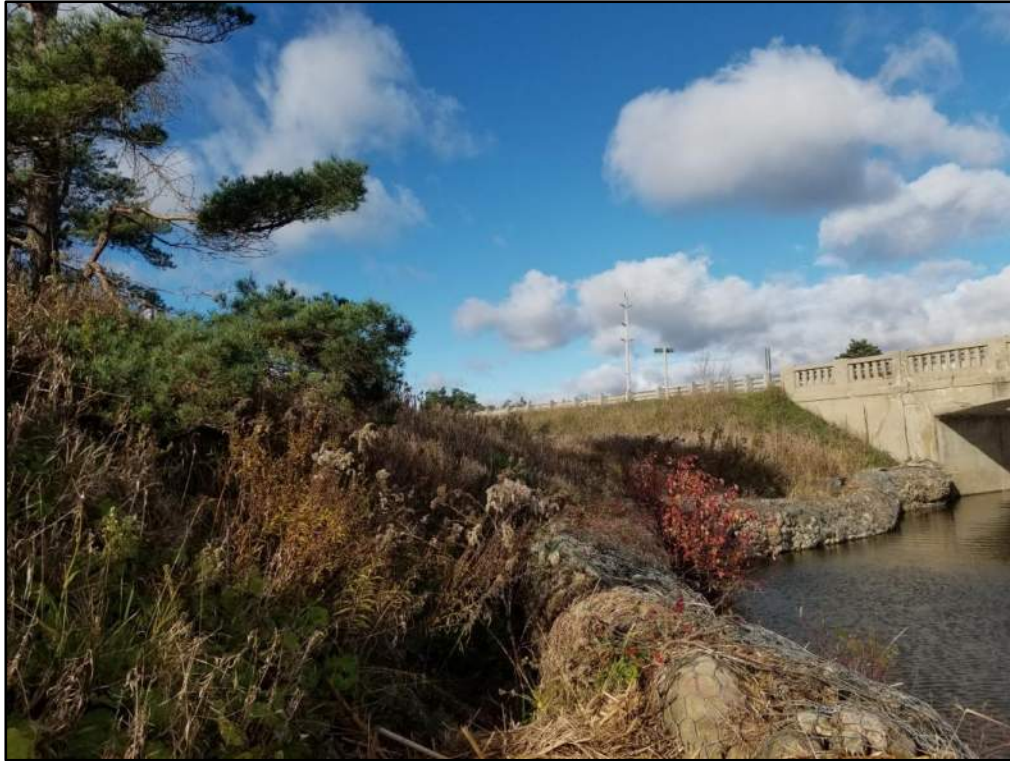
Photo 7: B109133 looking north downstream

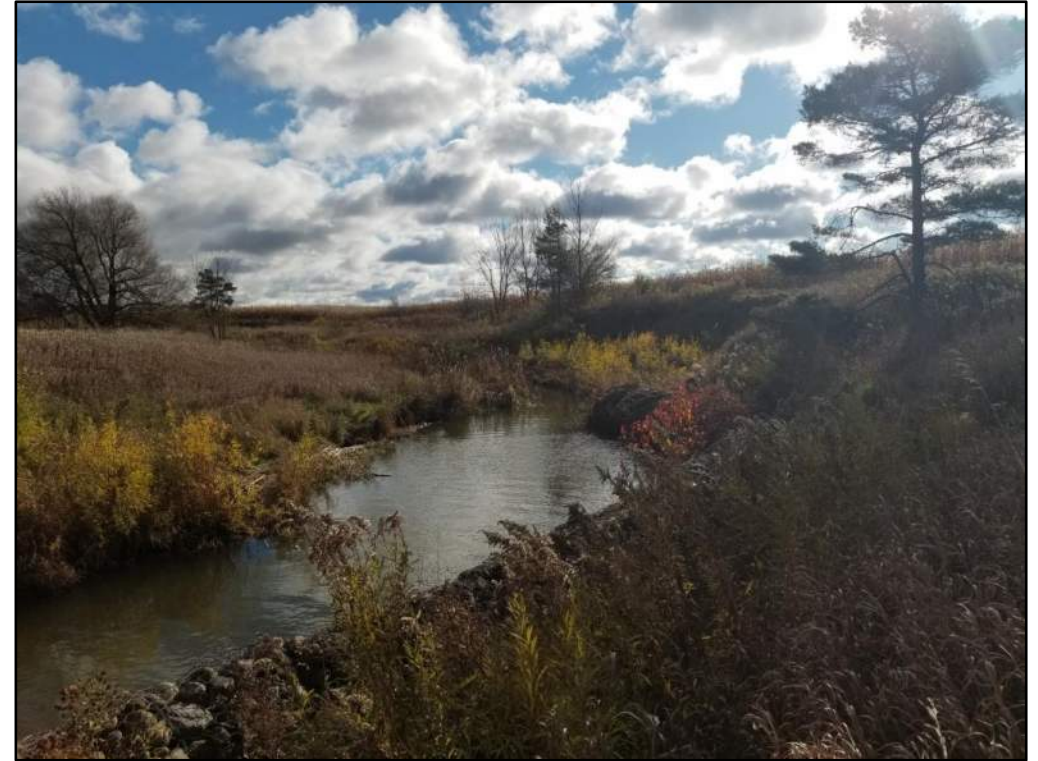
Photo 8: B109133 looking south upstream

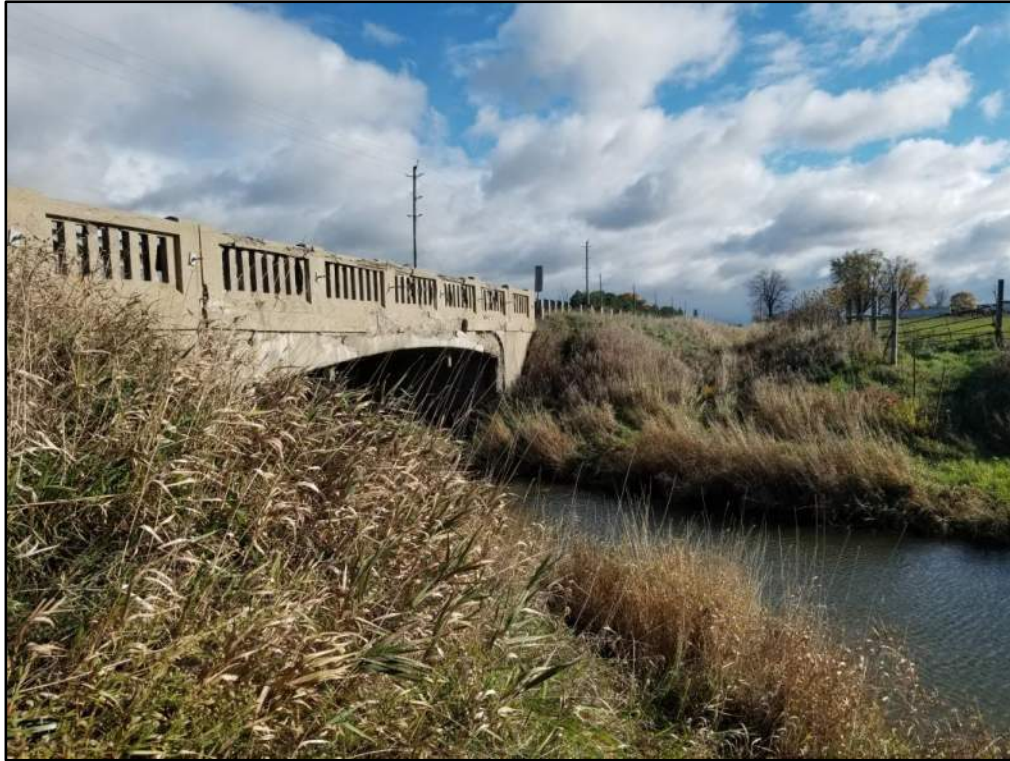
Photo 1: B109134 looking northeast at bridge

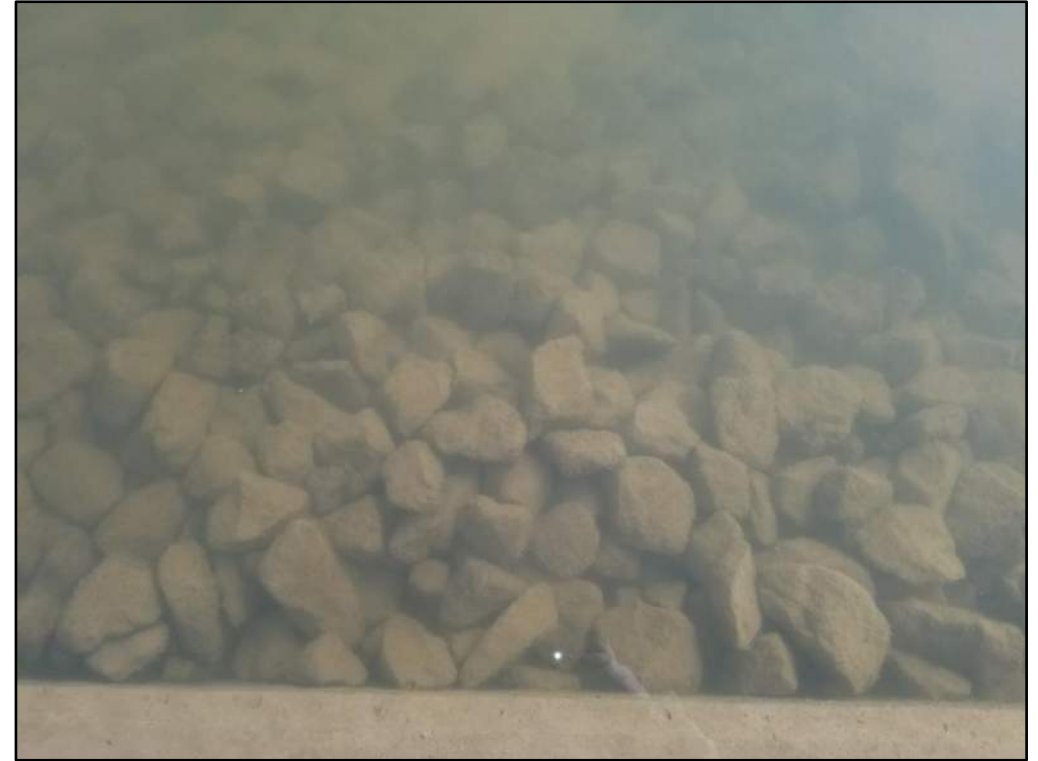
Photo 2: B109134 looking at bed sediment

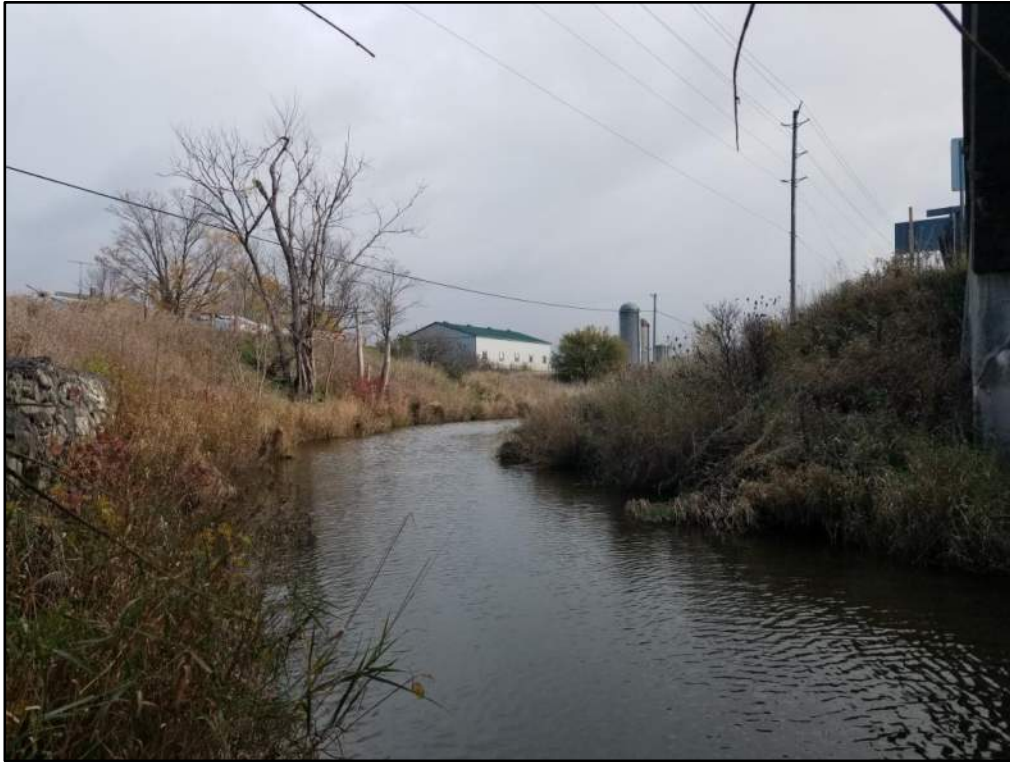
Photo 3: B109134 looking north upstream

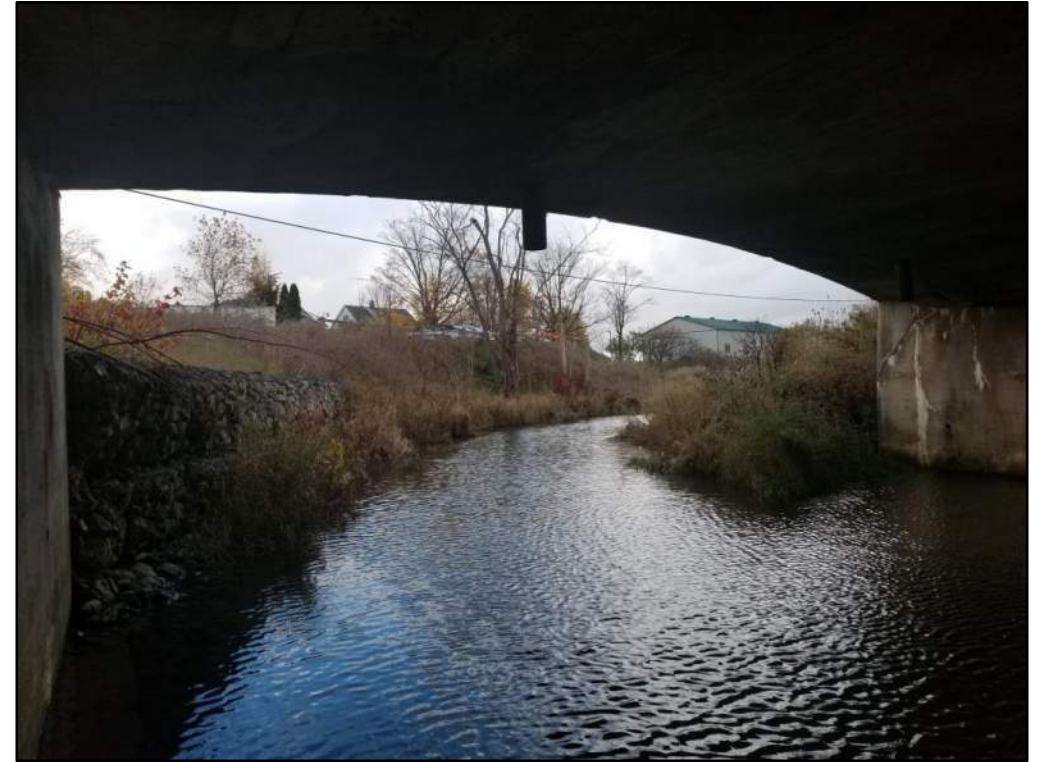
Photo 4: B109134 looking north upstream

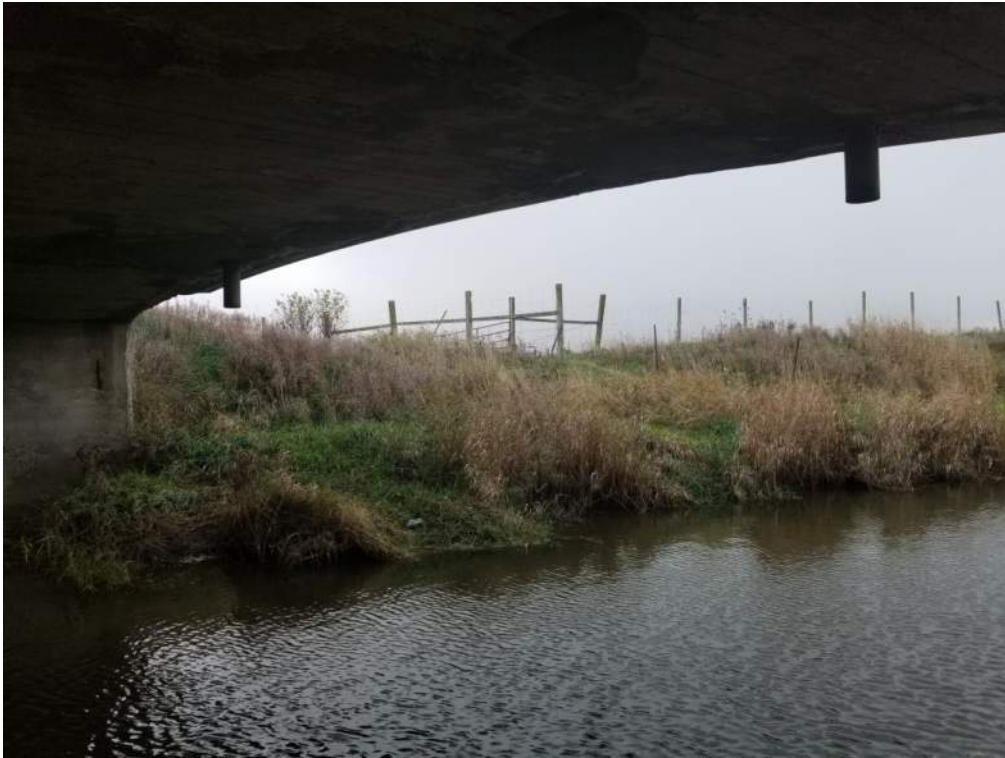
Photo 5: B109134 looking south downstream

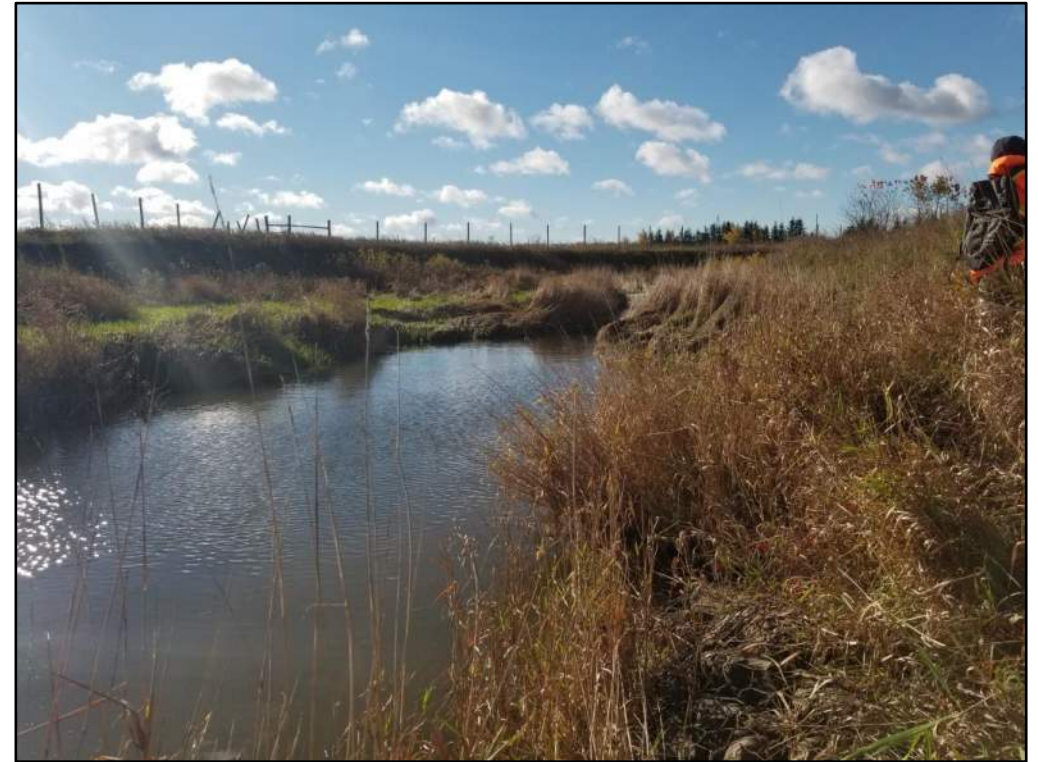
Photo 6: B109134 looking south downstream
