# Wellington Road 109 Bridges Municipal Class Environmental (EA) Study

From Highway 6 to Sideroad 7  
Township of North Wellington

**PUBLIC INFORMATION CENTRE #1**  
**Online Package**

Fall 2020

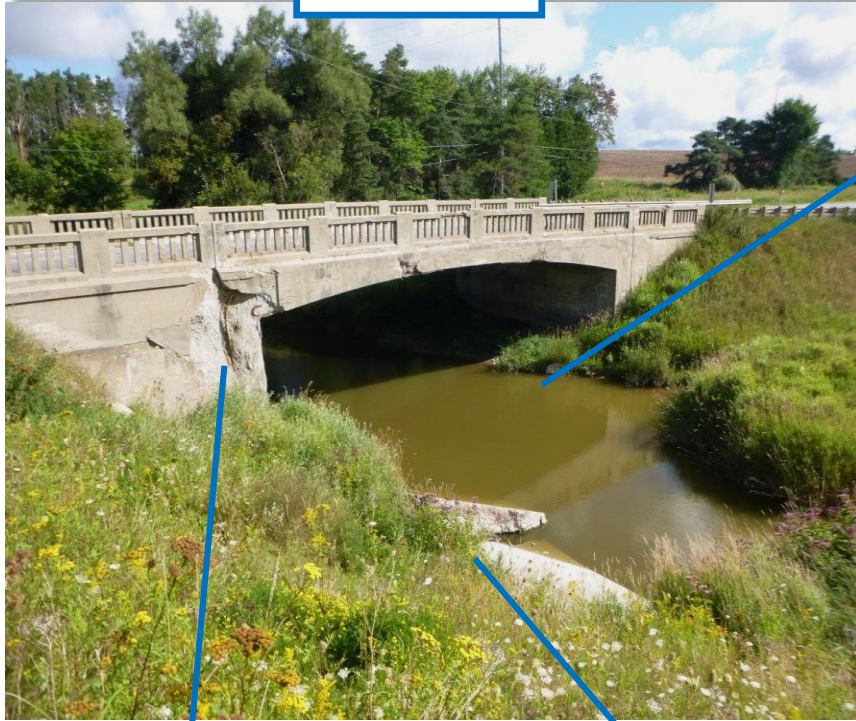
South Elevation

Large spall, severe scaling and disintegration of concrete throughout (worst at southwest)

Remains of collapsed retaining wall

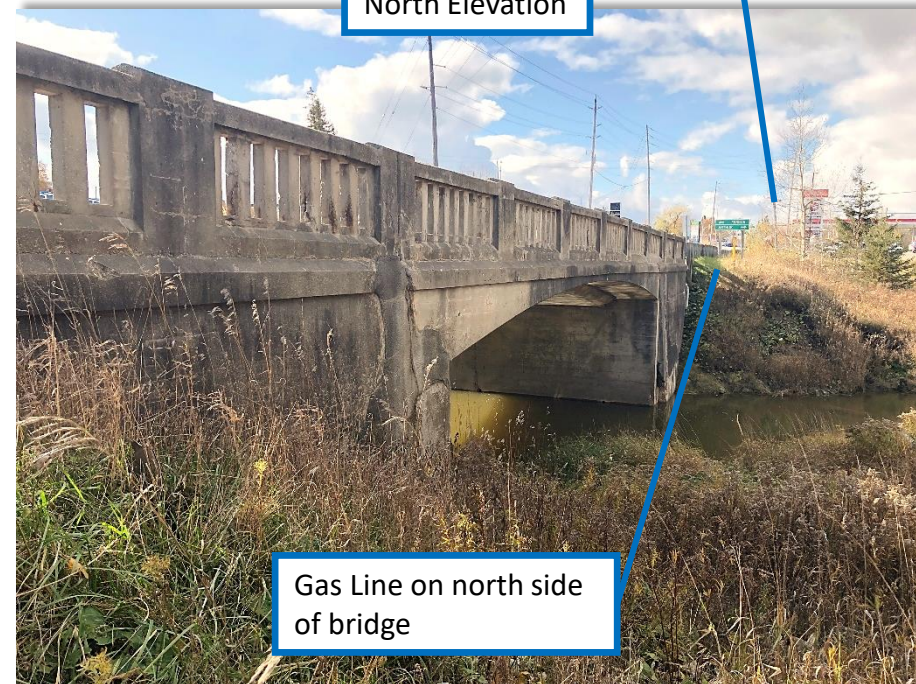
North Elevation

Gas Line on north side of bridge

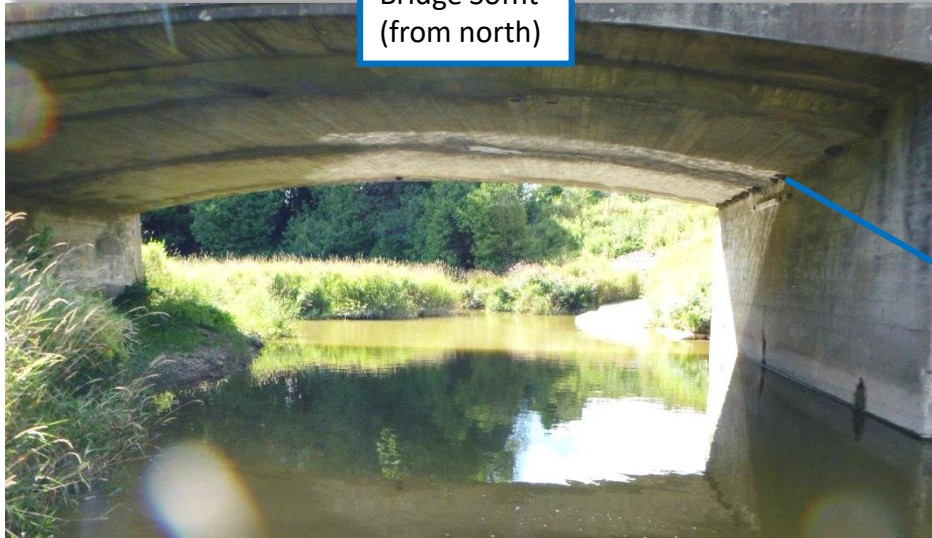
Bridge Soffit  
(from north)

Cliff Swallow Nests

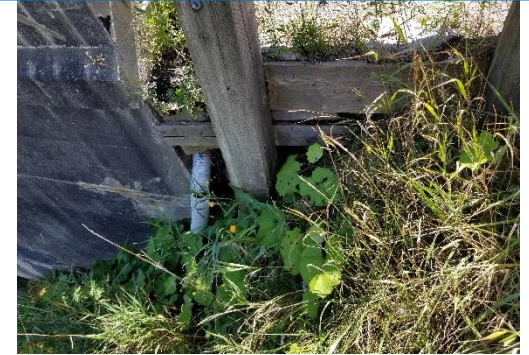
Temporary wood shoring of road (due to scour/erosion of northwest embankment)

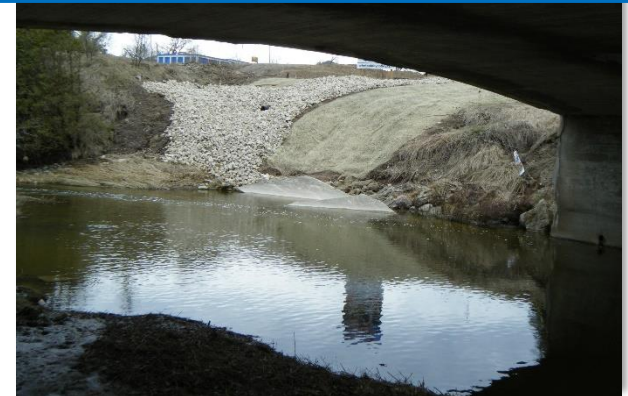
Bank stabilization measures have been put in place to address erosion on the outside meander bend on the south side of the bridge

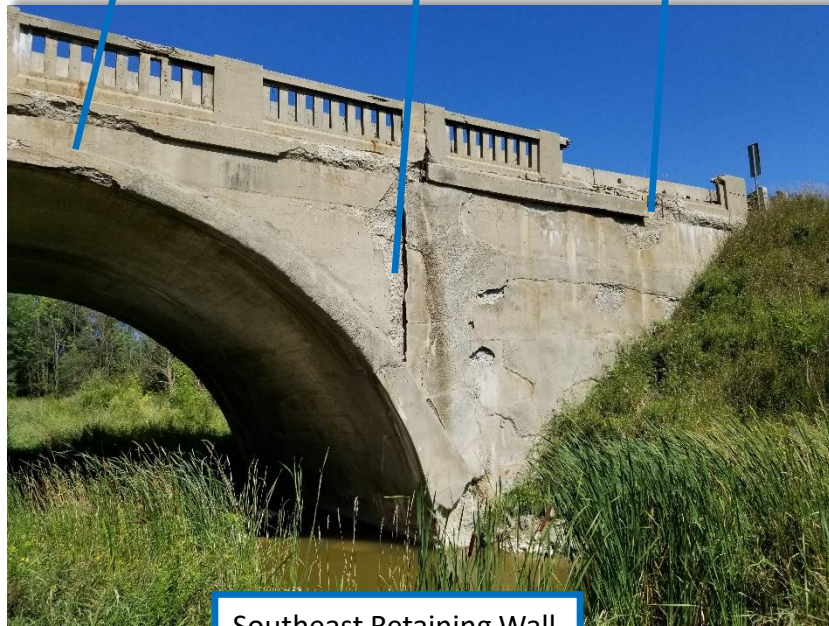
Large spall, severe scaling and disintegration of concrete

Concrete railing failure with temporary concrete barrier

Large delamination and wide crack

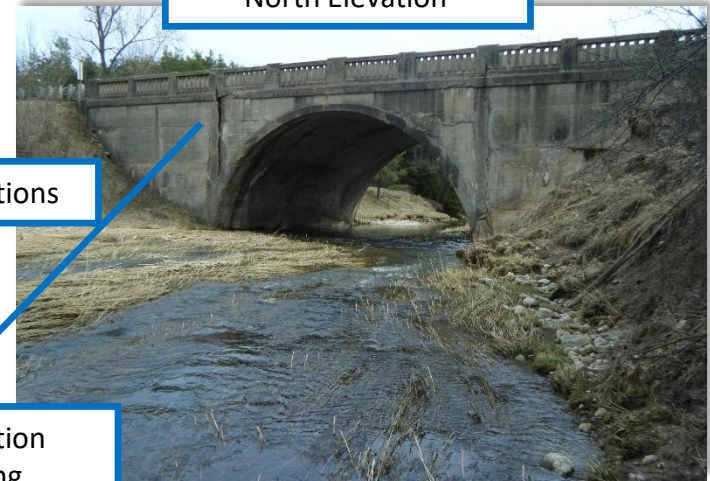
North Elevation

Concrete deterioration throughout including spalled and delaminated concrete with wide cracks

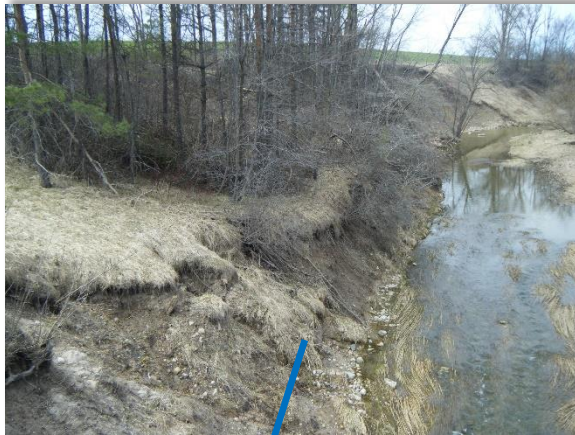
Bank erosion noted upstream, along outside of meander bend

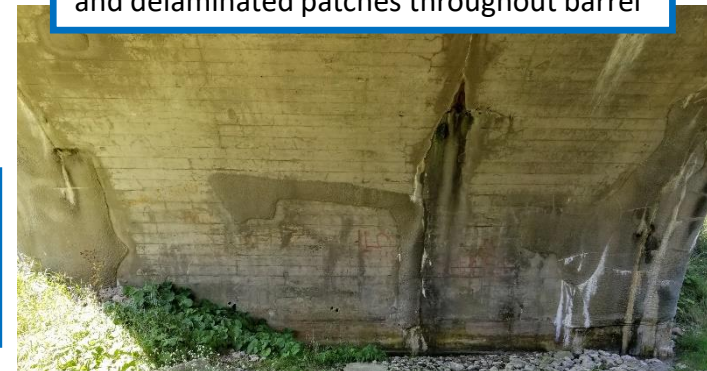
Wet wide cracks, rust staining, efflorescence and delaminated patches throughout barrel

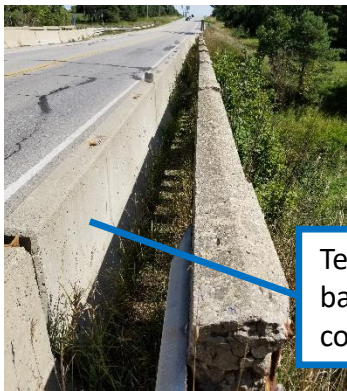
Temporary concrete barrier adjacent to concrete railing

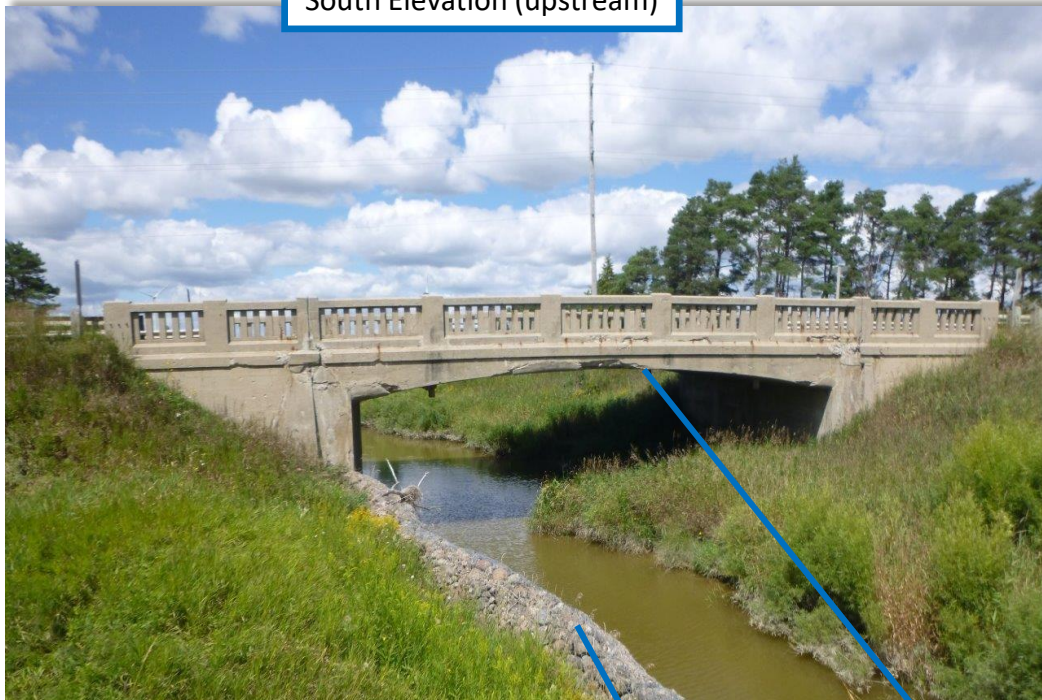
South Elevation (upstream)

Concrete deterioration throughout south elevation including spalled and delaminated concrete with rust staining and wide cracks

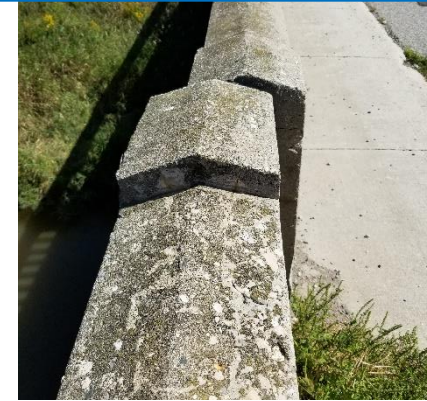
Rotation of northwest retaining wall and mis-alignment of railing

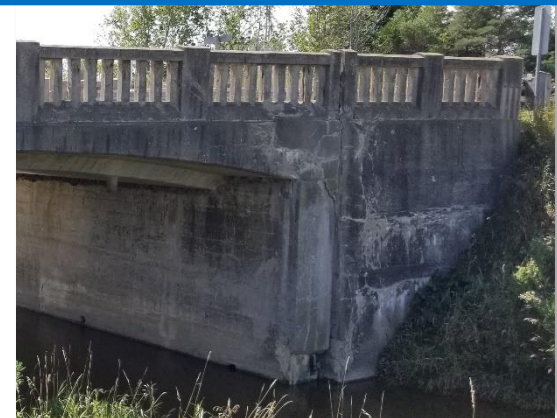
Spalled and delaminated concrete with wide cracks and efflorescence at northwest wingwall

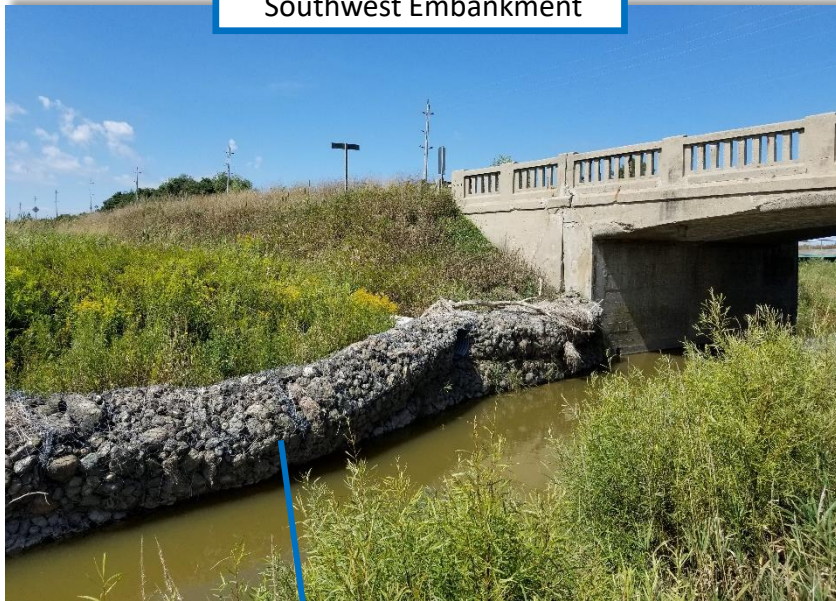
Southwest Embankment

Bank stabilization measures have been installed to control erosion however, the gabion shows signs of slumping

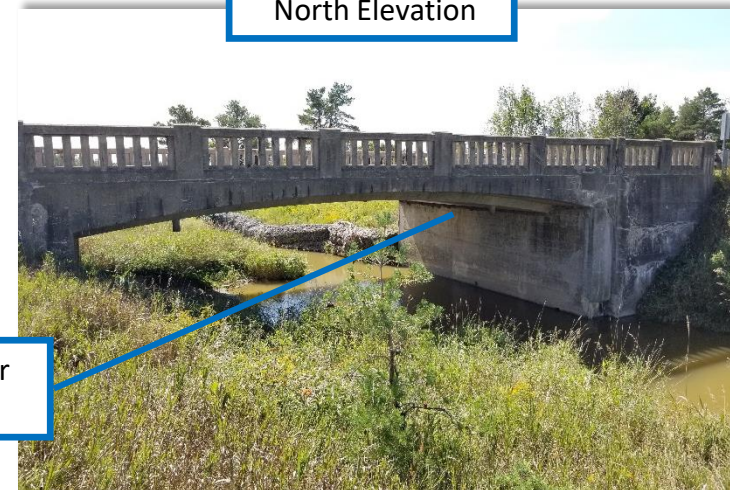
North Elevation

Cliff Swallow colony ~100 recent or active nests (2017 and 2020)

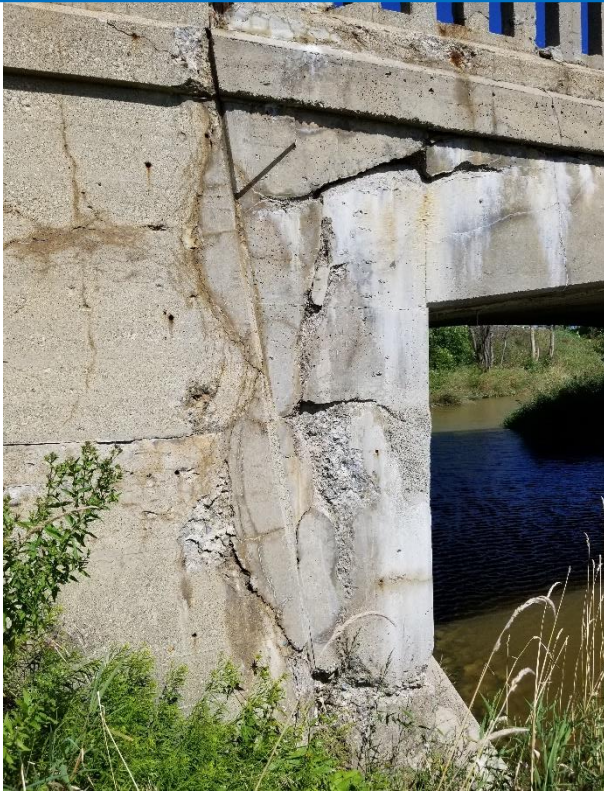
Spalled and delaminated concrete with severe scaling and concrete disintegration and efflorescence at southwest abutment/wingwall

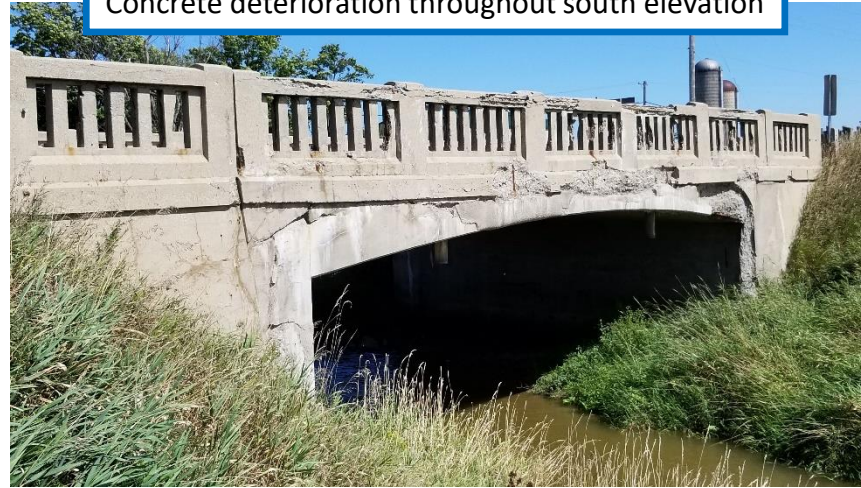
Concrete deterioration throughout south elevation

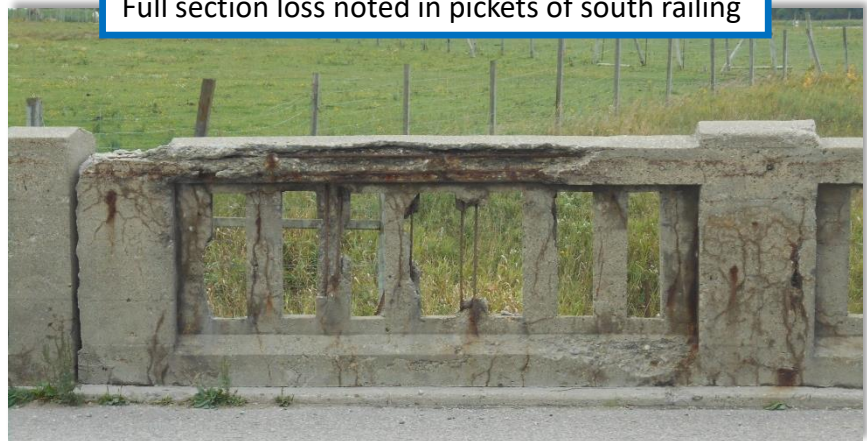
Full section loss noted in pickets of south railing

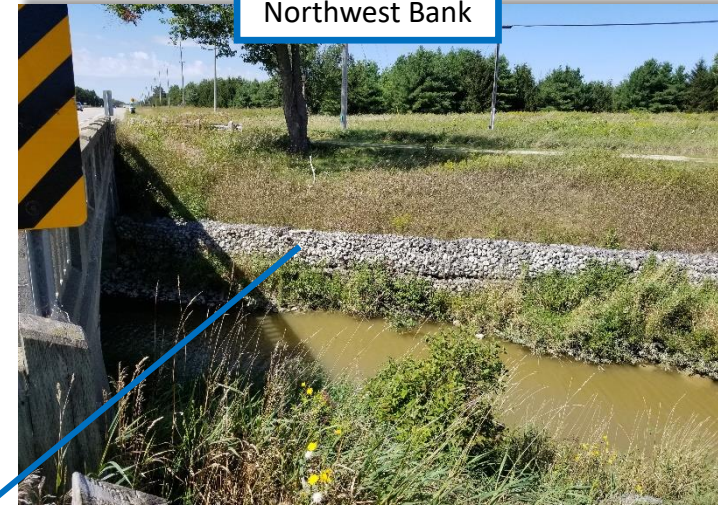
Northwest Bank

Bank stabilization measures have been installed along the meander bend on the north side of the bridge
