September 7, 2023

Reference: Block 39 – Youngblood Subdivision, Elora, ON
Arborist Report – Rev1: As per Township Comments

**Reference: Block 39 – Youngblood Subdivision, Elora, ON
Arborist Report**

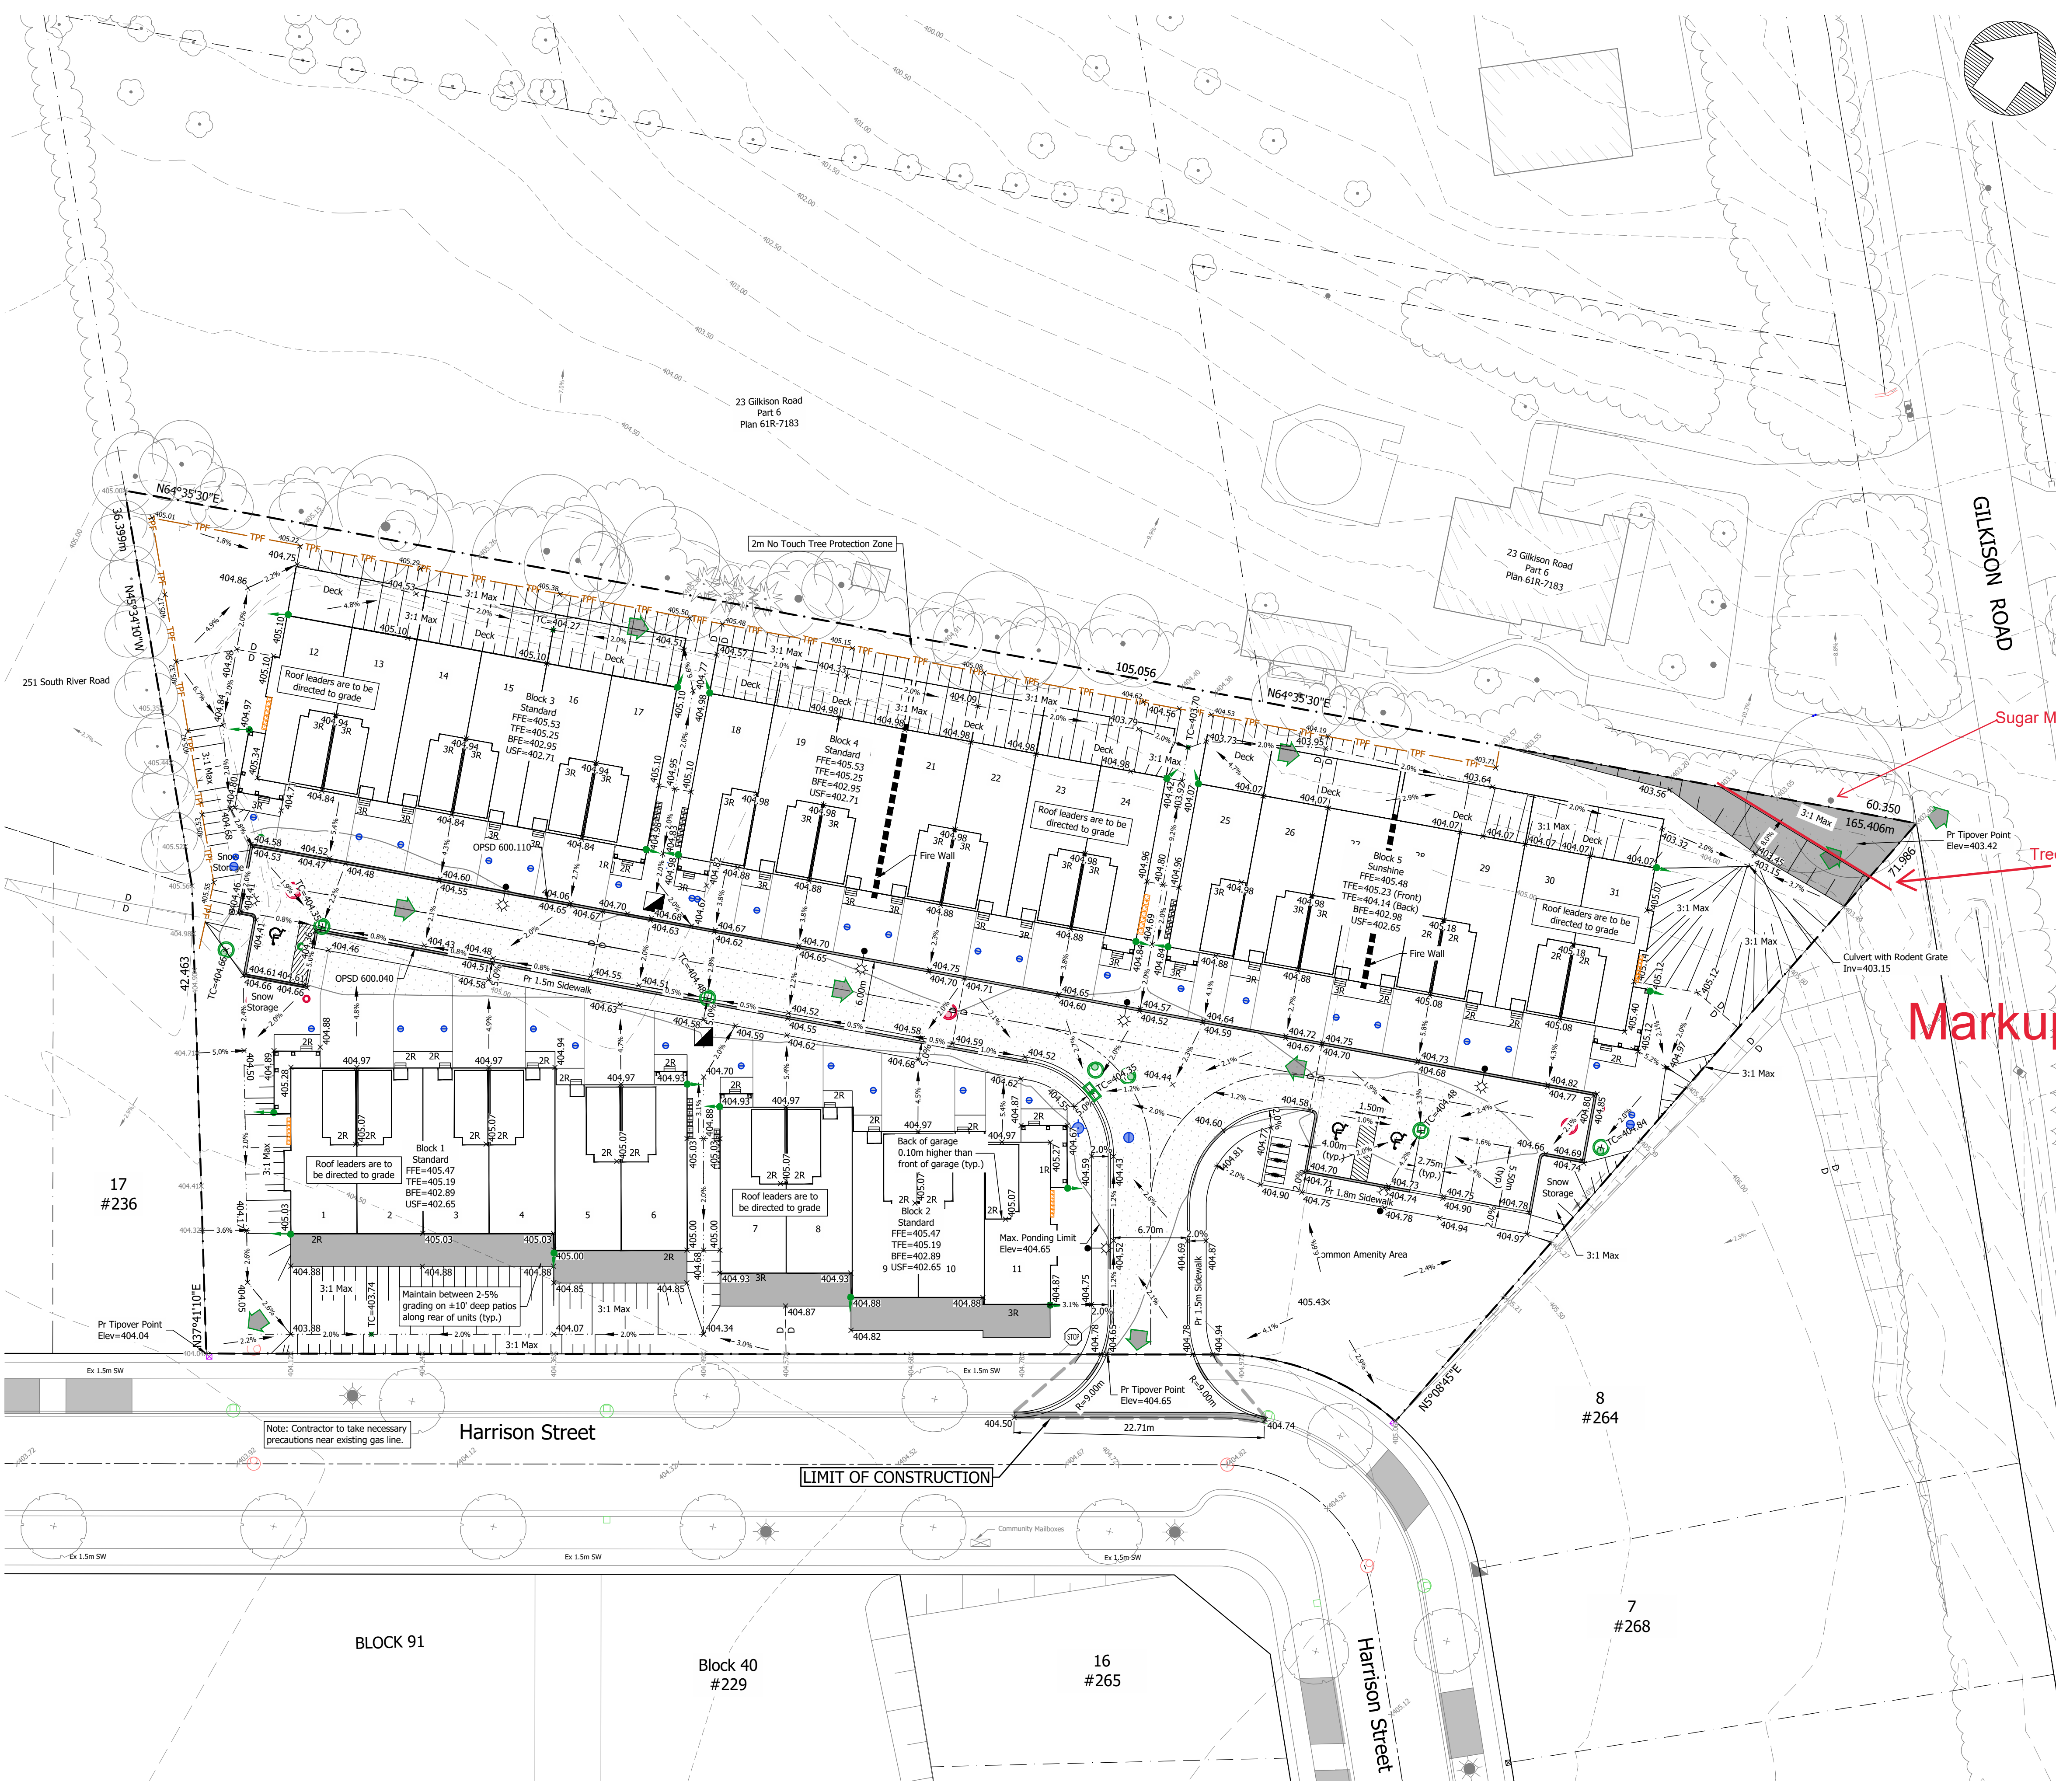
Markup By JK Consulting Arborists

The location of the property line was estimated in the field using the locations of existing trees identified on the Grading Plan. The trees on 23 Gilkison Street were predominantly located 1m off the property line, except for a large sugar maple (*Acer saccharum*). The sugar maple, growing adjacent to the northeast corner of Block 39, was located adjacent to the property line according to the legal survey. This tree was in good condition. This tree has been labeled on a draft Grading Plan, see attached.

The sugar maple will be impacted by grading; however, because the encroachment is <40% of the dripline it is believed that the health and condition of the tree will not be compromised.

The Grading Plan has been revised to include a two-metre setback to the north property line to protect the trees owned by the adjacent property owner, with the exception for the sugar maple located in the northeast corner. The setback from the property line adjacent to the Sugar Maple ranges from 1 metre to 5 metres. The overall encroachment for grading is less than 40% into the dripline of the Sugar Maple. Based on the encroachment into the dripline of trees located on adjacent property, it is believed that the health and condition of the trees will not be compromised. Tree Protection Fence recommendations as stated in this report shall be followed by the contractor.

A meeting with the Project team was held to discuss the current grading and construction in relation to trees on adjacent property. JK Consulting Arborists recommended a minimal two metre setback from the property line, as this would mitigate impacts to trees on adjacent property, and smaller trees located on the property line. The two-metre setback would allow a <40% or less encroachment into the tree's dripline, thus not compromising the health or structural integrity of the neighboring trees. Trees already in poor condition or dead would continue to naturally decline or fail. Meritech reviewed the setback recommendation and provided a revised Draft Grading Plan (refer to the attached). The Draft Grading Plan identifies a setback of two metres from the property line along the northern boundary, except for the northeast corner. In the northeast corner of the Block, grading has been designed to achieve the drainage required for the Project. Meritech has revised the grading to be set back from the northern property line and from the Sugar Maple. The grading to facilitate the construction of the slope will encroach <40% into the dripline of the Sugar Maple. As indicated in the attached draft Grading Plan, the proposed TPF will be installed at the bottom of the slope.

The two-metre setback from the property line has been identified to prevent excavation and impact to the roots of trees on the neighboring property. However, it is important to note that tree removal on the Project property can occur within this two-metre setback. Also, abiding by the Forestry Act, R.S.O. 1990, c. F.26 – Section 10, which identifies boundary trees and the legal ownership of trees located on a property line; no trees shall be removed which are located on the property line. No trees can be removed from neighboring property. Removal of trees owned by a neighboring property would require written permission. Also, injury to trees owned by a neighboring property which results in the tree declining in health also falls under the Forestry Act. Therefore, the TPF shall be installed prior to mobilization for construction and remain in place until the grading and construction has been completed.
