January 18, 2021

Reference Number: T20828-1

**Subject: Test Pit Investigation on the North Parcel
Proposed Residential Development
Erin Property
5520 8th Line, Erin, Ontario**

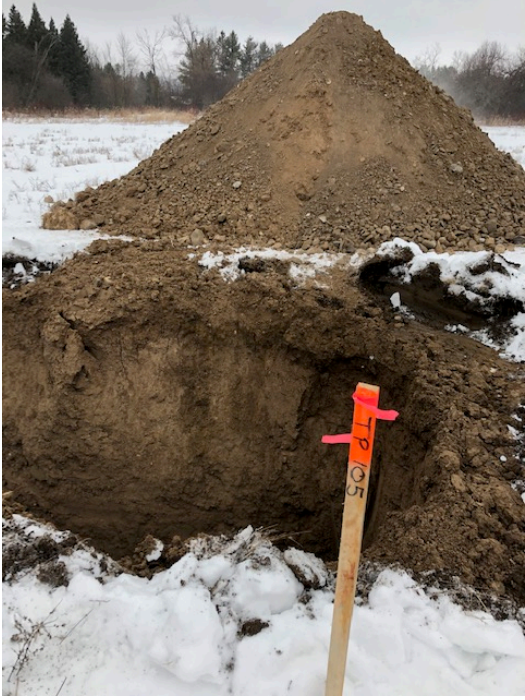
Photograph 5- Excavated soils from TP 105. After 4.0 hours, cave-in of sides and water level were observed at 3.0 m below existing grade.

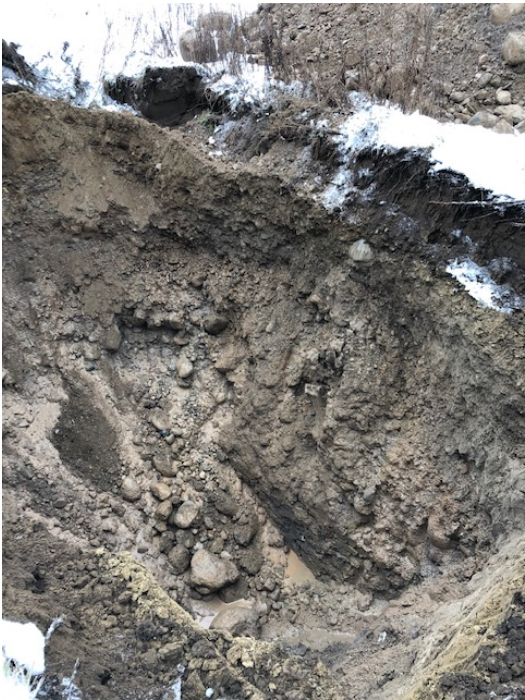
106	398.2	0 - 0.25 0.25 - 0.6 0.6 – 2.5 2.5 – 3.5 3.5 – 4.5	<p>Topsoil Organic stained Silty Sand with some gravel and rootlets, damp to moist Brown Silty Sand Till, with some silty seams, cobbles and boulders, compact to very dense, damp Brown sand and gravel, with boulders, wet (fast water seepage) Greyish brown Sandy Silt/Silty Sand Till, dense, damp</p> <p>Bulk unit weight @1.3 m: 2250 kN/m³, NMC:10%. Fast water seepage from sand and gravel seam was observed upon completion. Test pit was opened for 0.75 hours and cave-in and water level was observed at 3.8 m below existing grade.</p>
107	408.1	0 - 0.4 0.4 – 1.5 1.5 -4.5	<p>Topsoil Organic stained Sandy Silt/Silty Sand with some gravel, damp to moist Brown Silty Sand Till, with some cobbles and boulders, compact to very dense, damp</p> <p>Bulk unit weight @1.5 m: 2042 kN/m³, NMC:13%.</p>

Photograph 6- View of excavation for TP 106. Note fast water seepage from sand and gravel seam at about 2.5 to 3.5 m below the existing grade.

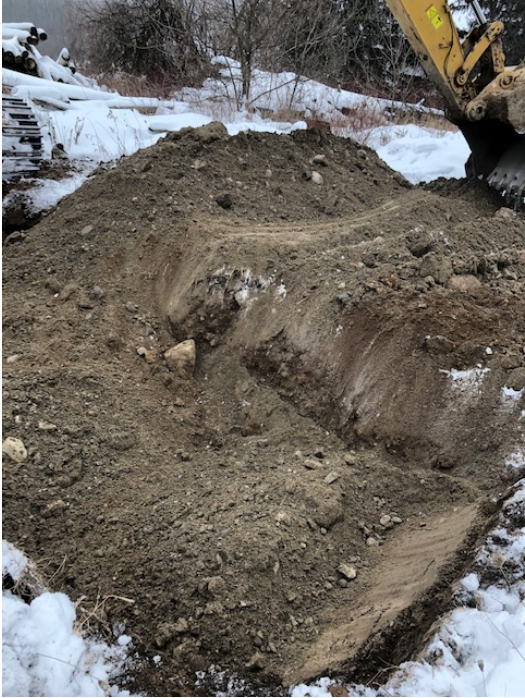
Photograph 14- View of excavated soil being used to backfill TP 110.

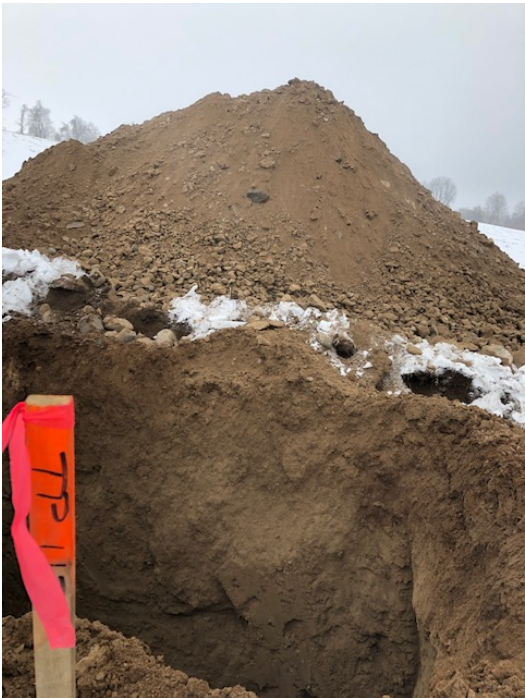
112	433.2	0 - 0.2 0.2 - 0.8 0.8 - 4.4	Topsoil Organic stained Silty Sand with some gravel and rootlets, damp Brown Silty Sand Till, with some silty seams, cobbles and boulders, damp Bulk unit weight @1.4 m: 2011 kN/m ³ , NMC: 9%. Test pit dry upon completion and open for 4.5 hours. After 4.5 hours, test pit was dry and no cave-in of the sides observed.
-----	-------	-----------------------------------	--

Photograph 16- View of excavated soils from TP 112. After 4.5 hours, test pit was dry and no cave-in observed.
