**Public Information Centre #1
Display Panels**

Wellington Road 109 Bridges Municipal Class Environmental (EA) Study

From Highway 6 to Sideroad 7
Township of North Wellington

PUBLIC INFORMATION CENTRE #1
Online Package

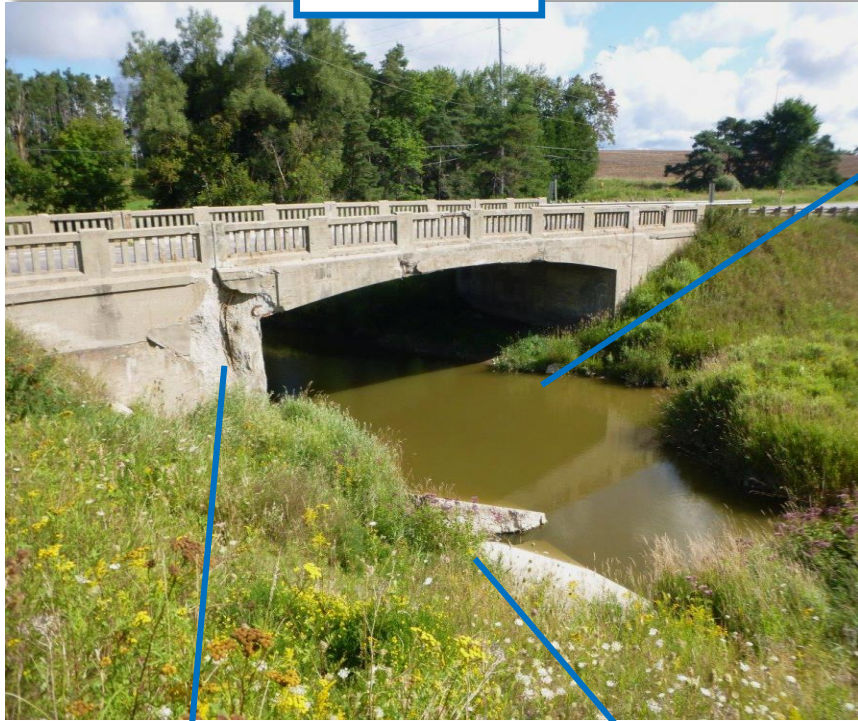
South Elevation

Large spall, severe scaling and disintegration of concrete throughout (worst at southwest)

Remains of collapsed retaining wall

In-stream habitat consists of large pool at the bridge with riffles and flats up and downstream. Pools offer potential Snapping Turtle hibernation habitat.

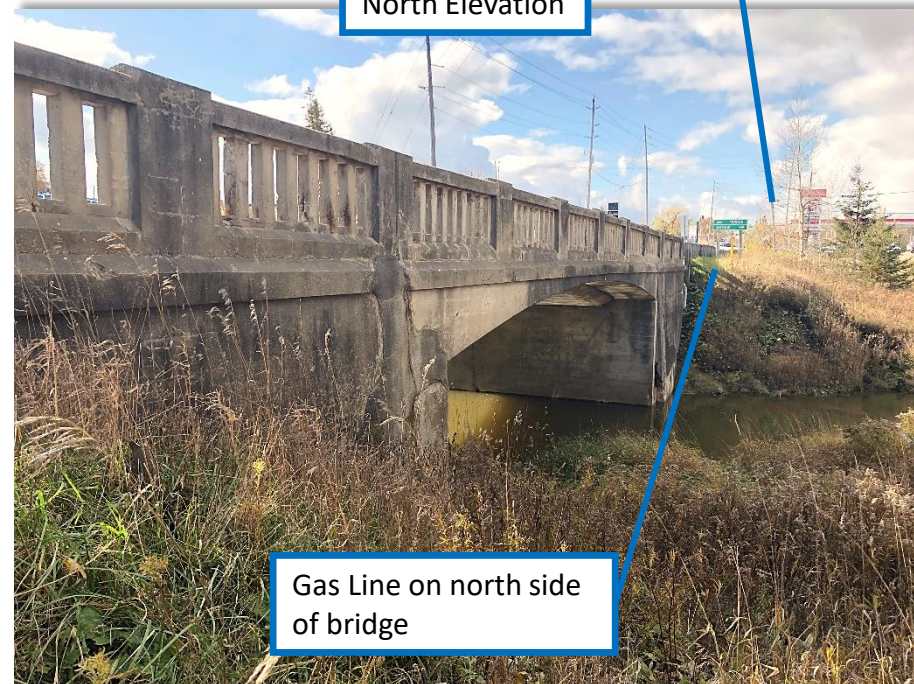
North Elevation

Gas Line on north side of bridge

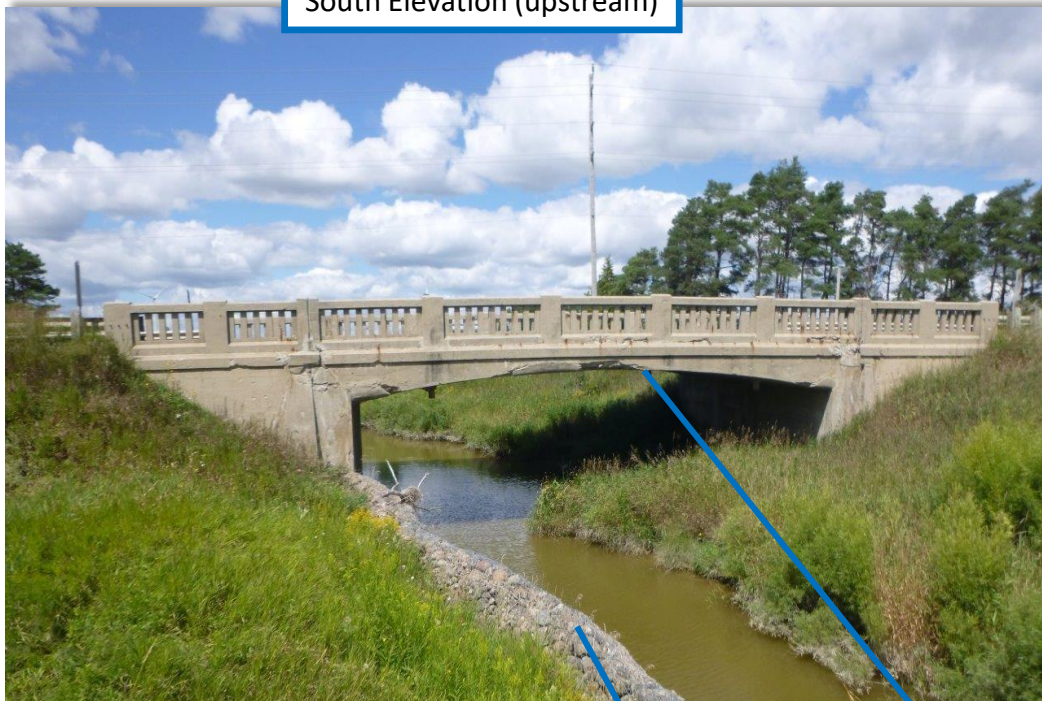
South Elevation (upstream)

Gabion baskets installed for bank protection

Concrete deterioration throughout south elevation including spalled and delaminated concrete with rust staining and wide cracks

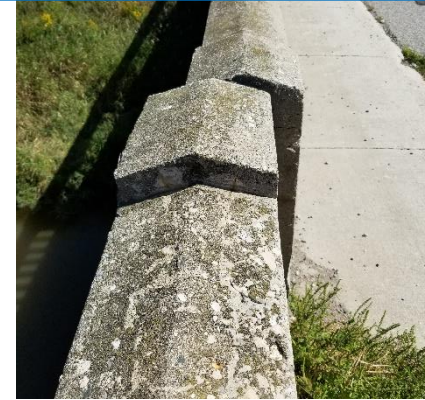
Rotation of northwest retaining wall and mis-alignment of railing

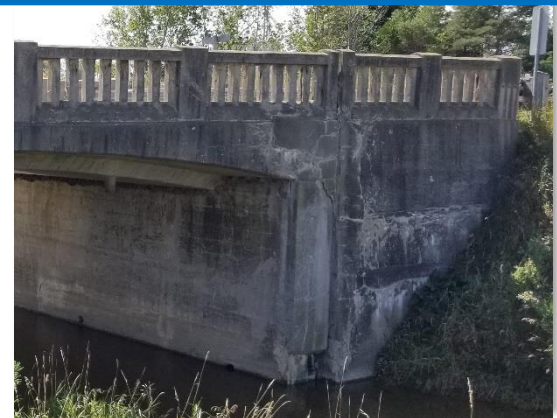
Spalled and delaminated concrete with wide cracks and efflorescence at northwest wingwall

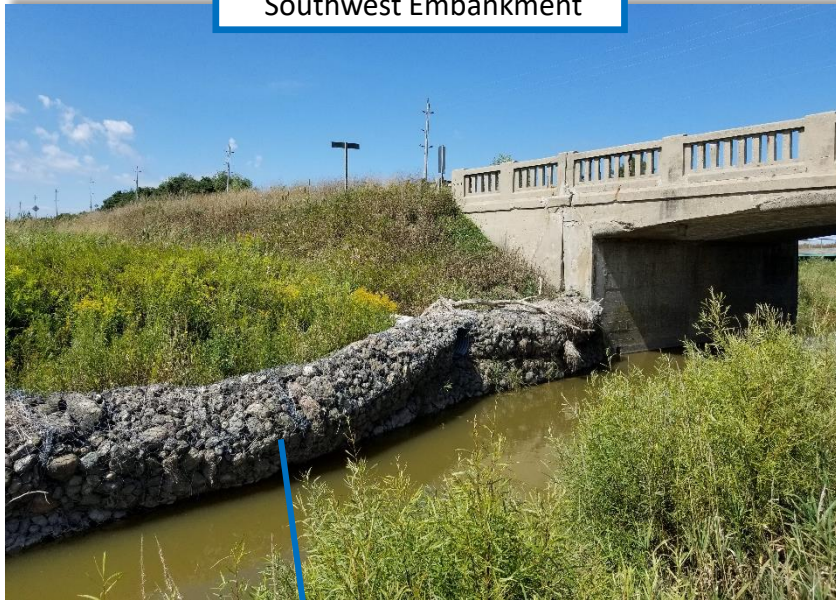
Southwest Embankment

Bank stabilization measures have been installed to control erosion however, the gabion shows signs of slumping

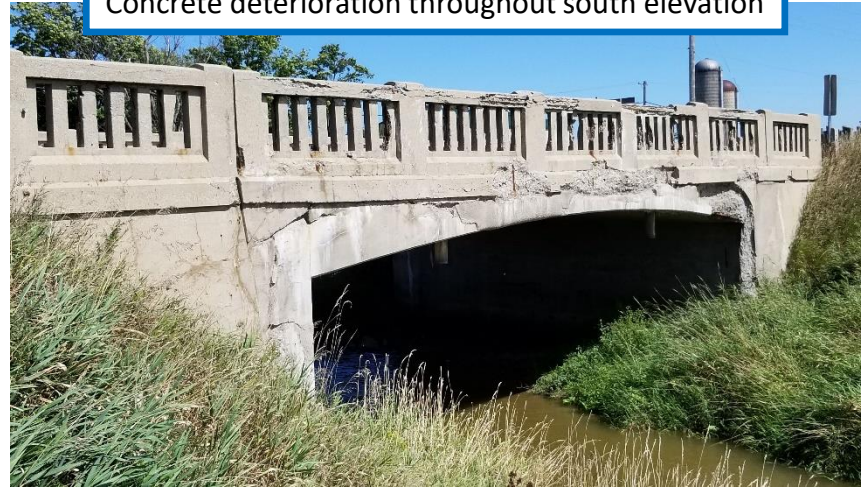
Concrete deterioration throughout south elevation

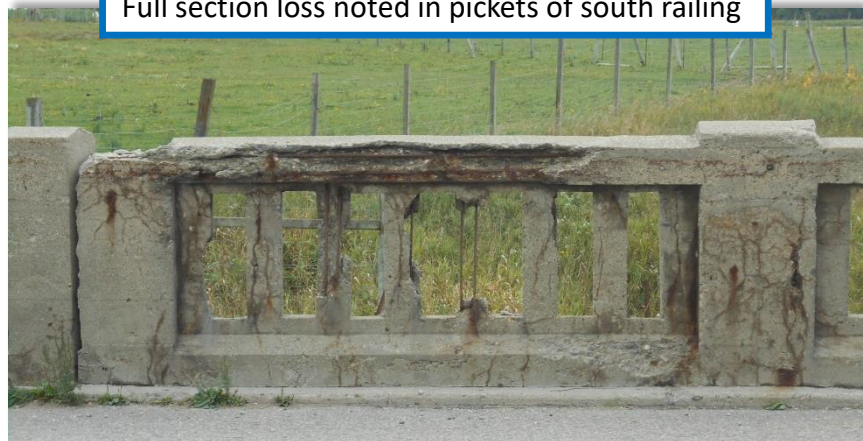
Full section loss noted in pickets of south railing
