**HYDROGEOLOGICAL INVESTIGATION
PROPOSED BRIARWOOD HILLSBURGH DEVELOPMENT
5916 Trafalgar Road North, Town of Erin, Ontario**

Project No. 2100428AH

**RE: Hydrogeological Investigation for Proposed Briarwood Hillsburgh Development
5916 Trafalgar Road North, Town of Erin, Ontario**

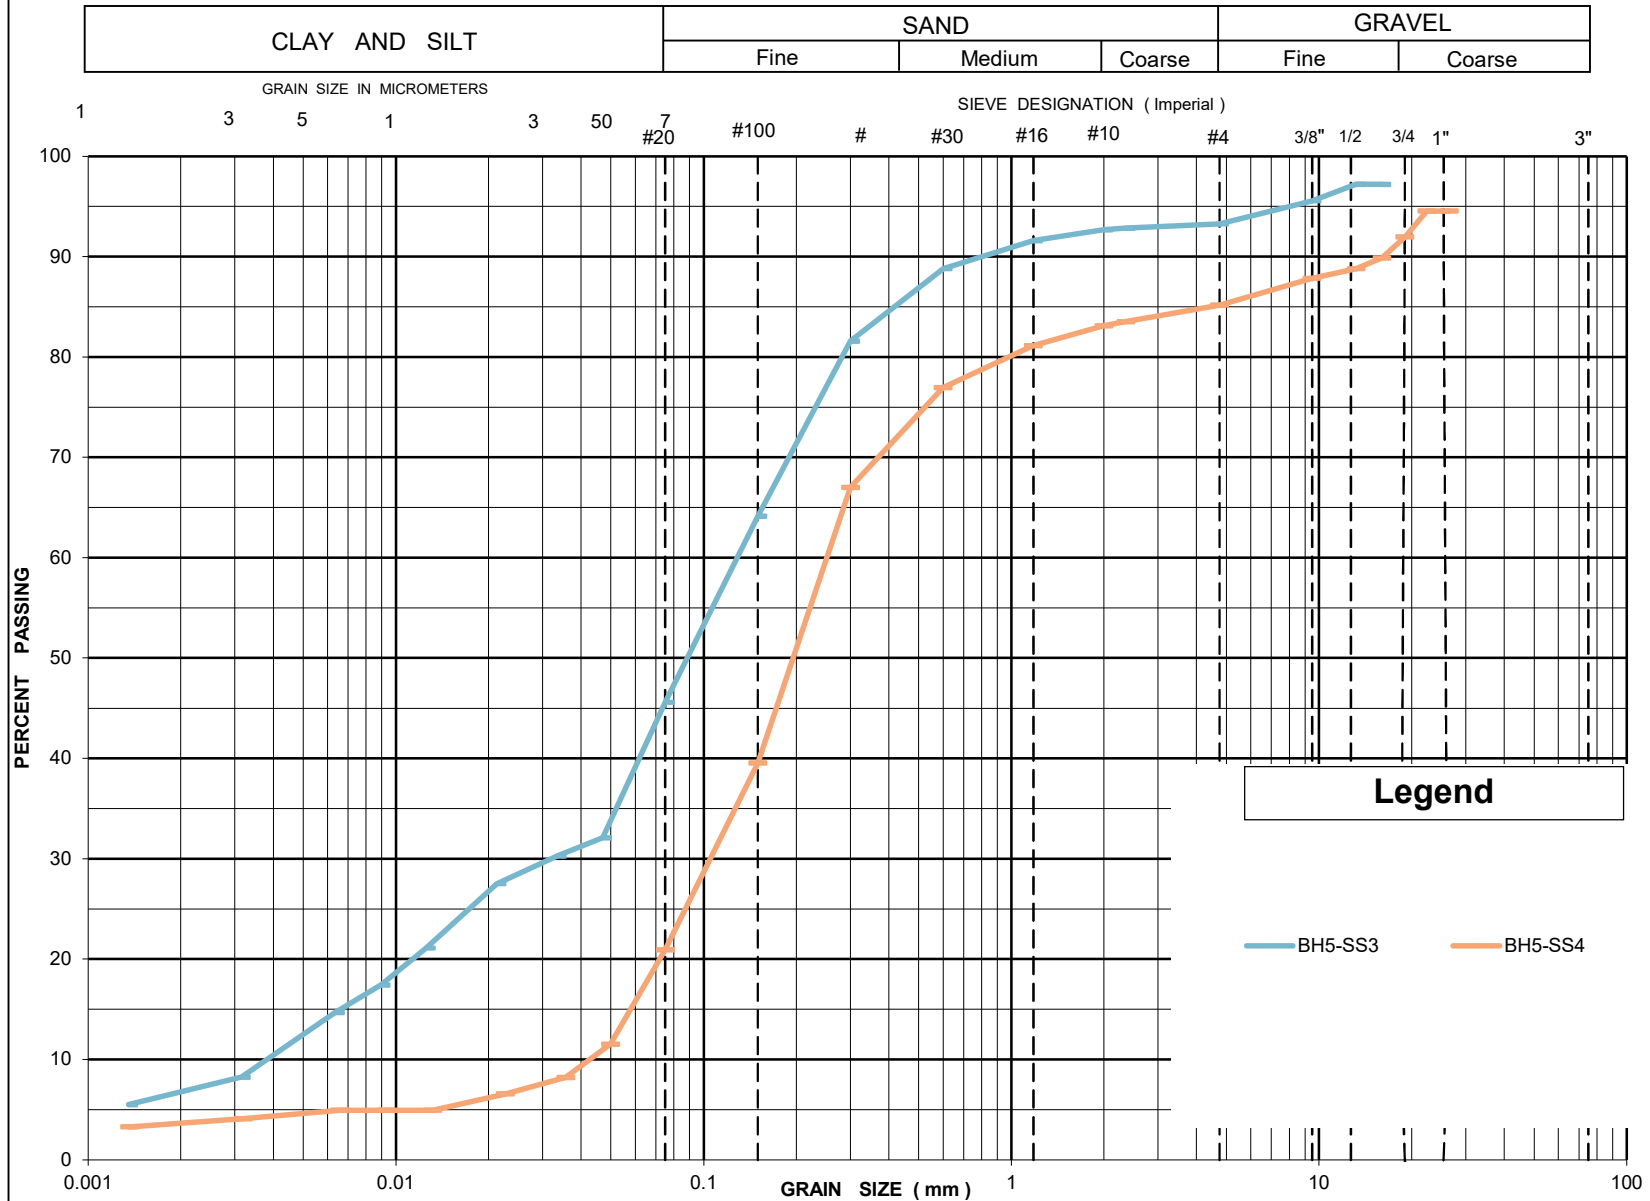
Drawing No : 2
 PROJECT # : 2100428AH
 DATE : Sept 23, 2021

GRAIN SIZE DISTRIBUTION
