# Ainley Farm Environmental Impact Study

Addendum # 2

Prepared for

Black, Shoemaker, Robinson, Donaldson

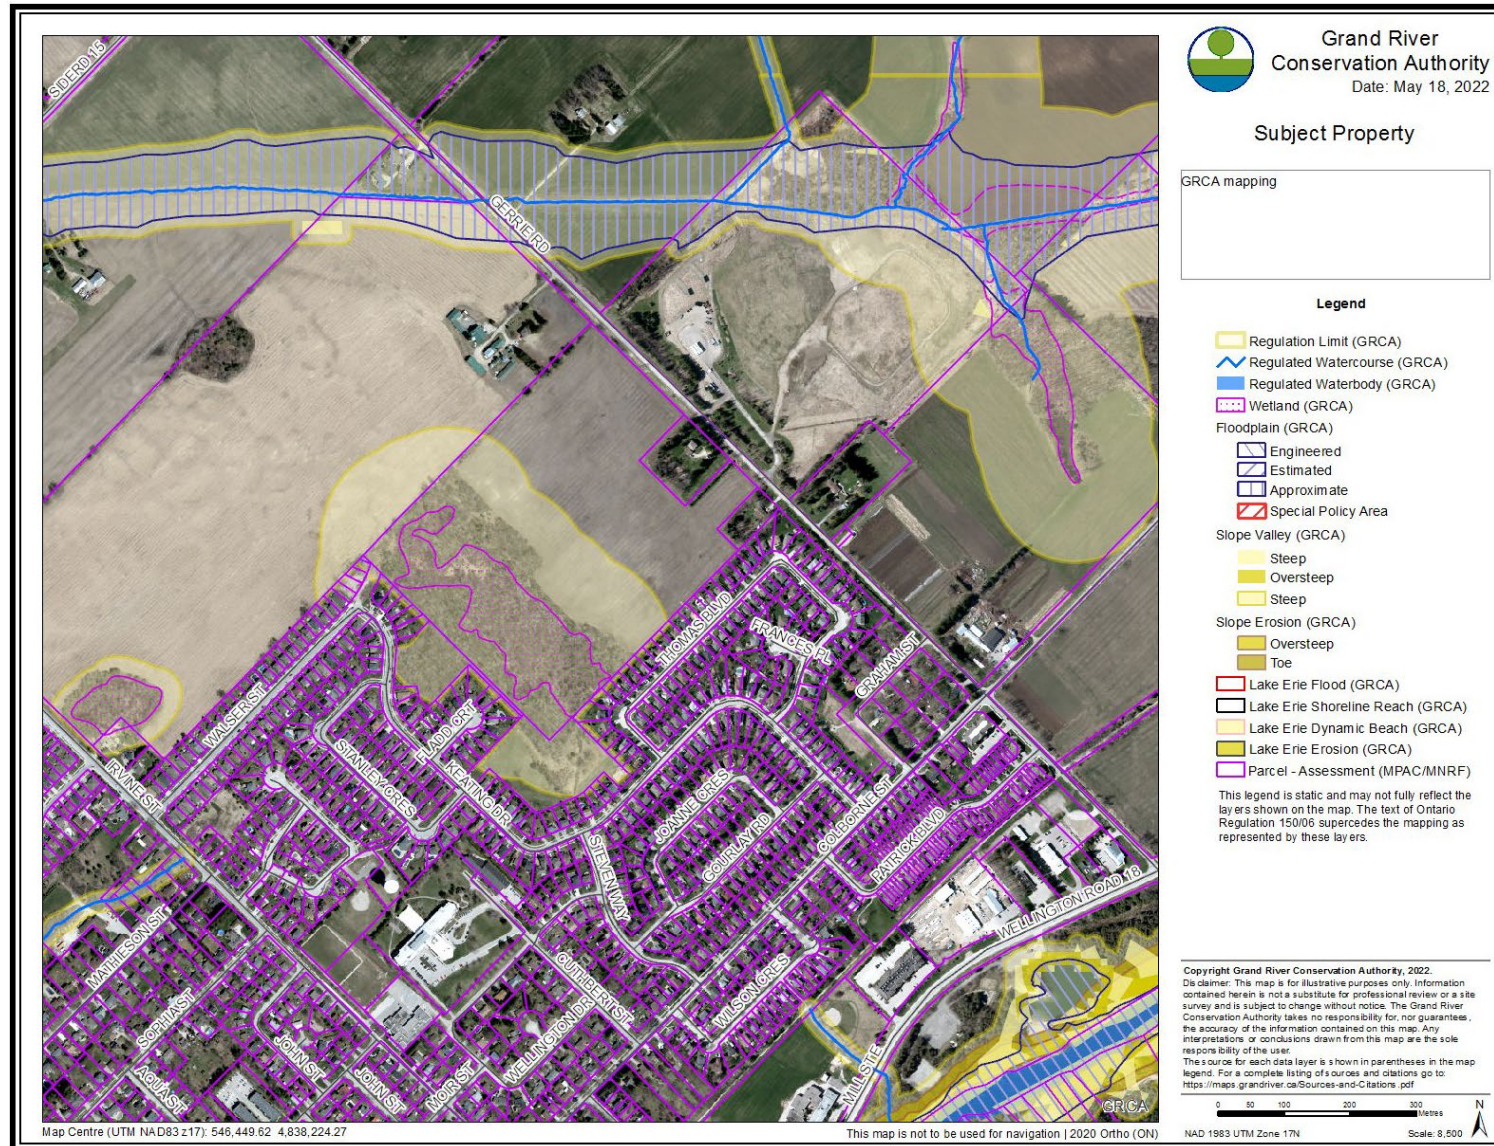
**Figure 2. GRCA (2022) mapping illustrating aerial mapping of wetland (purple) and regulated area (yellow)**

GRCA (2018) Regulation Mapping (**Figure 2**) illustrates a non-provincially significant wetland within the wooded area on the western portion of the Subject Property. The extent of the “Regulated Area” on the Subject Property is mapped as 120 m from the boundary of the wetland mapped by GRCA.
