9354 Wellington Road 22 Hillsburgh Subdivision

Environmental Impact Study

Project No. 2681 | November 2024

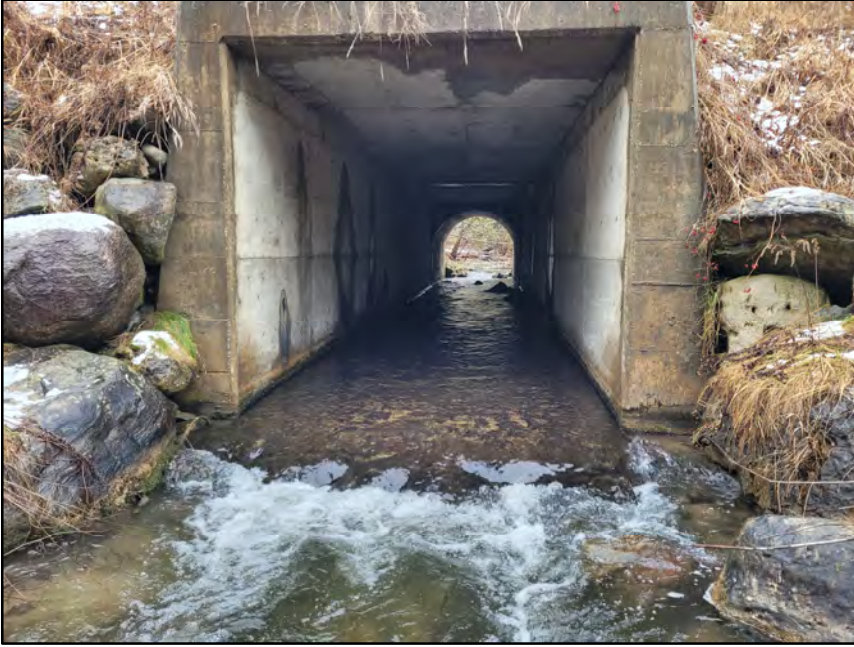
Photo 1. Facing WNW, downstream of Wellington 22. Elevation change creating a minor drop into a plunge pool at downstream extent of culvert.

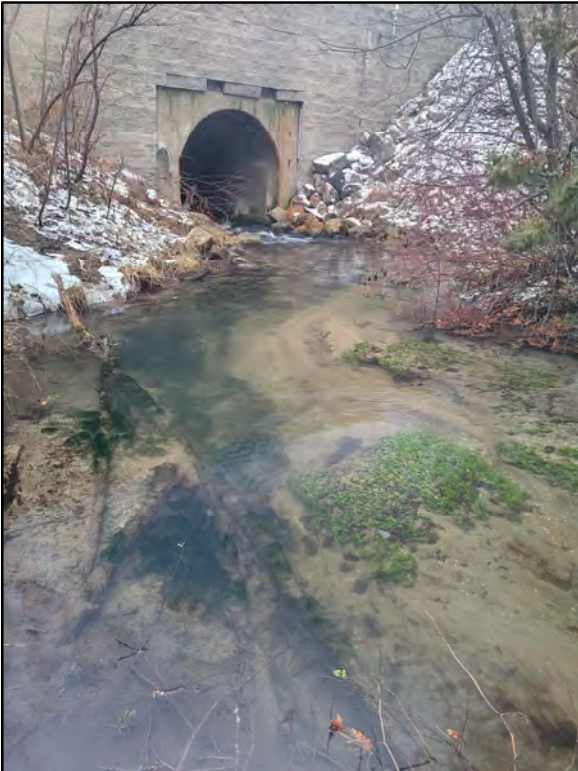
Photo 2. Facing SE, upstream of Wellington 22. Patches of aquatic vegetation and some woody debris are visible.

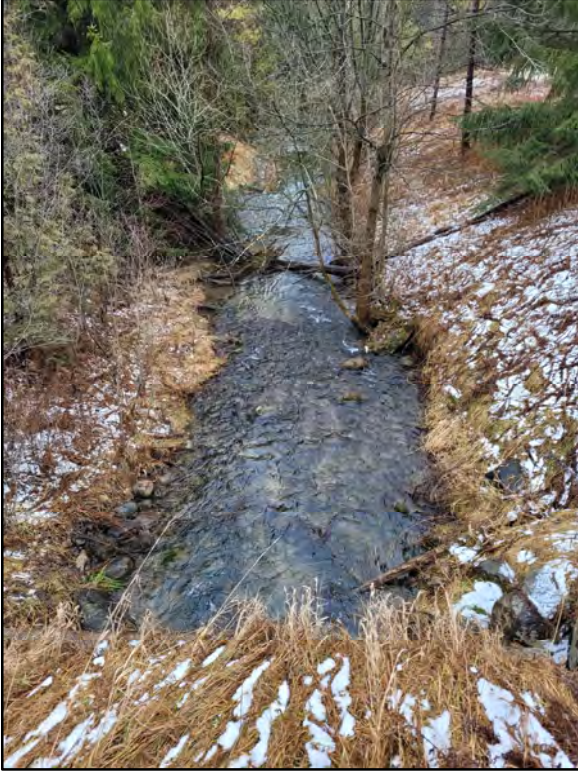
Photo 3. Facing ESE, downstream of Wellington 22. Reduced extent of natural vegetation along the banks.

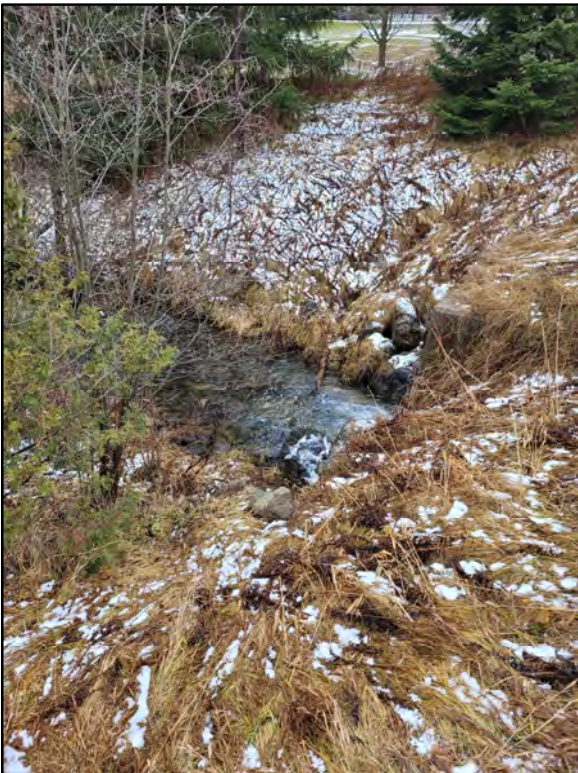
Photo 4. Facing SE, downstream of Wellington 22. Reduced extent of natural vegetation along the banks.
