# Heritage Impact Assessment

## Blatchford Bridge (Structure Number B032085)

### County of Wellington, Ontario

#### Draft Report

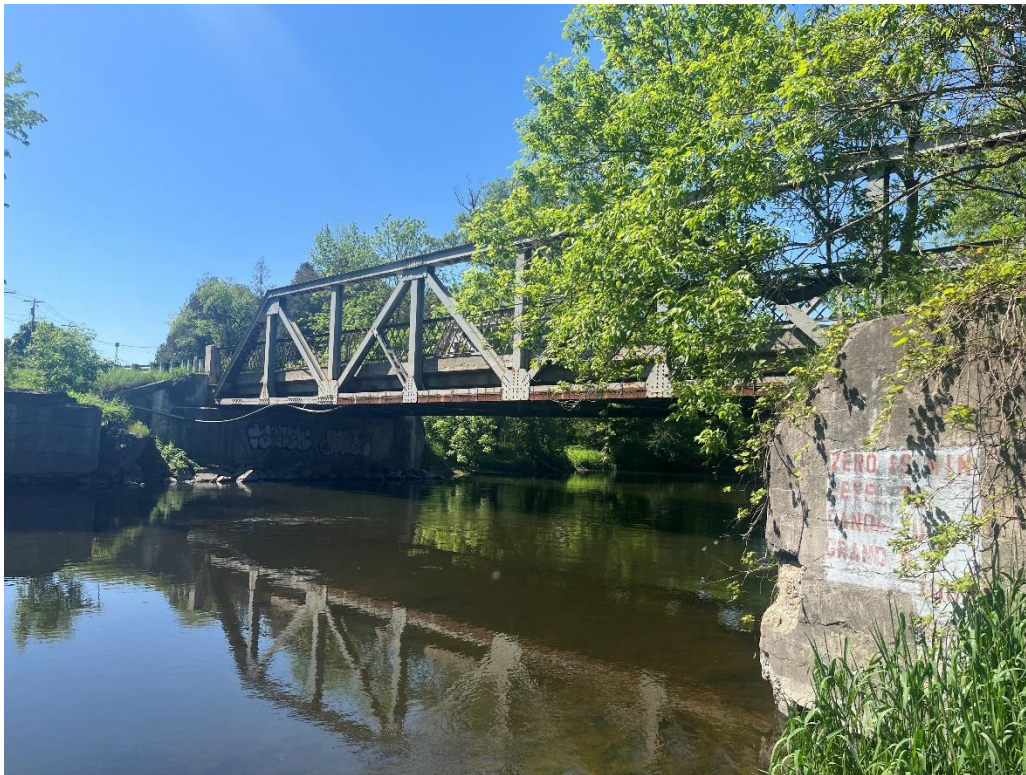
Figure 1: Blatchford Bridge, looking west (A.S.I. 2024).

The Blatchford Bridge (Structure Number B032085) is a single-span half-through truss structure that carries two lanes of vehicular traffic on Wellington Road 32 over the Speed River on the border of the Township of Guelph/Eramosa and the Township of Puslinch (Figure 1 and Figure 2). The structure measures 32.4 metres in overall length and an overall width of 8.1 metres. The subject bridge was constructed in 1949 and underwent rehabilitations in 1992 and 2010. The subject structure is not identified as a listed or designated structure either township. A 2023 Ontario Structure Inspection Manual (O.S.I.M.) evaluated the bridge with a Bridge Condition Index (B.C.I.) of 62.08 and recommended rehabilitation or replacement of the bridge within one to five years (Gannett Fleming Canada ULC, 2023).

The Blatchford Bridge is a single-span half-through truss structure resting on cast-in-place concrete abutments and wingwalls. The bridge measures 32.4

metres in overall length with a width of 8.1 metres and carries vehicular traffic over the Speed River in a north-south alignment. The bridge is located on the border of the Township of Guelph-Eramosa and the Township of Puslinch, along Wellington County Road 32 between Wellington County Road 124 and Laird Road West. The Blatchford Bridge was constructed in 1949 and underwent rehabilitation in 1992 and 2010 (Gannett Fleming Canada ULC, 2023; McCormick Rankin Consulting Engineers, 1992; WSP Canada Inc., 2021).

The Blatchford Bridge is a single-span half-through truss structure that carries two lanes of vehicular traffic over the Speed River on the border of the Township of Guelph-Eramosa and the Township of Puslinch. The Blatchford Bridge is located between Wellington County Road 124 and Laird Road West. The subject bridge measures 32.4 metres in overall deck length with a width of 8.1 metres (Gannett Fleming Canada ULC, 2023).

The substructure of the bridge features cast-in-place concrete abutments, ballast walls, and wingwalls. The bridge rests on steel roller bearings.

The superstructure of the subject bridge features a steel half-through truss with steel stringers; riveted plate girders; and steel riveted truss connections with rusting/perforation on top of all four supports, diagonals and verticals with corrosion at the connection plates of the railings, corrosion at the bracing panels, impact damage at the northeast and south sides, and rusting with perforation at the northeast side; as well as two plaques commemorating the date of construction and the builder of the bridge, the Dominion Bridge Company, located at the northwest and southeast corners of the bridge and a Suburban Road Commission commemoration plaque at the southeast corner.
