County of Wellington
Blatchford Bridge No. B032085
Municipal Class Environmental (EA) Study

Wellington Road 32
Township of Guelph/Eramosa and Township of Puslinch

PUBLIC INFORMATION CENTRE - Online Package

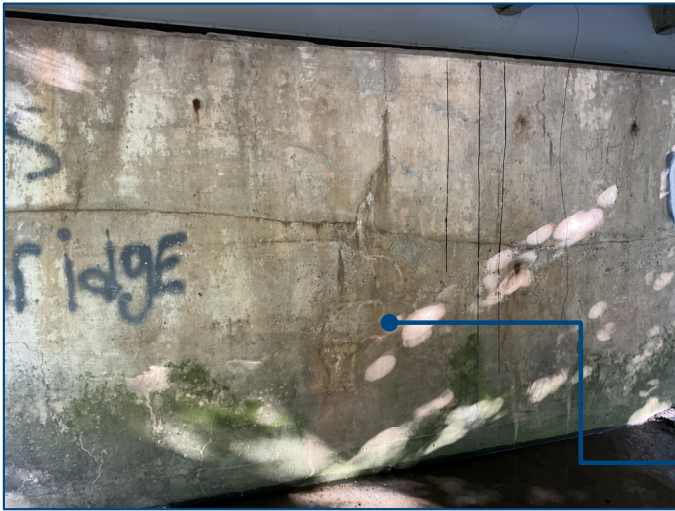
South Abutment

Spalling, Delamination,
Cracking, Efflorescence

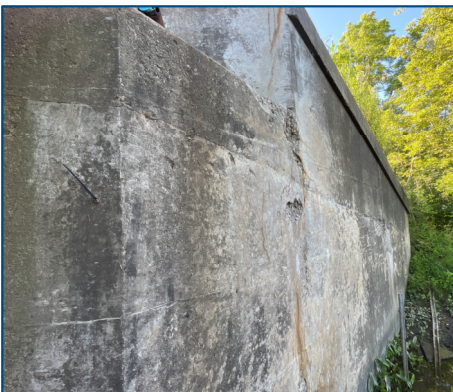
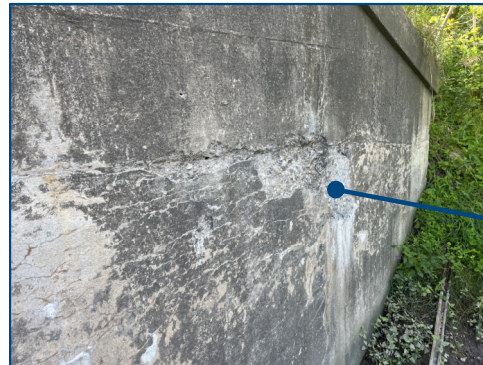
Southwest Wingwall

Cracks, Spall
and Scaling

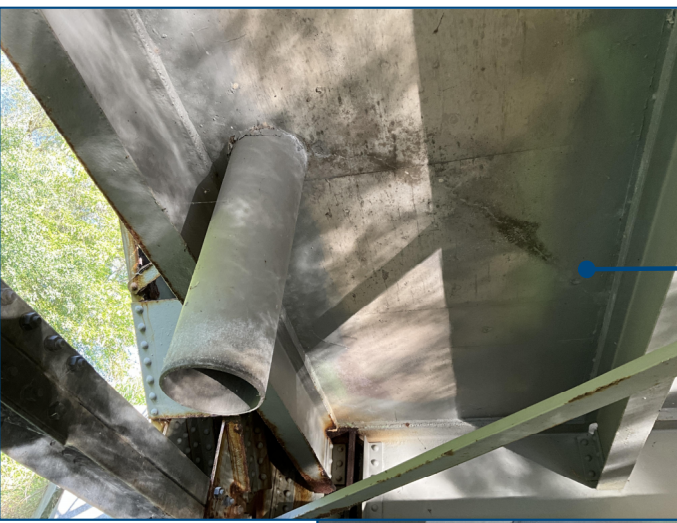
Deck Soffit

Cracking with Efflorescence

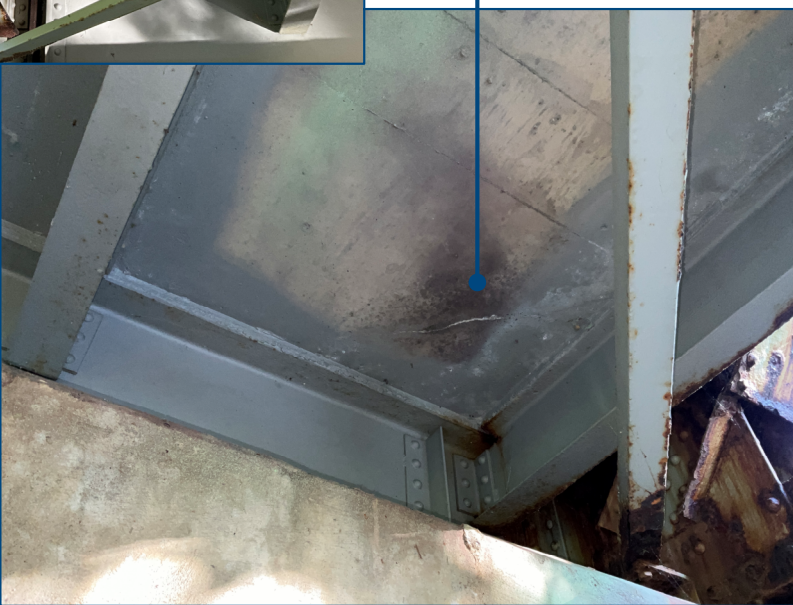
General View

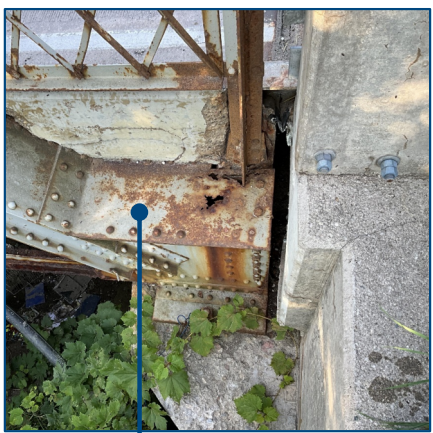
Bottom Chords

Corrosion and Perforations

- In general, severe corrosion and flaking of structural steel coating is present throughout bottom and top chord members and connection plates. Full depth perforations on bottom chords were identified around all quadrants. Abutment walls exhibited signs of deterioration with delamination, spalls, scaling, and cracks present. The traffic barriers and railing are in poor condition with missing panels and impact damage.
- Several components are in need of maintenance, rehabilitation and/or replacement and the bridge is approaching the end of its useful service life.
- Functional/operational deficiencies including sub-standard barrier protection are noted on this site.
- Main load bearing components (steel trusses) are exposed to potential traffic impact damage that could impact the capacity.

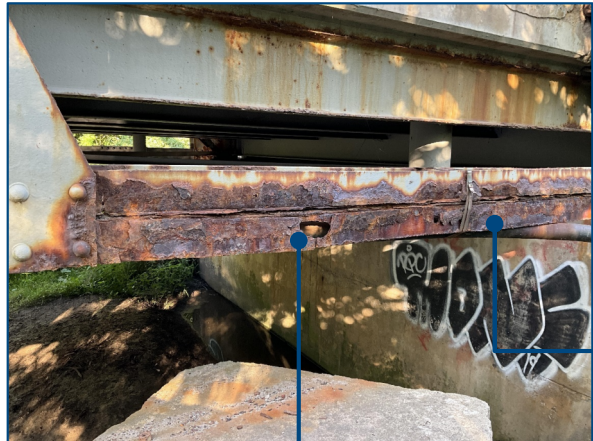
Deteriorated Coating

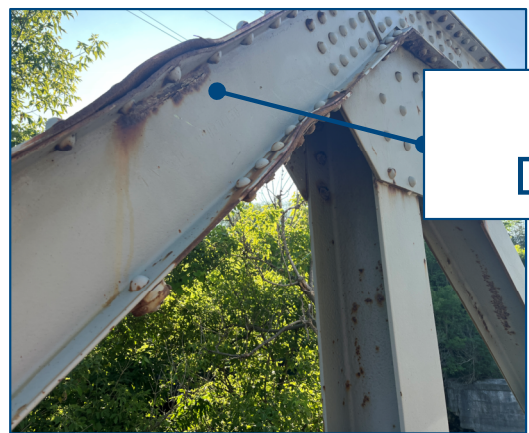
Vertical & Diagonal Members

Impact Damage

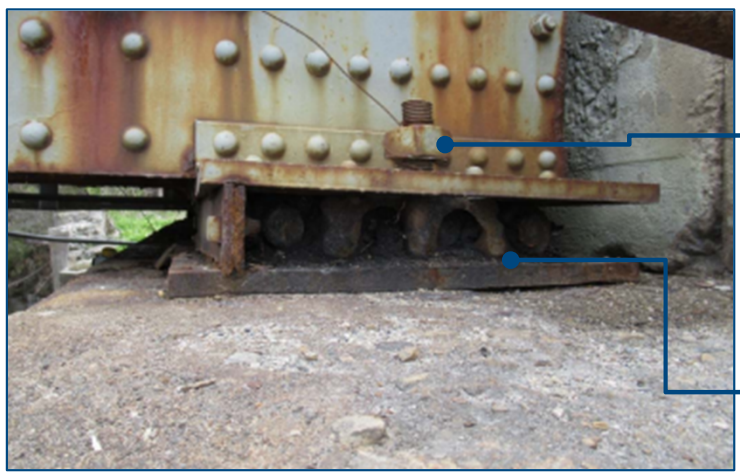
Southwest Bearing

Corrosion on Bolts

Severe Bearing Deterioration

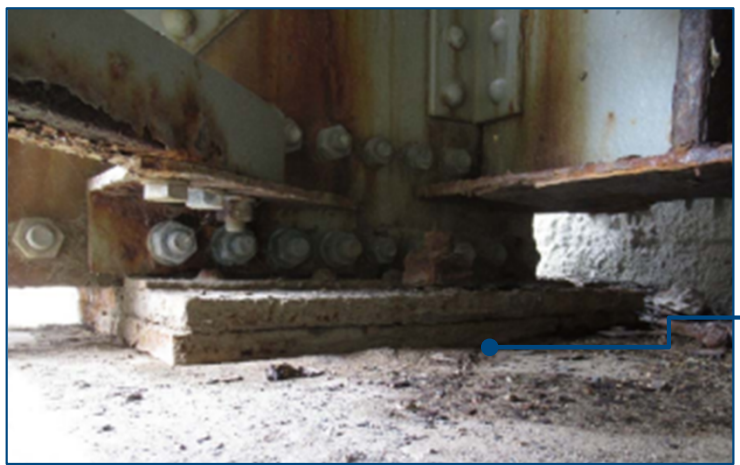
Northwest Bearing

Reduction of Bearing Seat

Medium Plate Corrosion

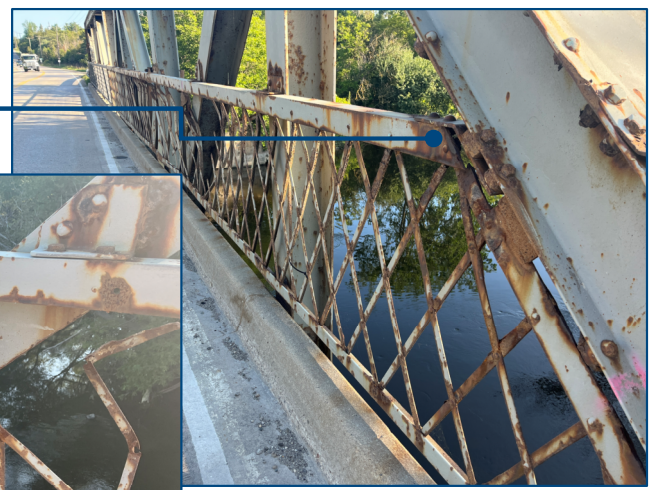
East Traffic Barrier

Medium Corrosion

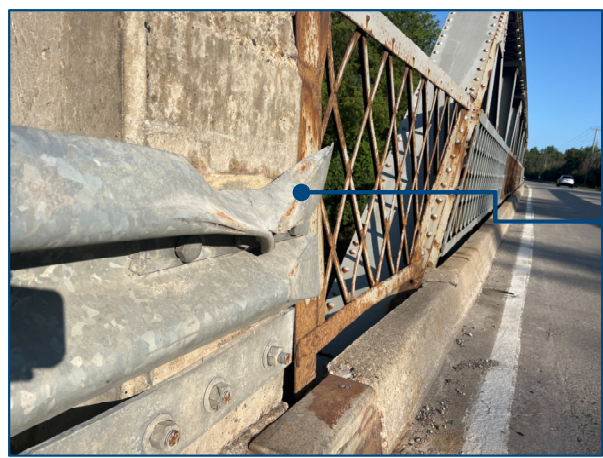
West Guiderail

Impact Damage

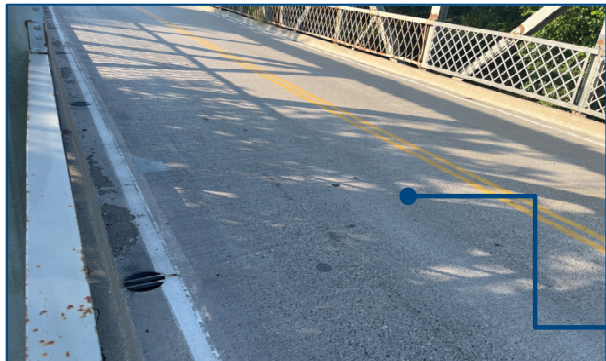
Wearing Surface

Light Surface Scaling
