## CULTURAL HERITAGE EVALUATION REPORT AND IMPACT ASSESSMENT

**CULTURAL HERITAGE EVALUATION REPORT  
BOSWORTH BRIDGE, No. B007028  
WELLINGTON ROAD 7 (WR 7)**

# HERITAGE IMPACT ASSESSMENT BOSWORTH BRIDGE (B007028)

REVISED REPORT – SEPTEMBER 16, 2021

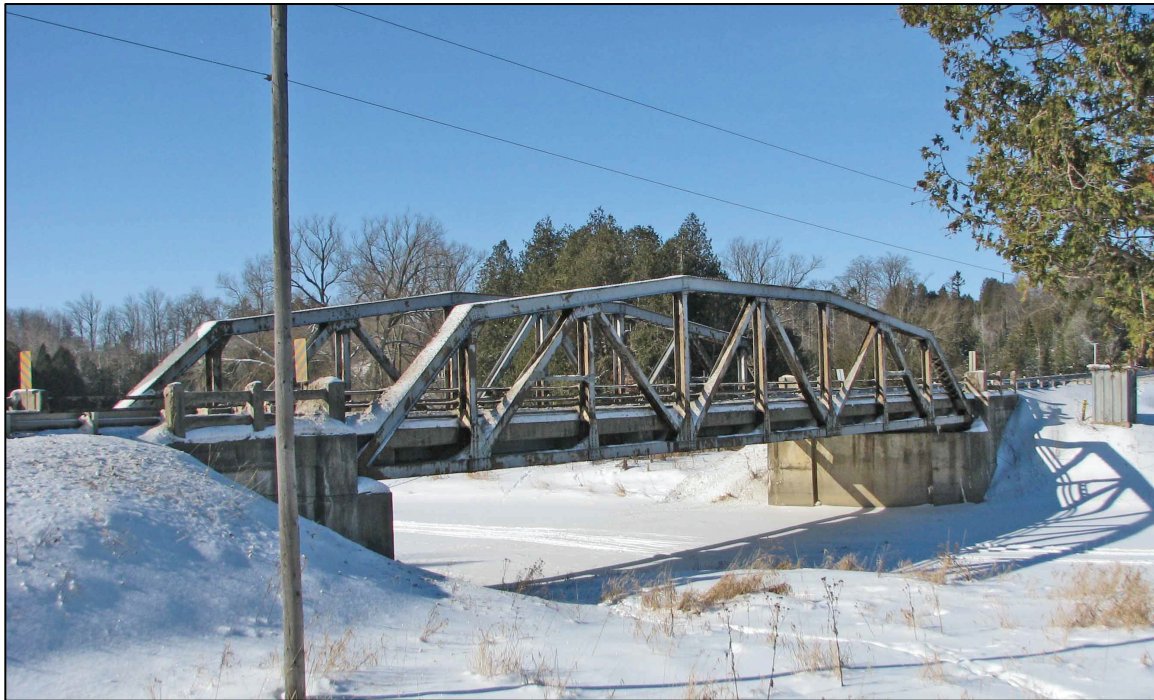
Figure 3. East elevation of the Bosworth Bridge.

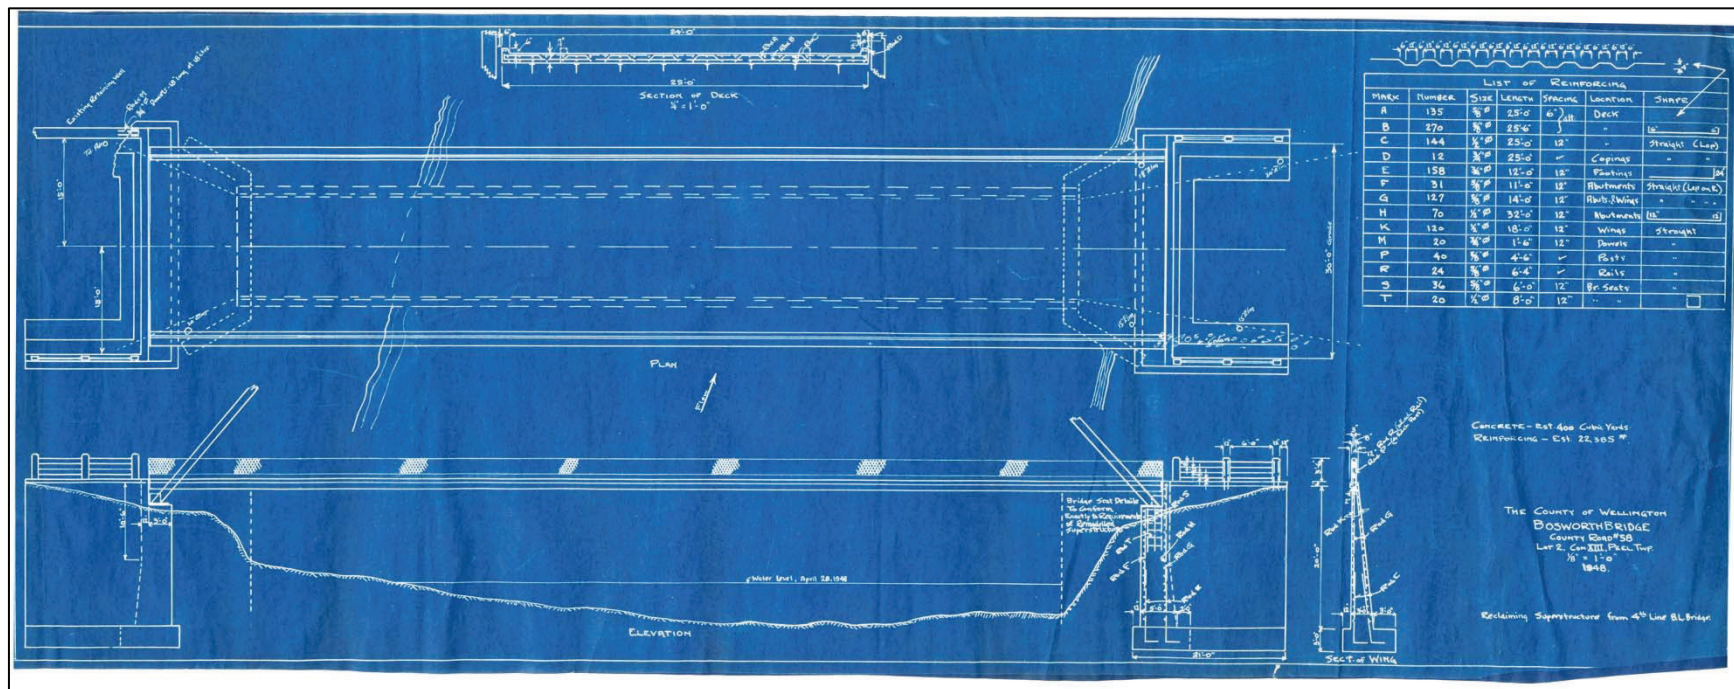
WCMA, Map 285: Peel Twp. Plan for Bosworth Bridge, County Road 58 [now County Road 7] Concession 13, 1948.

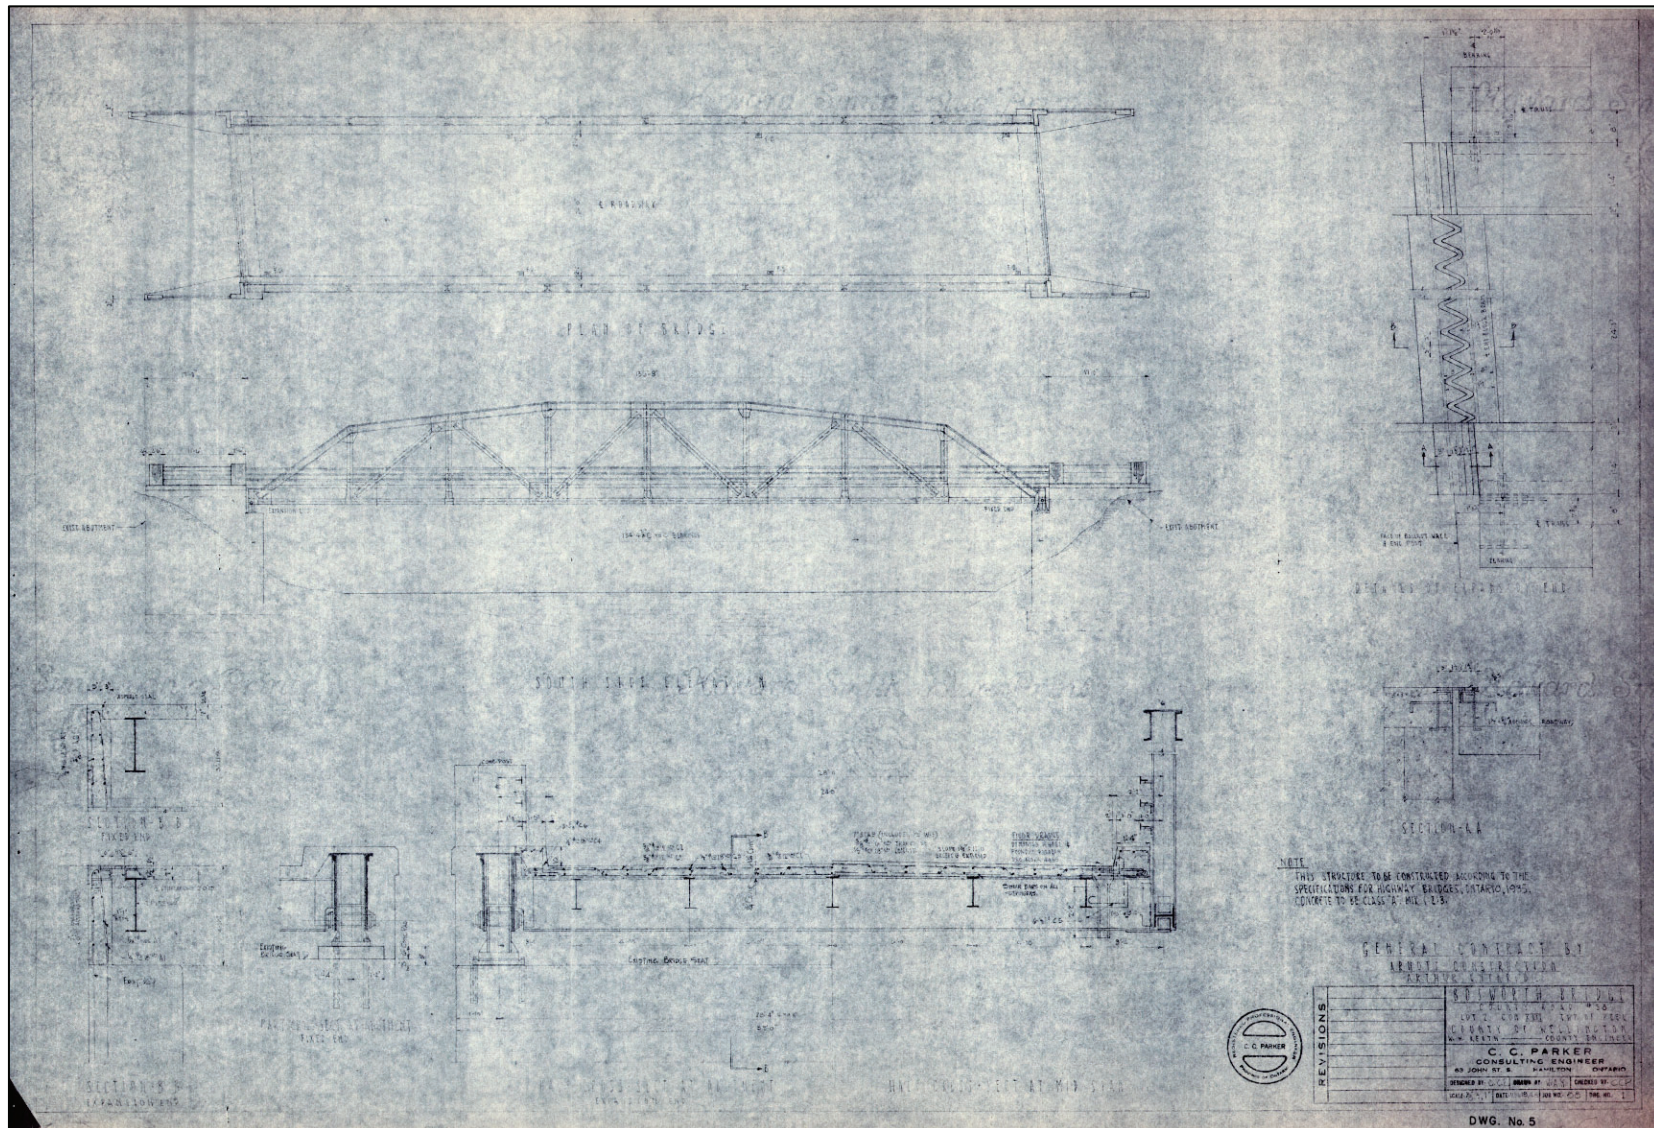
C.C. Parker. Consulting Engineer. Dwg. No. 6, General Contract by Arnott Construction, Arthur, Ontario. Bosworth Bridge, County Road #58, Lot 7, Concession XIII, Twp. Of Peel, County of Wellington, November 18, 1948.

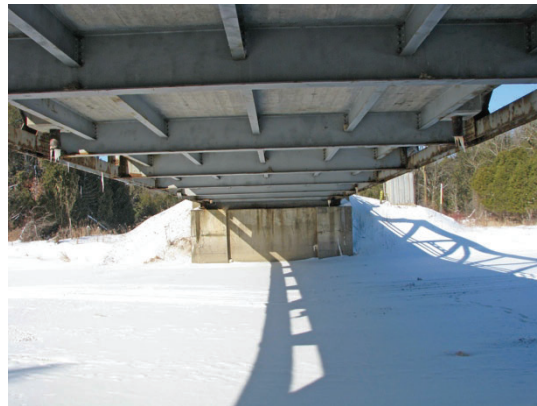
View to north abutment showing underside of deck [UMcA February 2015].

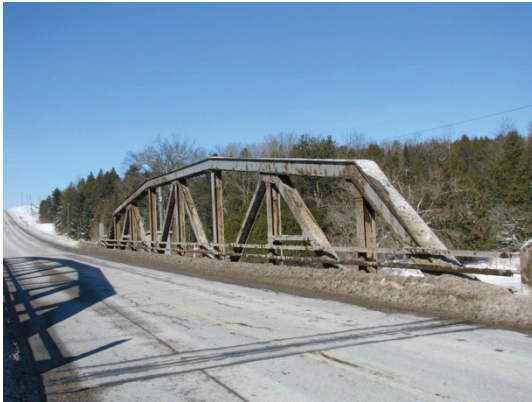
East metal truss roadside [UMcA February 2015].

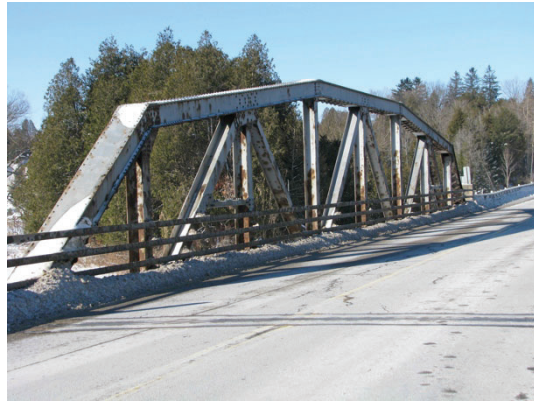
West metal truss roadside [UMcA February 2015].

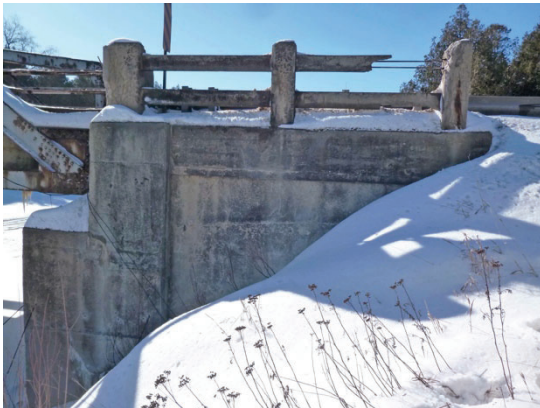
Detail of the original concrete handrail on the northeast corner [UMcA February 2015].

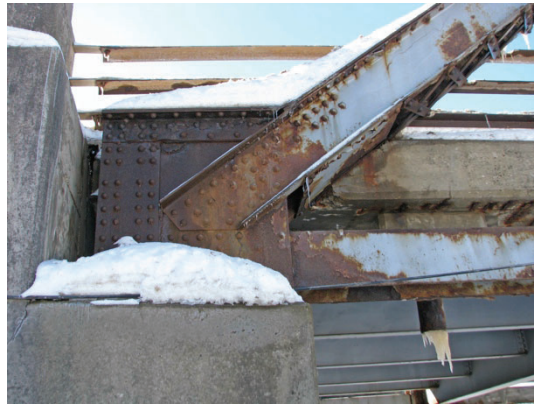
Metal truss and abutment connection [UMcA February 2015].

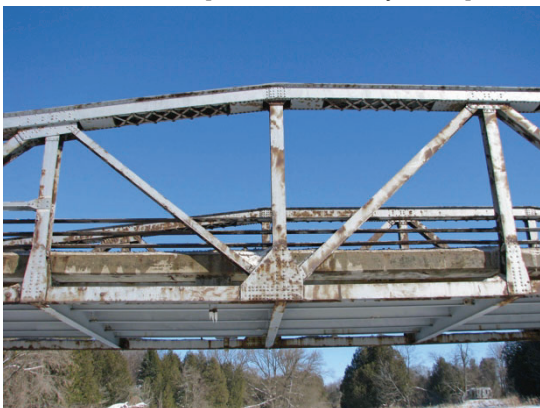
Detail of middle section of truss system [UMcA February 2015].

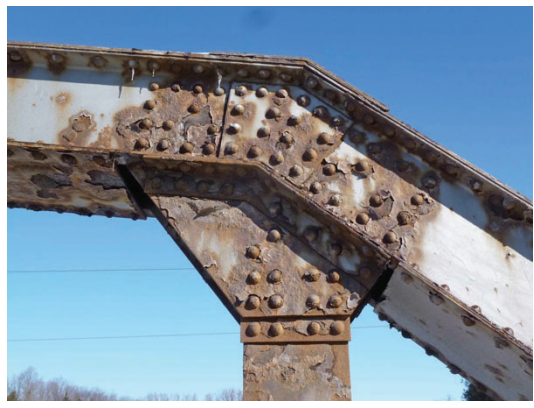
Detail of rivetted connection on metal truss [UMcA February 2015].

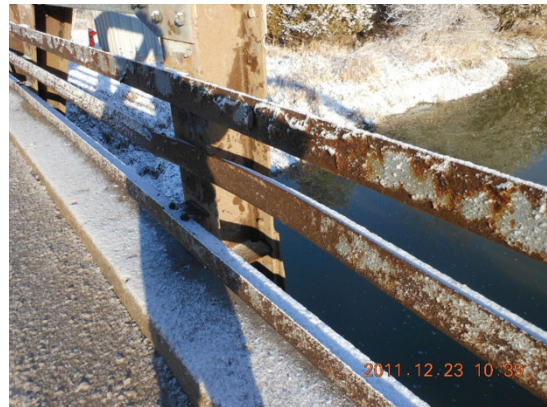
Metal guiderail on bridge [MMM Group Dec. 23, 2011].

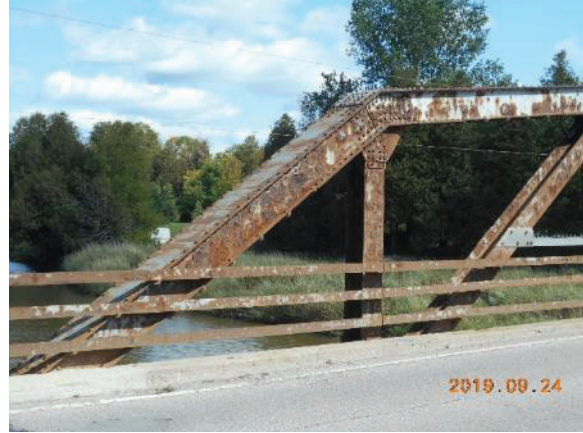
**Image 6: View of the end diagonal truss member**

The two steel trusses consist of wide flange beam units with three centre panels and two end panels, each measuring 5.2 m in length (UMcA 2015) (Image 1-4). The centre section of the top chord is 4.88 m high and sections on either side slope downwards to a height of 3.7 m (UMcA 2015). The Warren truss design is evidenced through the use of equilateral triangles (Image 7) and the Camelback design is characterized by the five angles of the upper chord. A commemorative plaque is located on the east end of the east top chord of the truss (Image 18). The original concrete railings located on each corner of the bridge are comprised of two balustrades and an end post with two horizontal concrete railings spanning between the posts (Image 15-16). The total length of each railing is 4.9 m and each concrete post is 0.9 m (UMcA 2015). The east and west bridge approaches include long steel guardrails on both sides of the road.

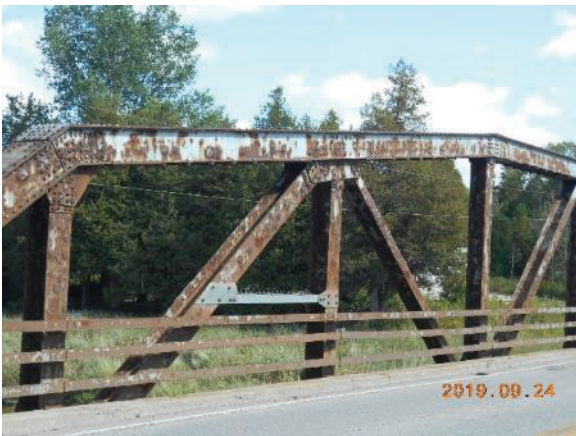
**Image 7: View of the top chord**

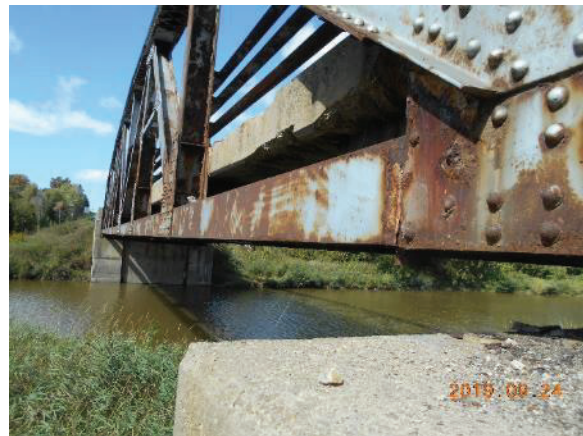
**Image 8: View of the bottom chord**

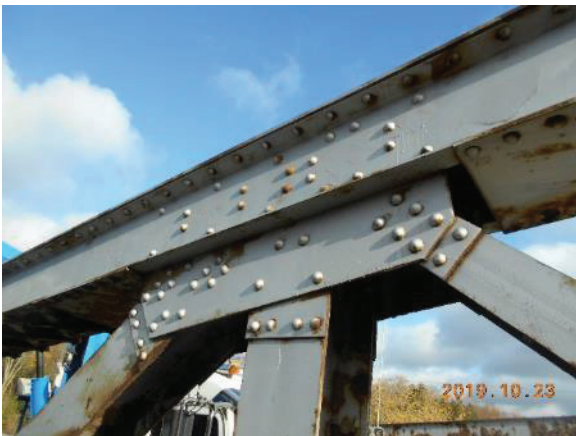
**Image 9: Detail of the rivets connecting truss members**

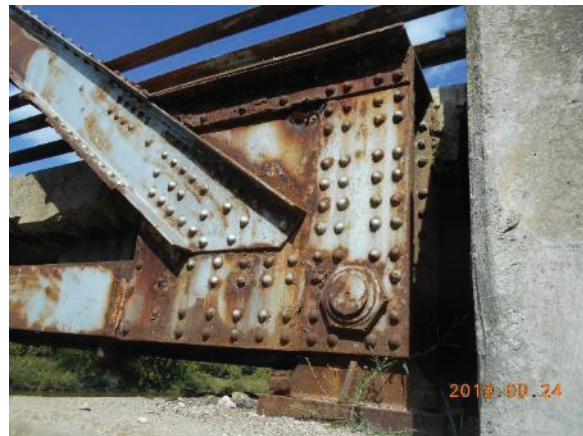
**Image 10: Detail of the gusset connection**

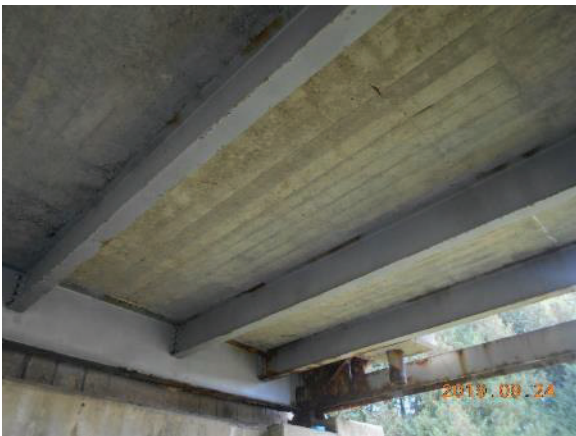
**Image 13: Detail of concrete soffit, floor beam and stringer**

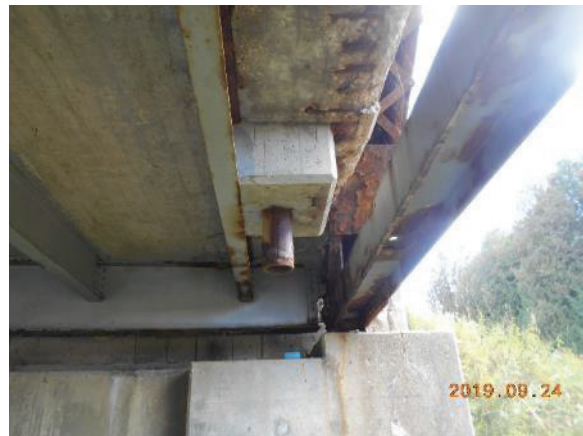
**Image 14: View of the superstructure's underside, note drainage pipe**

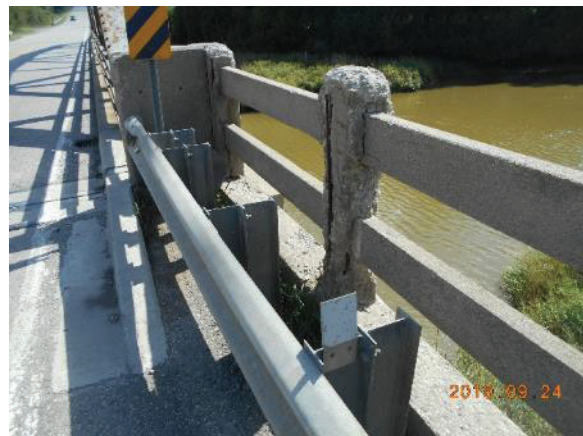
**Image 16: Detailed view of concrete railings, note exposed rebar**

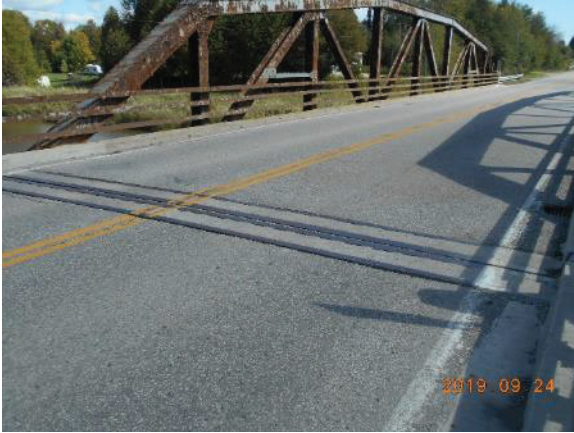
**Image 17: Detail of west bridge joint and asphalt wearing surface**

The Bosworth Bridge has not undergone any major changes to its original design intent, and it retains the original handrail system (UMcA 2015). The first known rehabilitation completed for the subject bridge took place in 1987 when the structure was 38 years old. The work was done under Contract No. 87-61 prepared for the County of Wellington by McCormick Rankin. This rehabilitation involved cleaning and coating of the structural steel, strengthening the truss lower chord connections, replacement of the expansion joints, concrete overlay, waterproofing and paving (WSP 2018). The second known repair took place in 2008 and included the installation of braces at the compression diagonals to improve the load capacity of the bridge (WSP 2018). The last known repairs took place in 2013 and included jacking the bridge and placing shims underneath of the rocker bearings to level the deck with the concrete end dams at the ballast wall (WSP 2018).

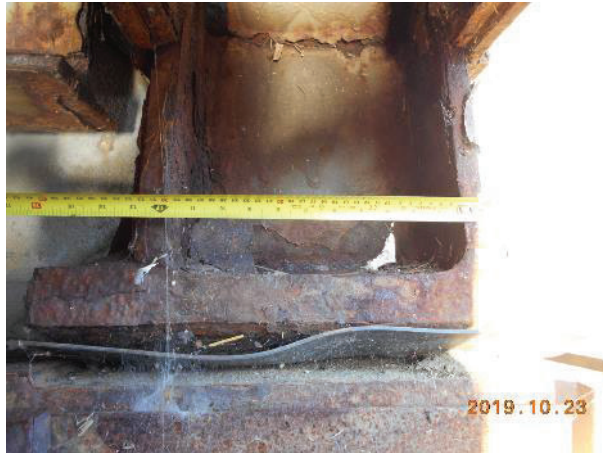
Image 19: Detail of support bearing indicating full depth section loss

In addition, the structural support staff noted that truss bridges have main load carrying members that are designed without redundancy. As such, if one element is in poor condition and fails, the entire structure is likely to also have a catastrophic failure, unlike rigid frame or girder structures that can accommodate local failure. One of the bridge’s support bearings was noted to have full depth section loss (Image 19). Local rehabilitation of this member was reviewed and it was determined that the bridge was not designed to be temporarily jacked and a replacement of the bearing would require major work (i.e., removal of the deck, strengthening of connections to temporarily jack and replace the bearing).
