Wellington Road 7, Bosworth Bridge No. B007028

Schedule B Municipal Class Environmental Assessment

**PUBLIC INFORMATION CENTRE
Online Package**

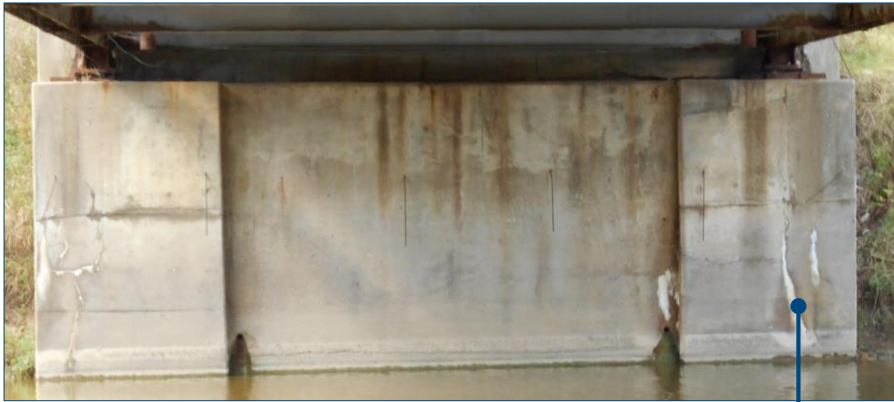
West Abutment

Cracks and Efflorescence

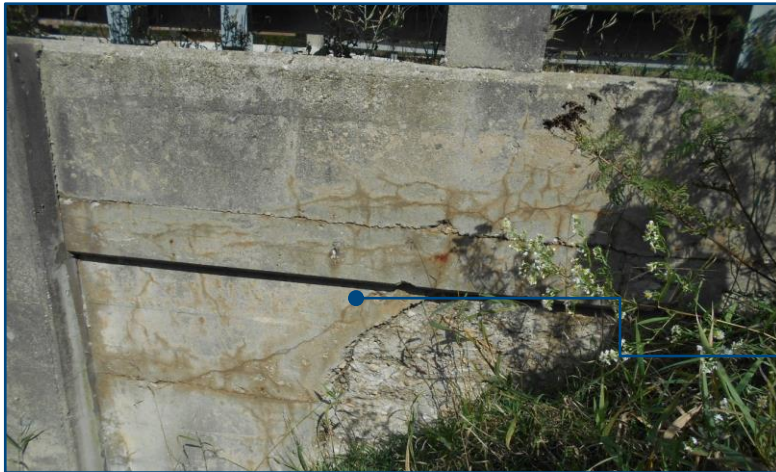
South East Wingwall

Cracks, Spall and Scaling

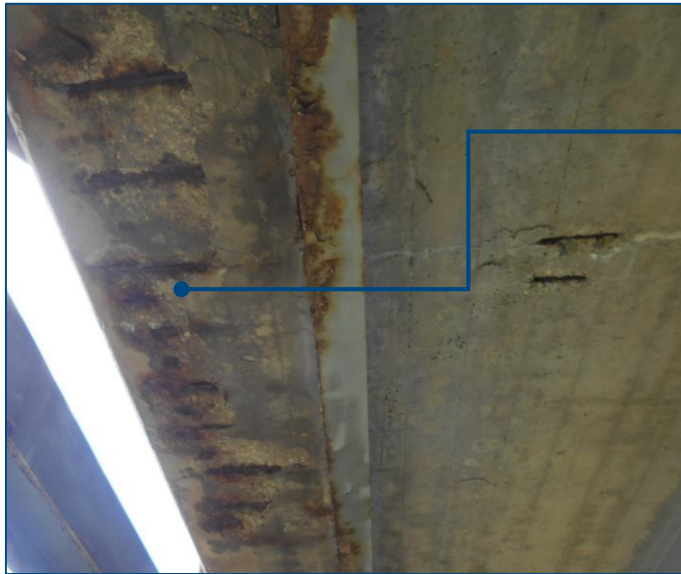
Exterior Deck Soffit

Spall with Exposed Rebar, Honeycomb and Efflorescence

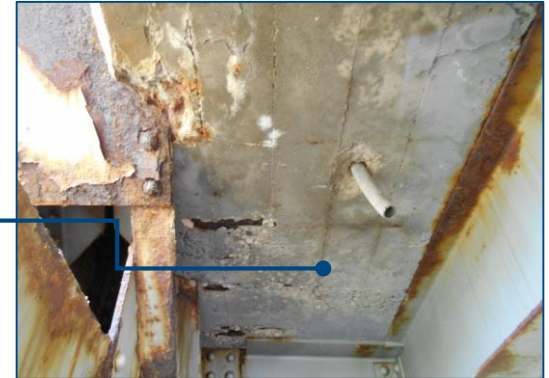
Deck Soffit

Severely Rusted Deck Drains

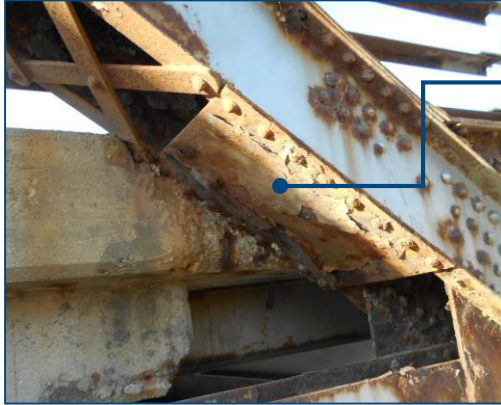
Severely Corroded and Flaked Batten Plate

Corroded and Flaked Diagonal Lattice Bars

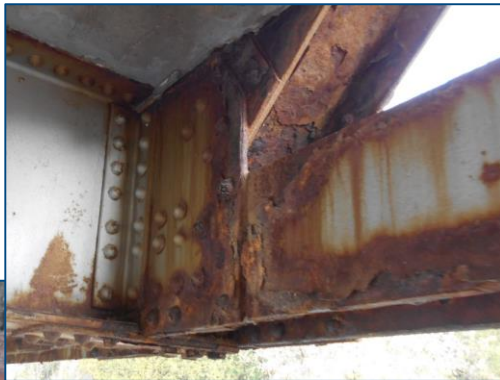
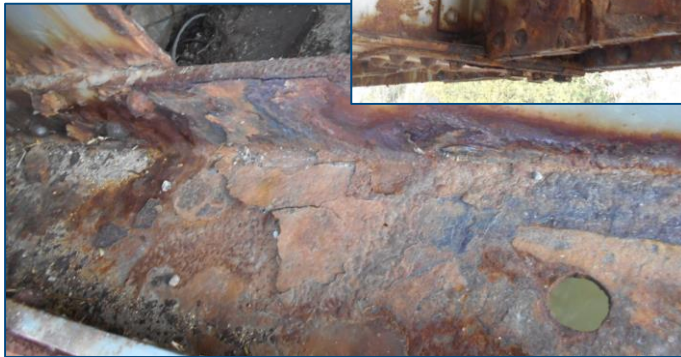
Corrosion and Rust Jacking at Gusset Connections

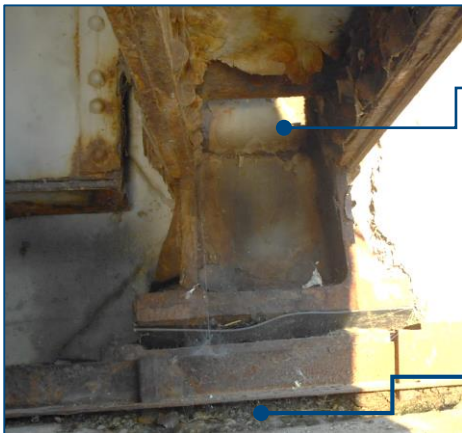
Northwest Bearing

Perforation through Diaphragm

Section Loss

Upward Movement

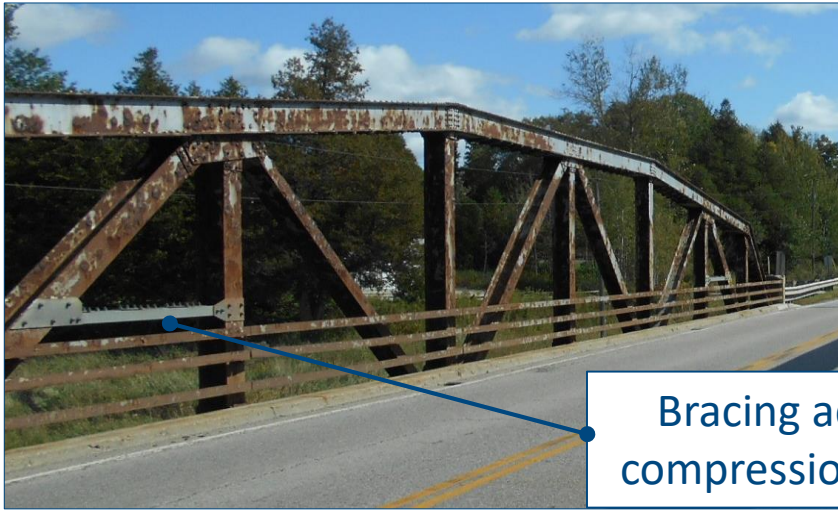
South Traffic Barrier

Bracing added to diagonal compression members (2008)

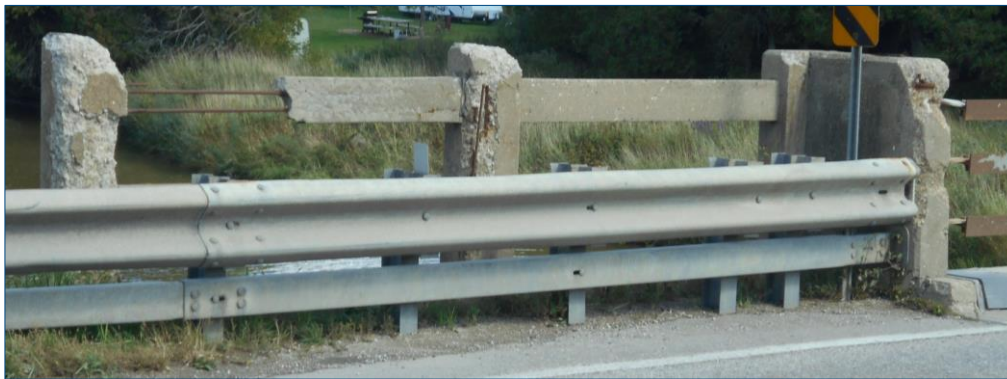
Damaged & Substandard Barrier

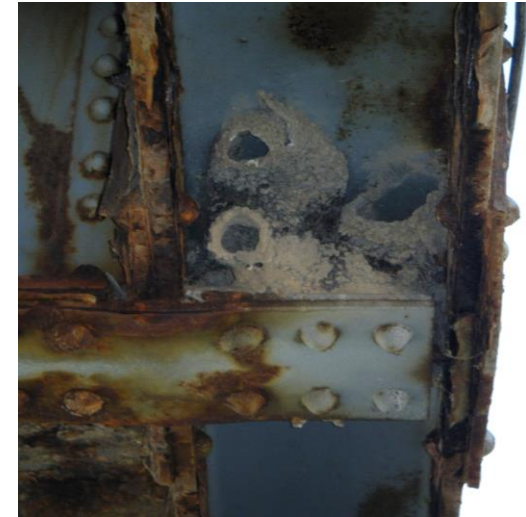
Cliff Swallow nests (>30) were documented on the underside of the Bridge in 2020
