# WELLINGTON ROAD 7, BOSWORTH BRIDGE NO. B007028 PROJECT FILE

# WELLINGTON ROAD 7, BOSWORTH BRIDGE NO. B007028

PROJECT FILE

PROJECT NO.: 20M-01326-00  
DATE: JANUARY 01, 2022

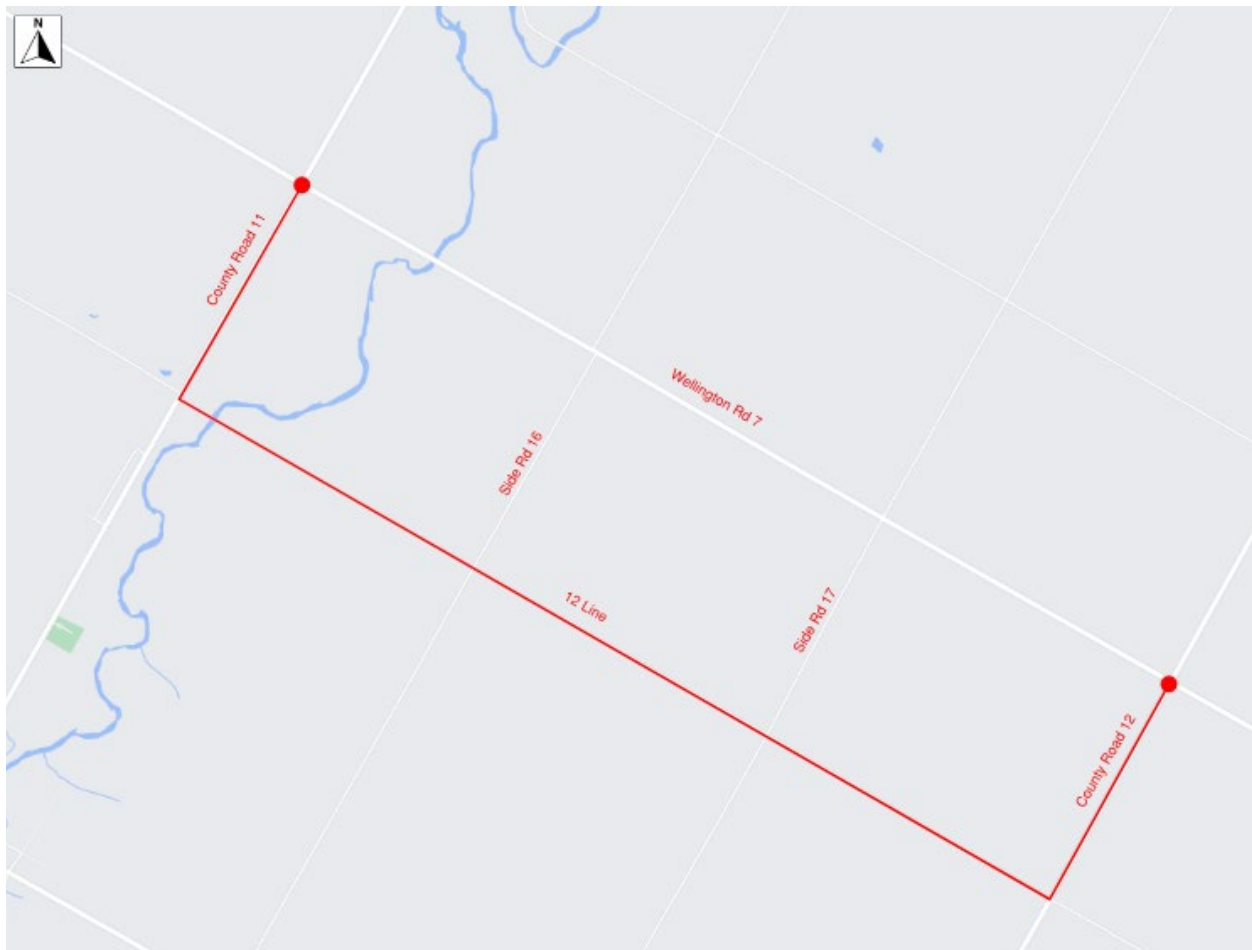
**Figure 6-1** Proposed Preliminary Detour Route

During construction, Wellington Road 7 will be closed at the bridge. Traffic will be detoured to adjacent roads and would likely follow the 8.2 km long signed detour route illustrated in **Figure 6-1**, which includes travel along County Road 11, 12 Line, and County Road 12. This route avoids the unpaved roads of Side Road 16 and Side Road 17. The detour route will be evaluated further during preliminary and detailed design.
