665 Eliza Street Meander Belt Width Assessment

FINAL REPORT

Tribute/Sorbara Arthur Holdings Inc.

Project No. P2022-616

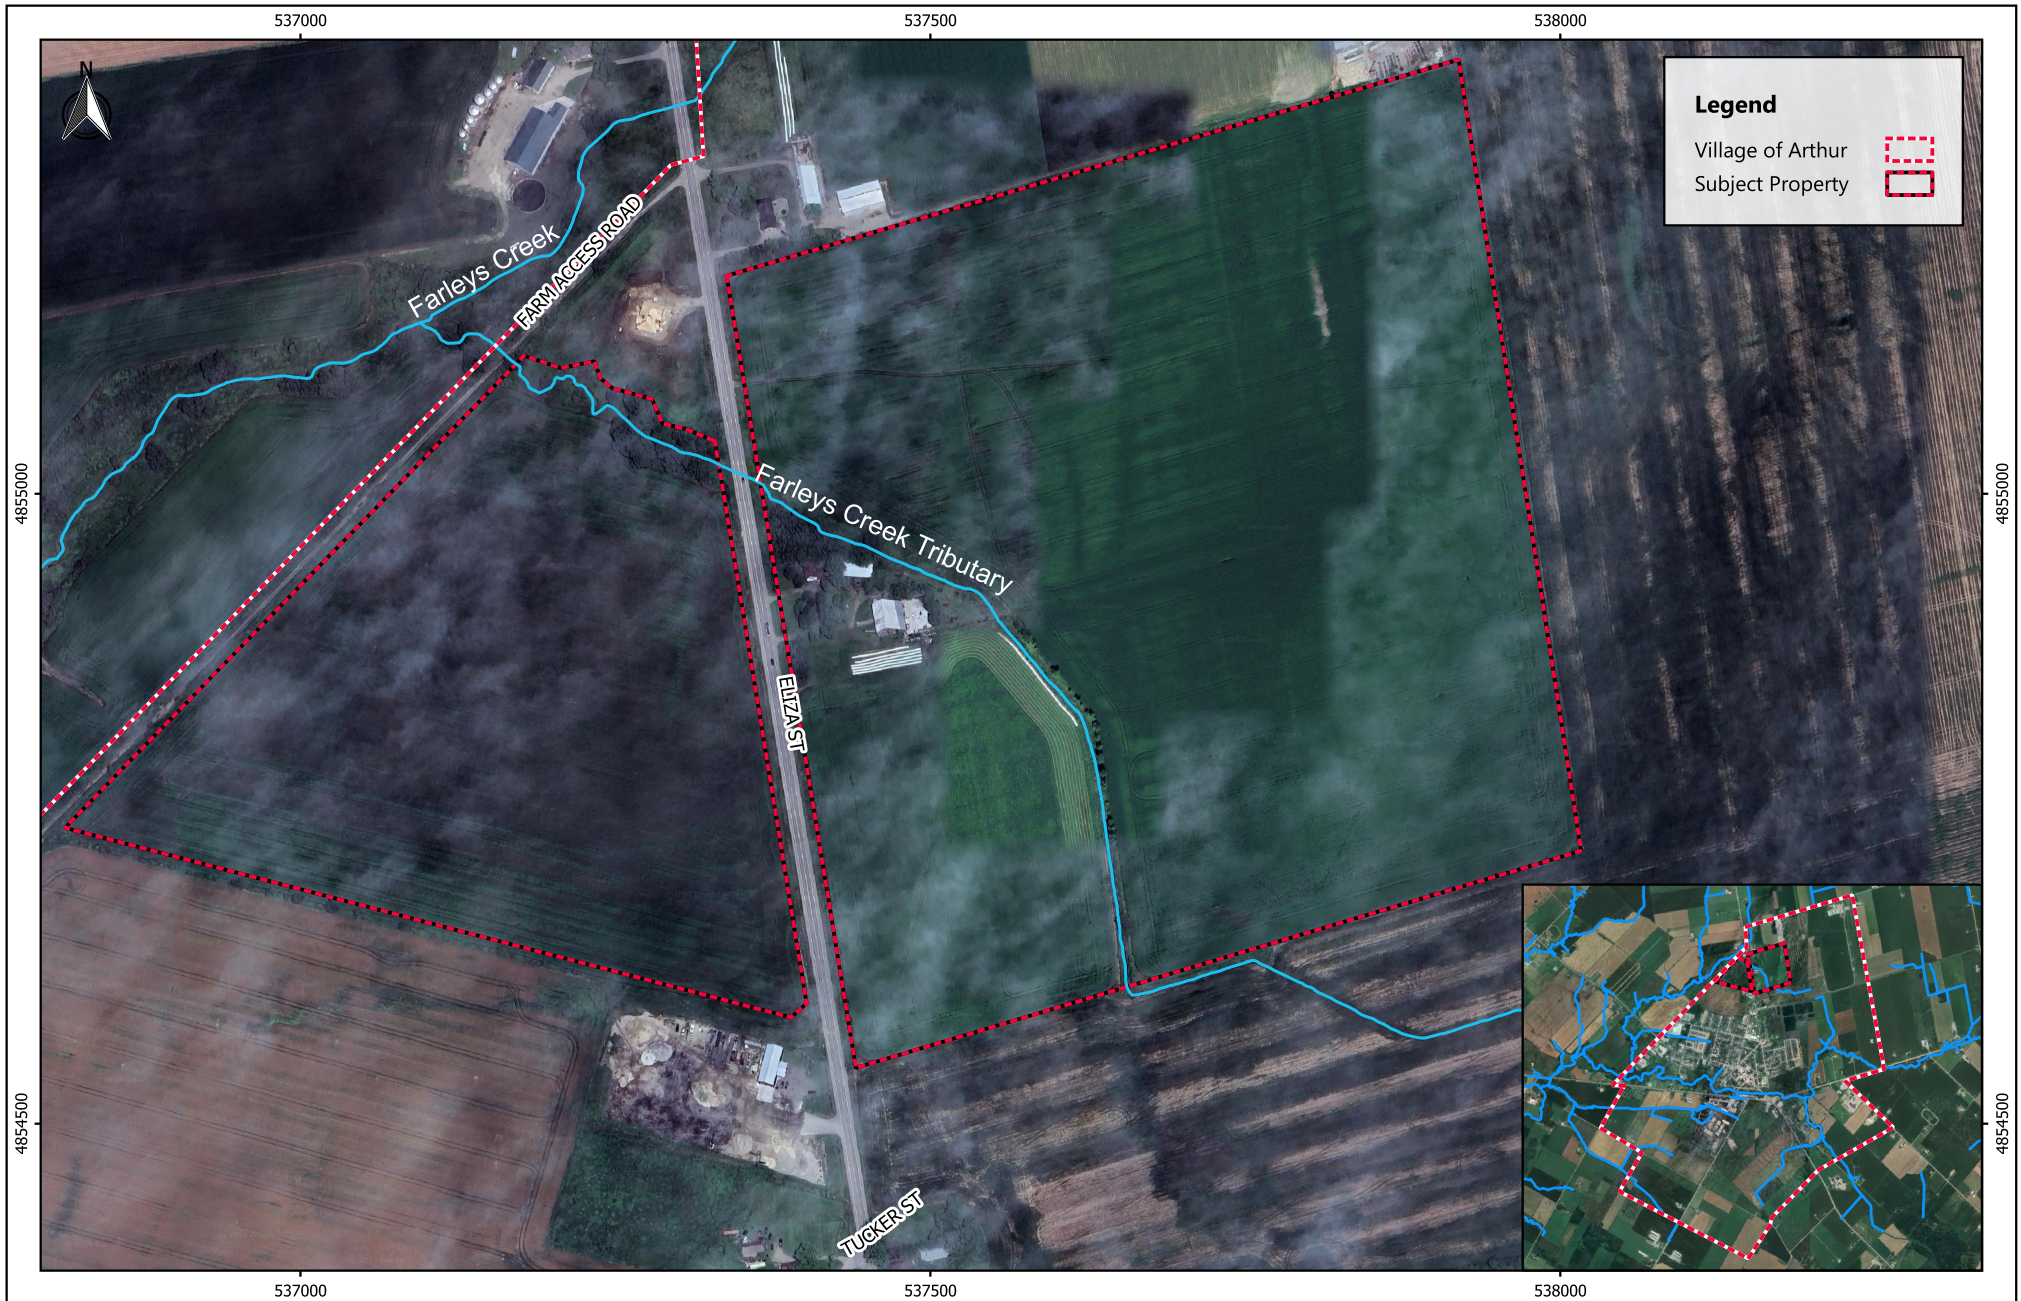
Figure 1.

Subject properties.

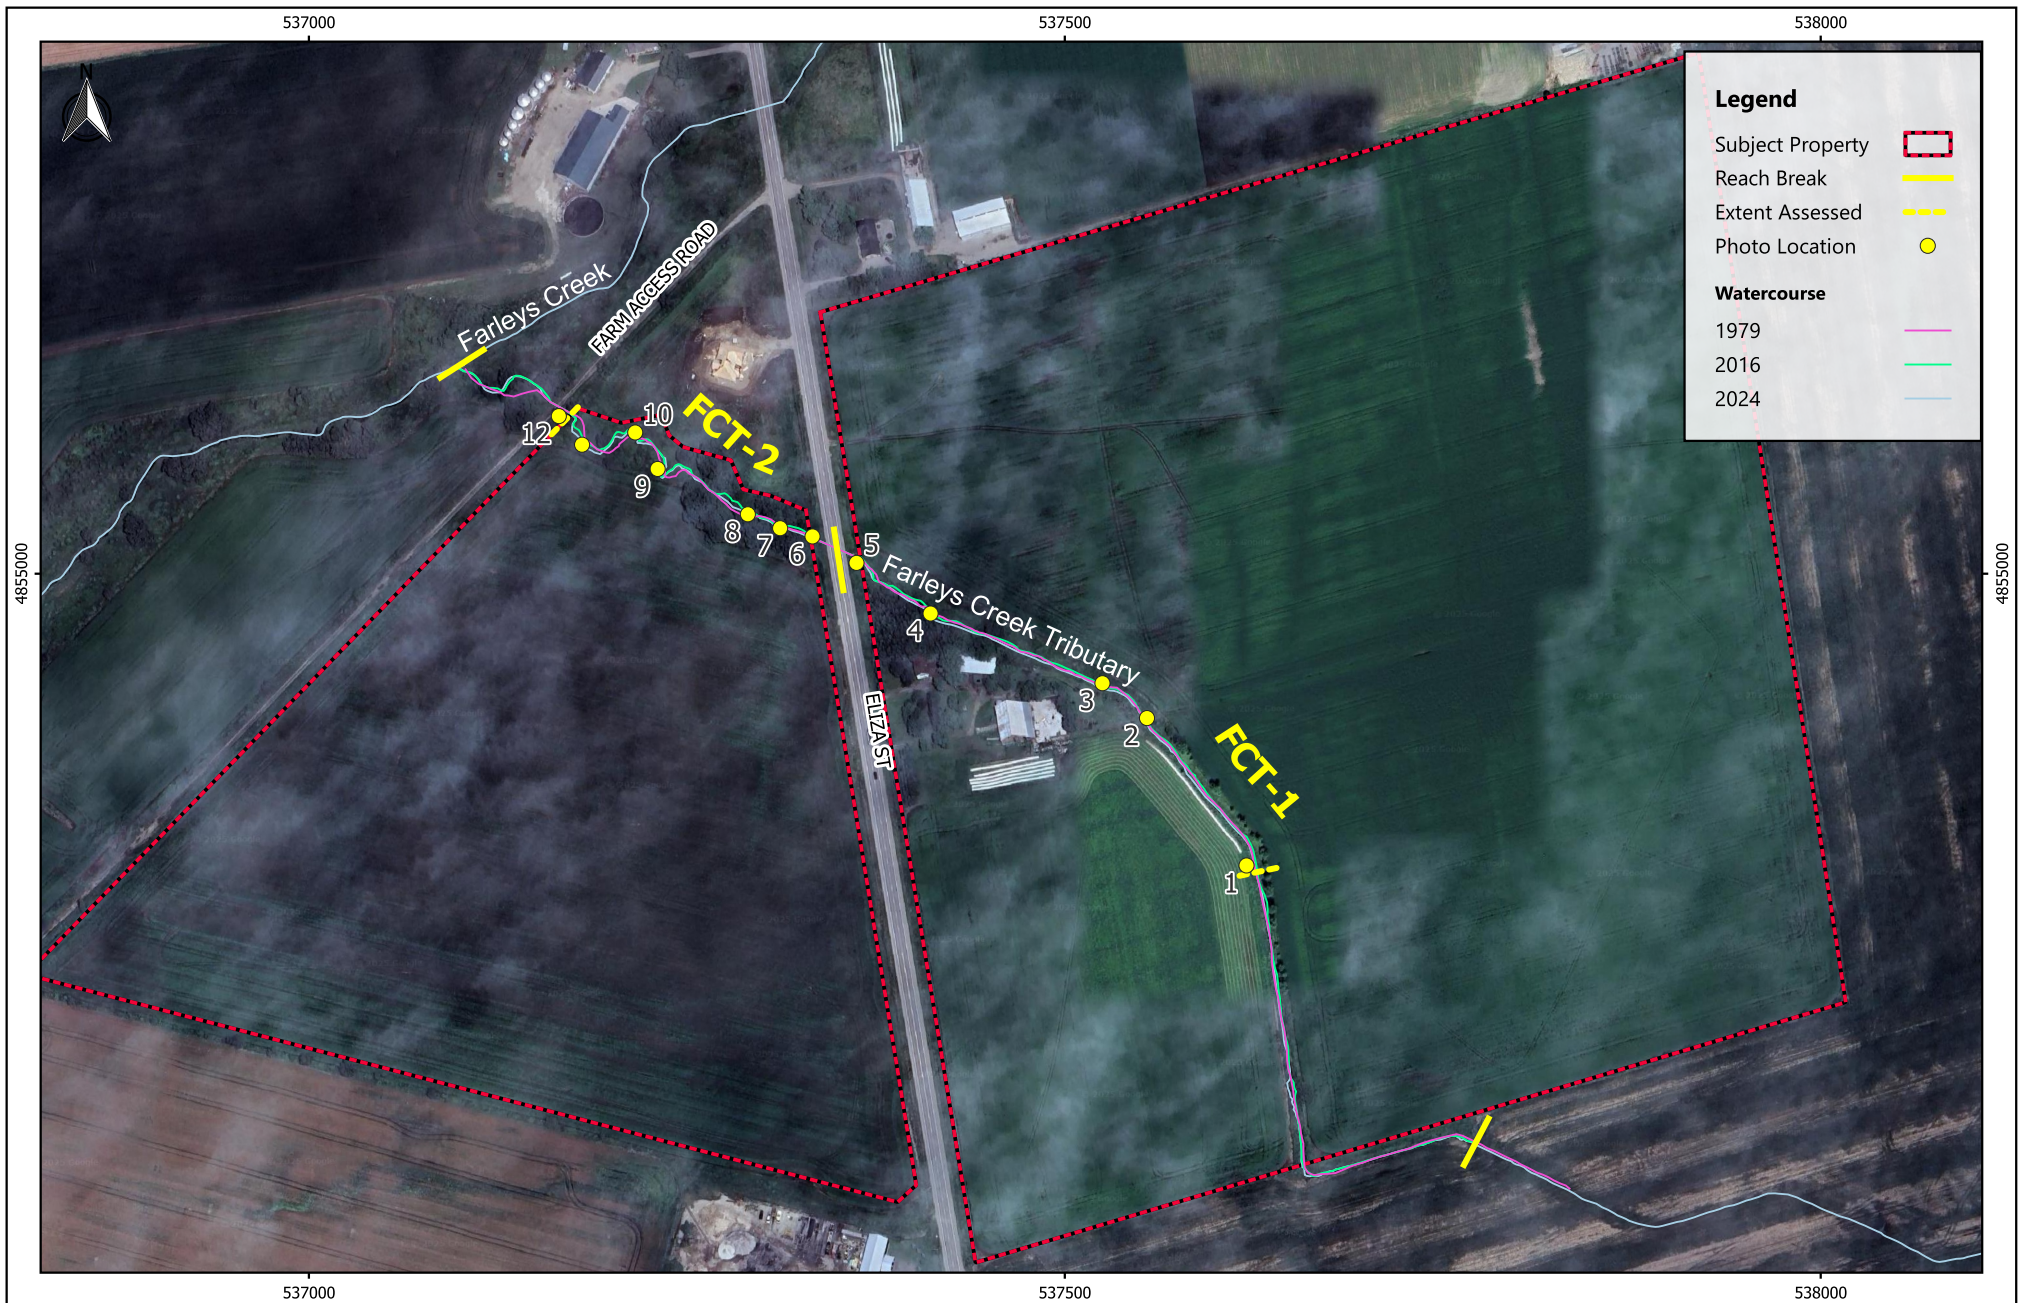
Figure 3.
 Reach delineation and existing conditions characterization for FCT-1 and FCT-2.

Two reaches were delineated within the Subject Properties: Reaches FCT-1 and FCT-2 (Figure 3). Reach breaks were defined based on changes in the degree of historic alteration, riparian vegetation, and channel planform. Reach FCT-1 extends approximately 125 m upstream of the property limit, flowing through an unconfined and channelized corridor within the property to Eliza Street. Reach FCT-2 extends from Eliza Street to the tributary confluence with Farleys Creek. Reach FCT-2 maintains a sinuous planform within a broader, unconfined valley corridor.

To characterize existing geomorphic conditions along Reaches FCT-1 and FCT-2 of the Farleys Creek Tributary, a reconnaissance-level field investigation was conducted by GeoProcess staff on December 19, 2024. A photographic record of conditions at the time of the assessment is provided in Appendix B; photo locations are shown on Figure 3.

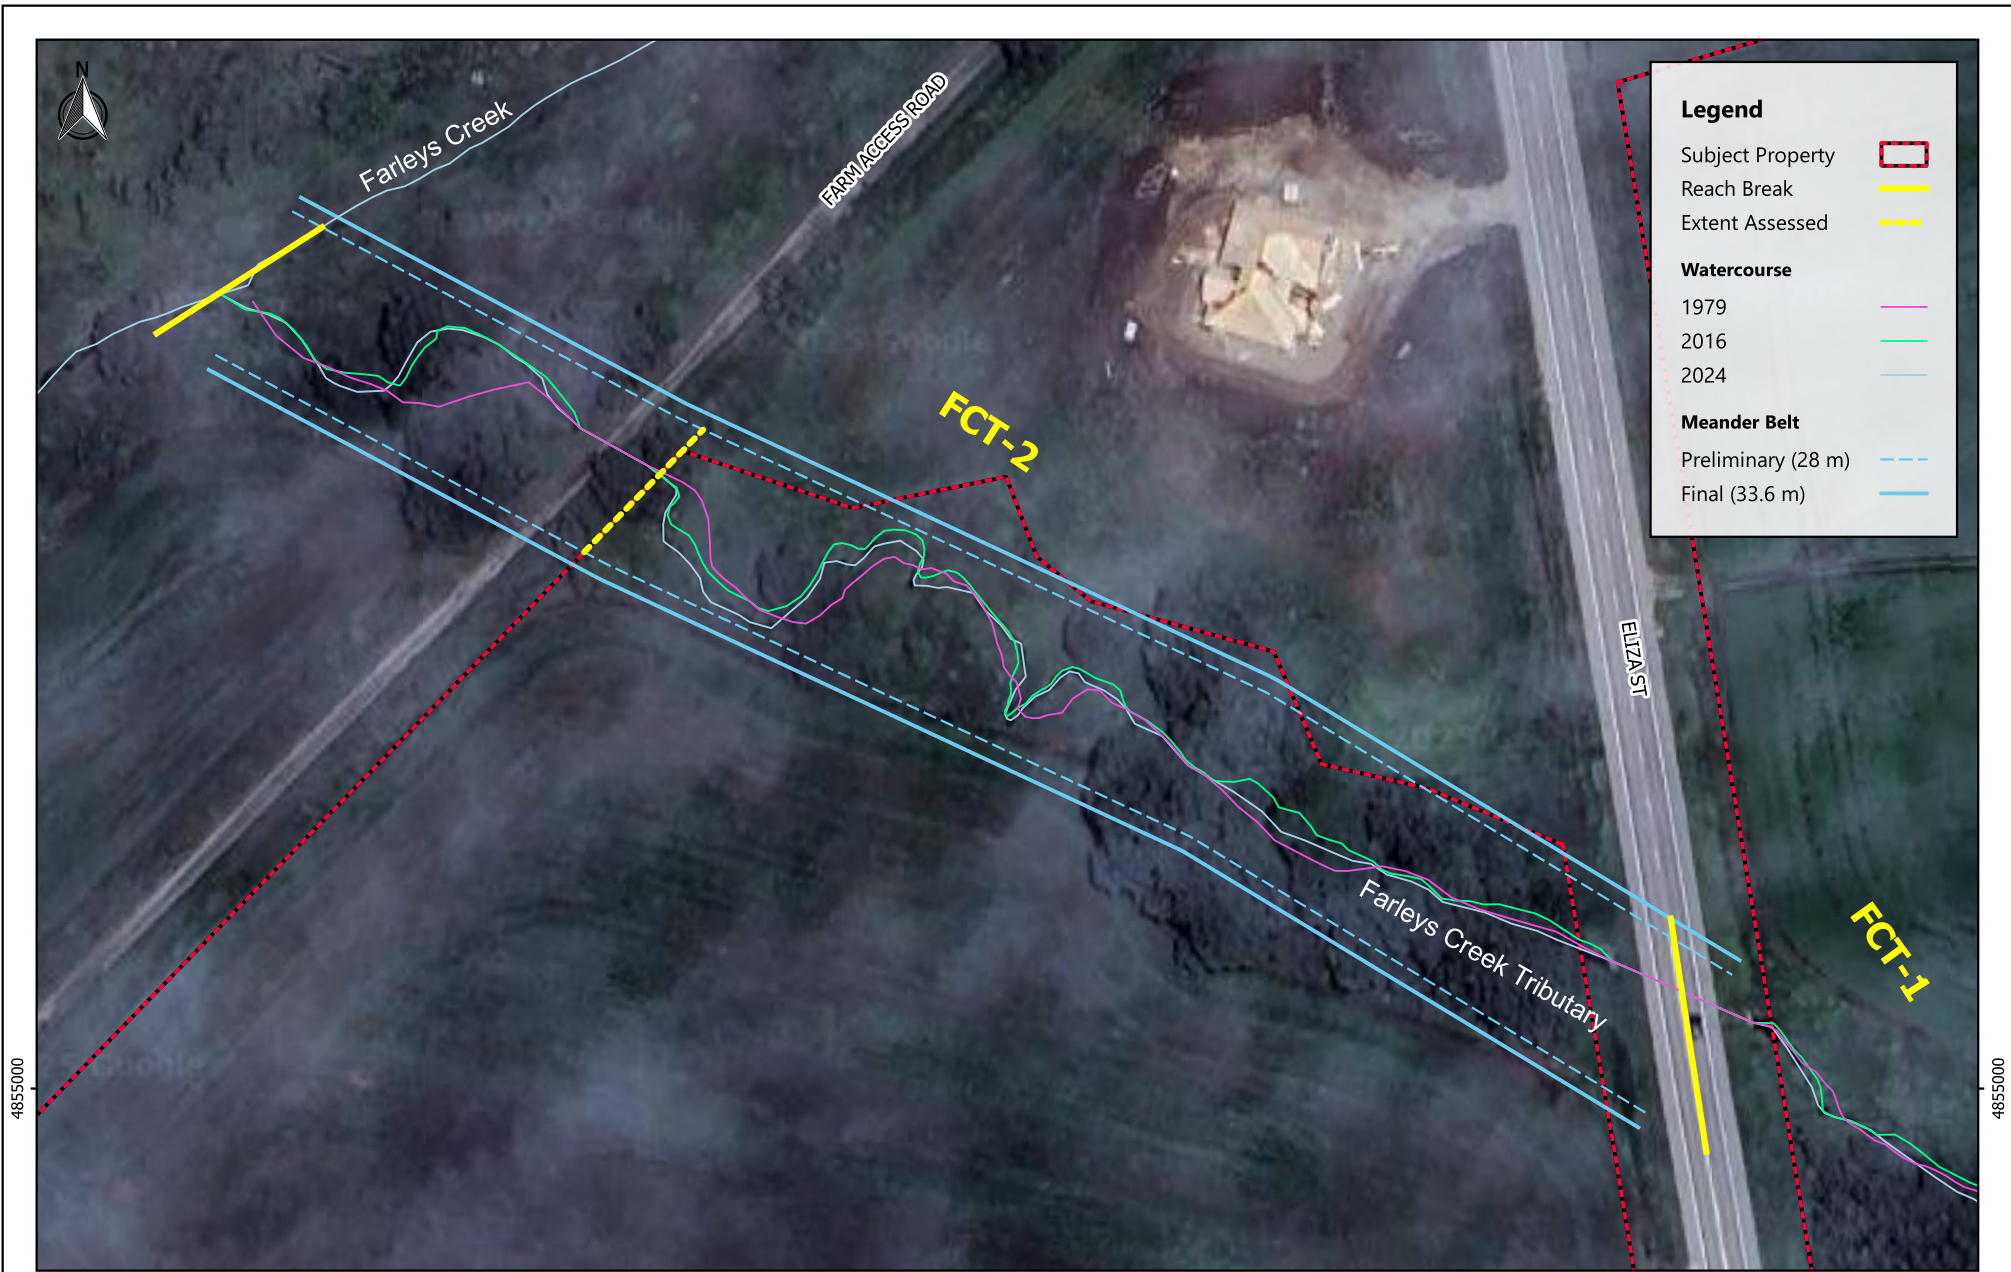
Following methods outlined in the TRCA (2004) procedures, the 28 m preliminary meander belt for Reach FCT-2 was based on the lateral extent of governing (outermost) meander bends over the available historical record. To account for potential long-term adjustments in the hydrologic regime and/or channel form, a 20% factor of safety was applied, resulting in a recommended meander belt dimension of 33.6 m. Meander belt limits for Reach FCT-2 are shown on Figure 4.

Meander belt delineation for FCT-2.

Based on a review of available background information, including historical aerial imagery, and field confirmation of existing geomorphic conditions, meander belt dimensions of 24.6 m (Reach FCT-1) and 33.6 m (Reach FCT-2) are recommended for the portion of Farleys Creek Tributary relevant to the Subject Properties. The 24.6 m meander belt dimension for Reach FC-1 will be incorporated into the bottom width dimension of the proposed linear corridor design to ensure that the corridor size is sufficient to support a natural, sinuous planform and potential long-term adjustments in channel form.

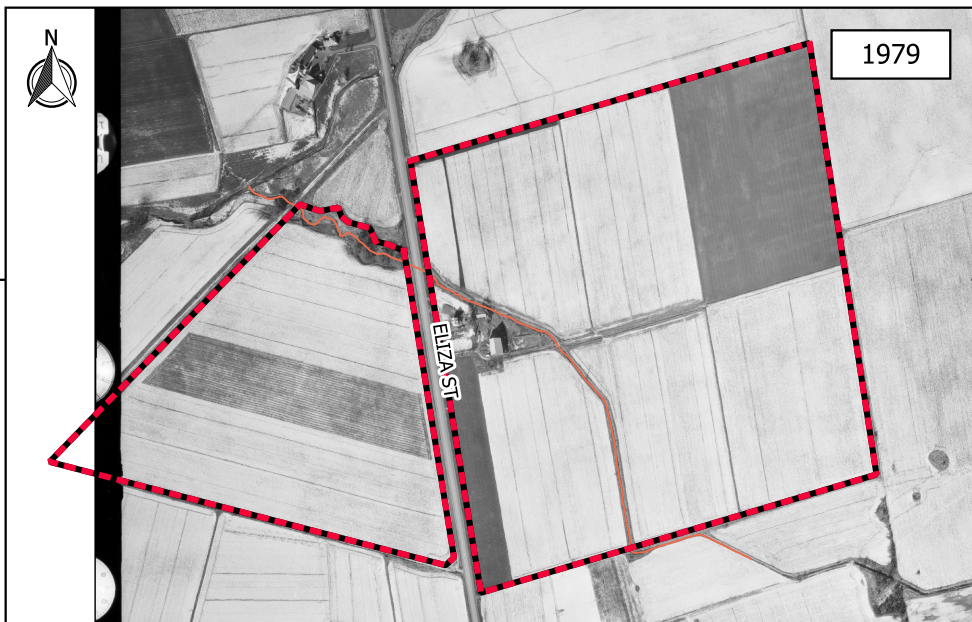
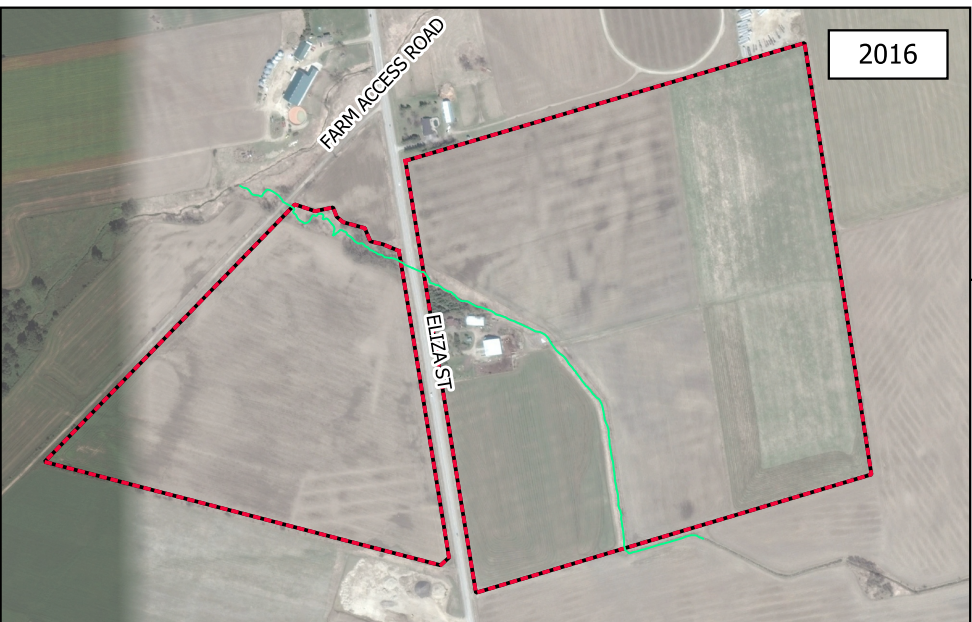
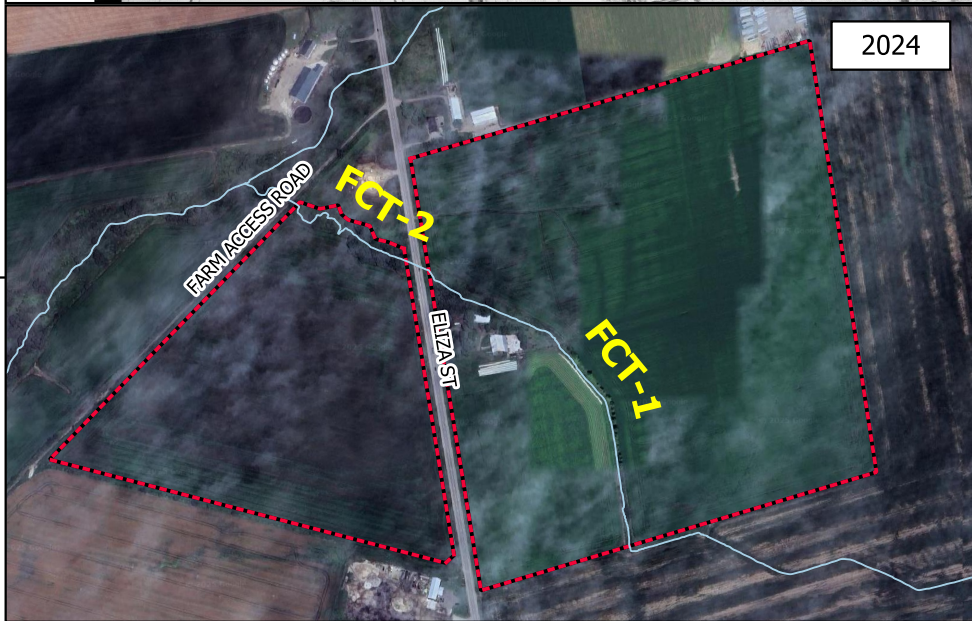
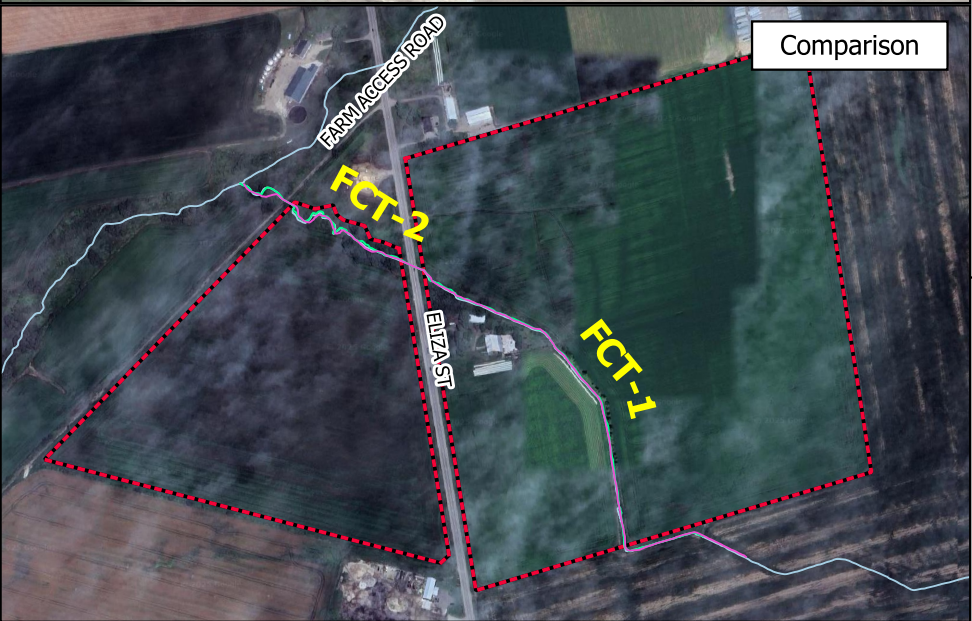
Appendix A.
 Historic Watercourse

A series of historical aerial photographs spanning approximately 45 years were reviewed to evaluate changes in channel form and land use conditions over time. Table 1 summarizes key historical observations, while Appendix A illustrates an overlay of the channel planform as delineated for each year of record.

Year	Observation
1979	Land use within and surrounding the Subject Properties consists of agriculture. Eliza Street and a farm access road have been constructed. Within the Subject Properties the existing barn and residence can be observed. East of Eliza Street, the tributary has been channelized within a narrow riparian corridor. A driveway crossing of the tributary can also be observed, along with an associated upstream backwater zone. Downstream of the driveway, there is evidence of channel planform adjustment in the form of slumping banks and secondary flow paths. West of Eliza Street, the tributary maintains a sinuous planform within a wider, vegetated corridor. Active erosion is evident through the formation of scour pools downstream of Eliza Street and at the farm access road crossing. There is evidence of channel planform adjustment in the form of erosion and slumping along banks and the formation of secondary flow paths

1984	Except for the construction of a residence at 8565 Eliza Street and a commercial trucking business at 8035 Line 2, there is no discernible change in land use. or channel planform relative to 1979. East of Eliza

Year	Observation
	Street, minimal change in channel planform can be observed. West of Eliza Street, adjustments in channel planform can be observed through the development of a secondary meander pattern.
2024	No discernible changes in land use or channel planform can be observed.

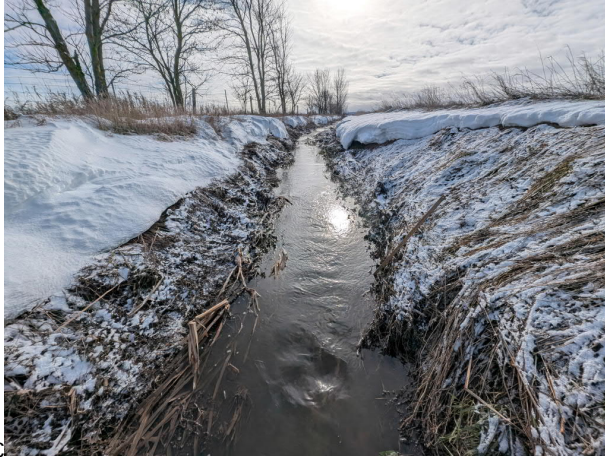
Photograph 1
Location 1
Reach FCT-1

Upstream view of general conditions at the extent assessed.

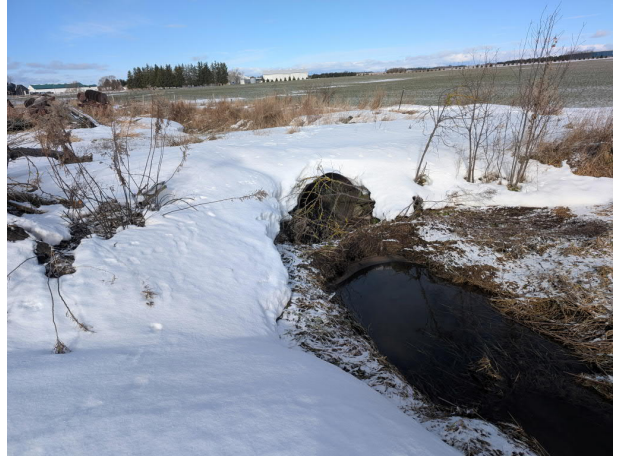
Photograph 2
Location 2
Reach FCT-1

Downstream view of 1.0 m CSP farm crossing with debris jam.

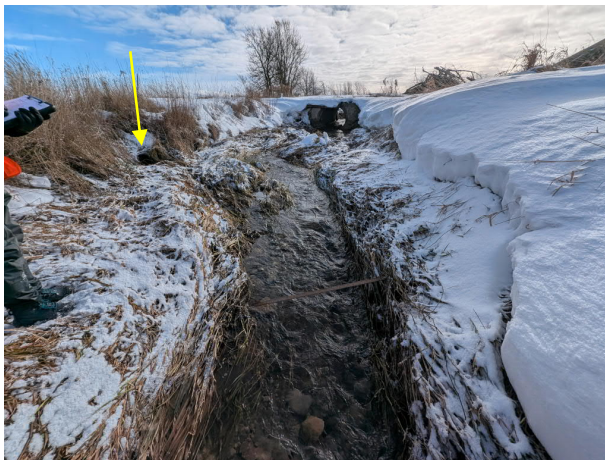
Photograph 3
Location 2
Reach FCT-1

Upstream view of riffle feature located downstream of large scour pool and tile drain outlet on right bank (photo left).

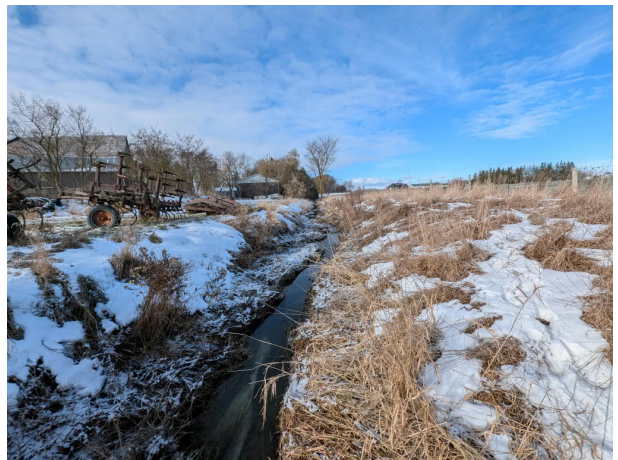
Photograph 4
Location 3
Reach FCT-1

Downstream view of a slightly steeper section with a narrowing flow path and minor evidence of planform adjustment with a narrow meander within the channelized ditch.

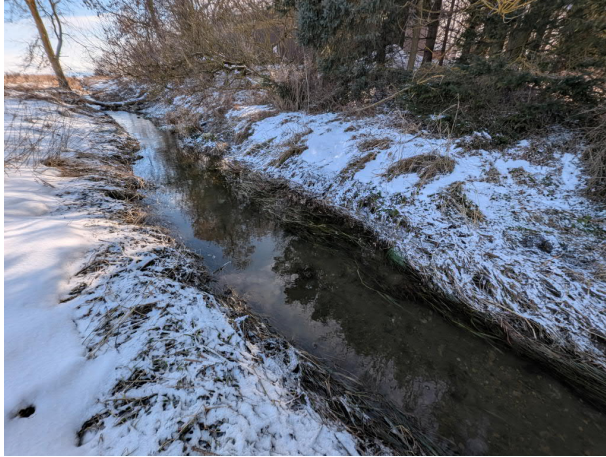
Photograph 5
Location 4
Reach FCT-1

Upstream view of run with wide bankfull width and embedded coarse materials.

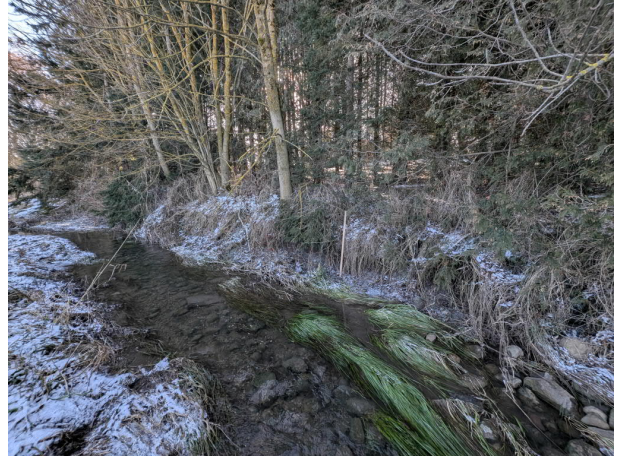
Photograph 6
Location 4
Reach FCT-1

Upstream view of left bank undercutting of confined ditch embankment. Note, that large cobble materials were likely added as ad hoc protection as they are not representative within this reach.

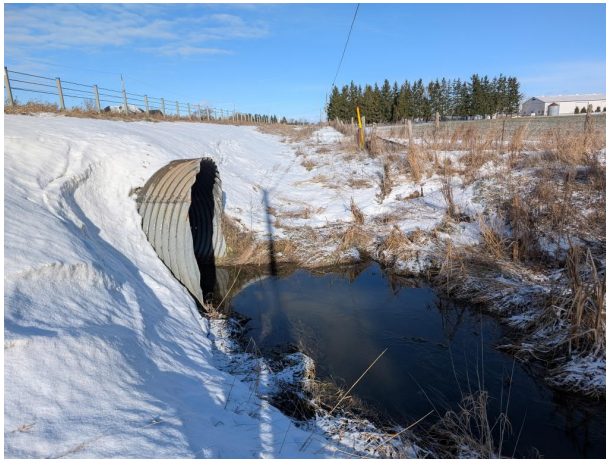
Photograph 7
Location 5
Reach FCT-1

The upstream end of the Eliza Street 2.8 m diameter CSP with a large sand deposit as flows transition through sharp bend into the culvert.

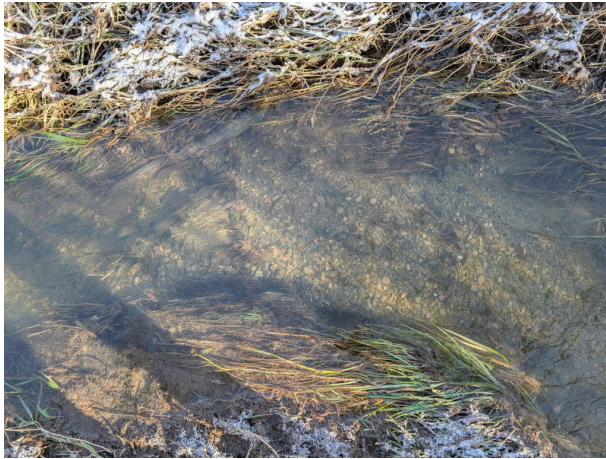
Photograph 9
Location 6
Reach FCT-2

View of channel bed gravel deposit downstream of the Eliza Street CSP.

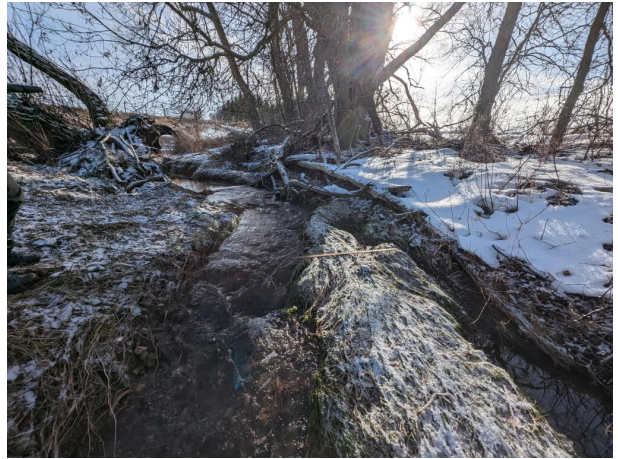
Photograph 10
Location 7
Reach FCT-2

Upstream view of riffle grade bound by dense willow roots.

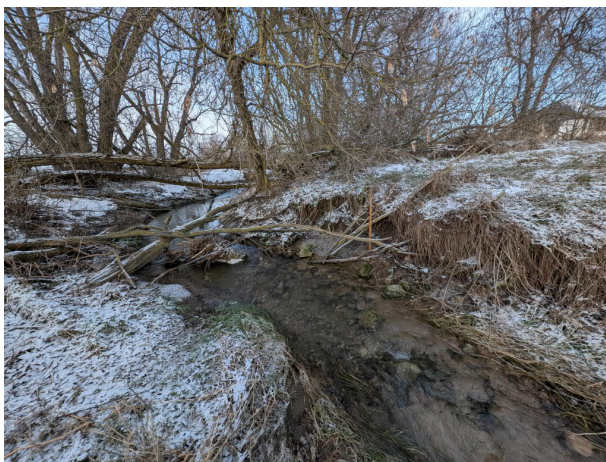
Photograph 11
Location 8
Reach FCT-2

Downstream view of right bank erosion and woody debris within the channel.

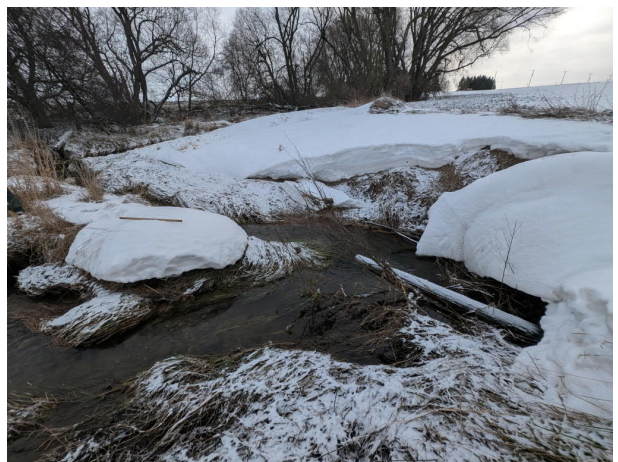
Photograph 12
Location 9
Reach FCT-2

Upstream view of a sharp meander bend with erosion all the left bank valley wall contact resulting in a fallen fence post.

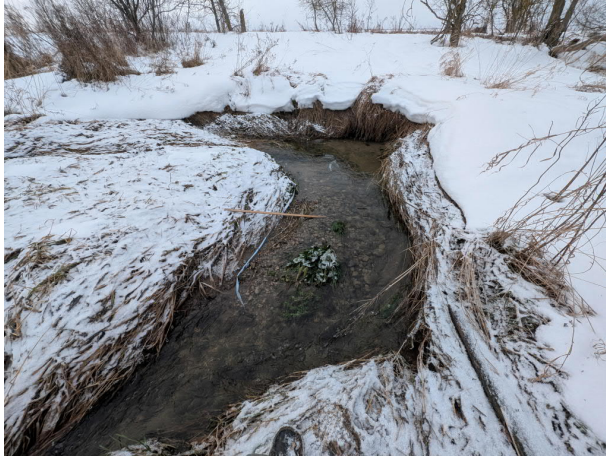
Photograph 13
Location 10
Reach FCT-2

Downstream view of right valley wall contact with fracture banks and well sorted point bar of fine to coarse gravels.

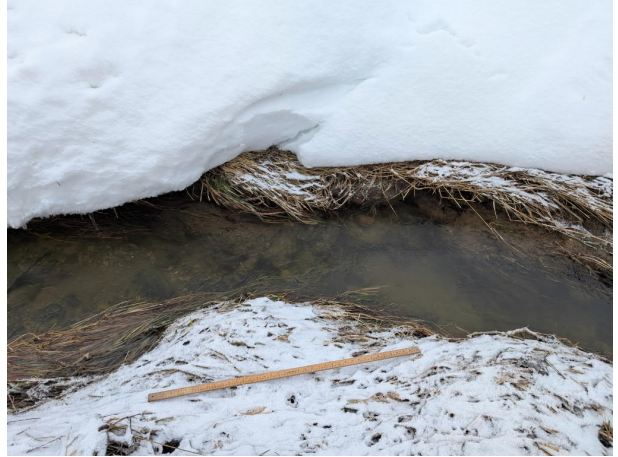
Photograph 14
Location 11
Reach FCT-2

Exposed till materials in channel bed.

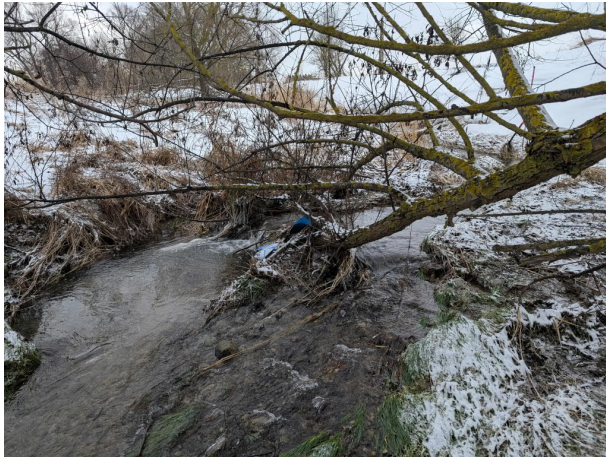
Photograph 15
Location 12
Reach FCT-2

Upstream view of wood debris resulting in an alternative flow path.

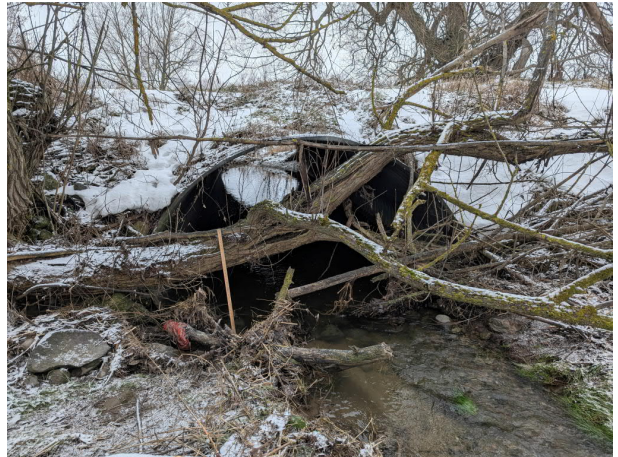
Photograph 16
Location 12
Reach FCT-2

Downstream view of Wells Street East with 1.8 m tall and 2.8 m wide CSP at downstream extent of the Subject Property.
