Intersection Assessment

Wellington County Roads Committee

September 14, 2021

Intersection Location: Wellington County Road 18 & Wellington Road 26 (Intersection 1)

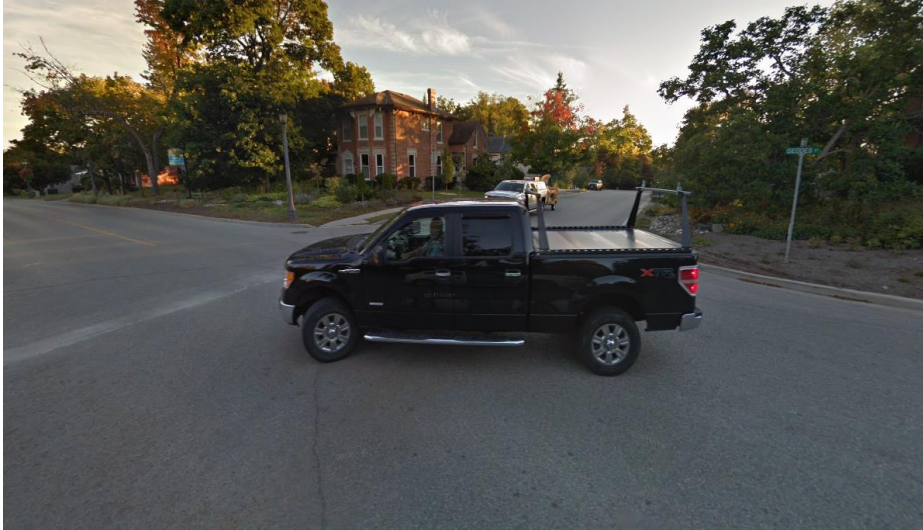
WR 18 and David Street

- Majority of recommended solutions require significant capital funding and time to design and construct
- Recommend that Staff use intersection assessment to inform future capital road budgets
- Potential short-term intersection change:
 - **Location:** WR 18 (Geddes Street) and David Street, Township of Centre Wellington
 - **Recommendation:** Implement a permanent all-way stop
 - **Context:** Requires a bylaw change to turn the temporary all-way stop to a permanent all-way stop
 - To be approved at an upcoming Roads Committee meeting

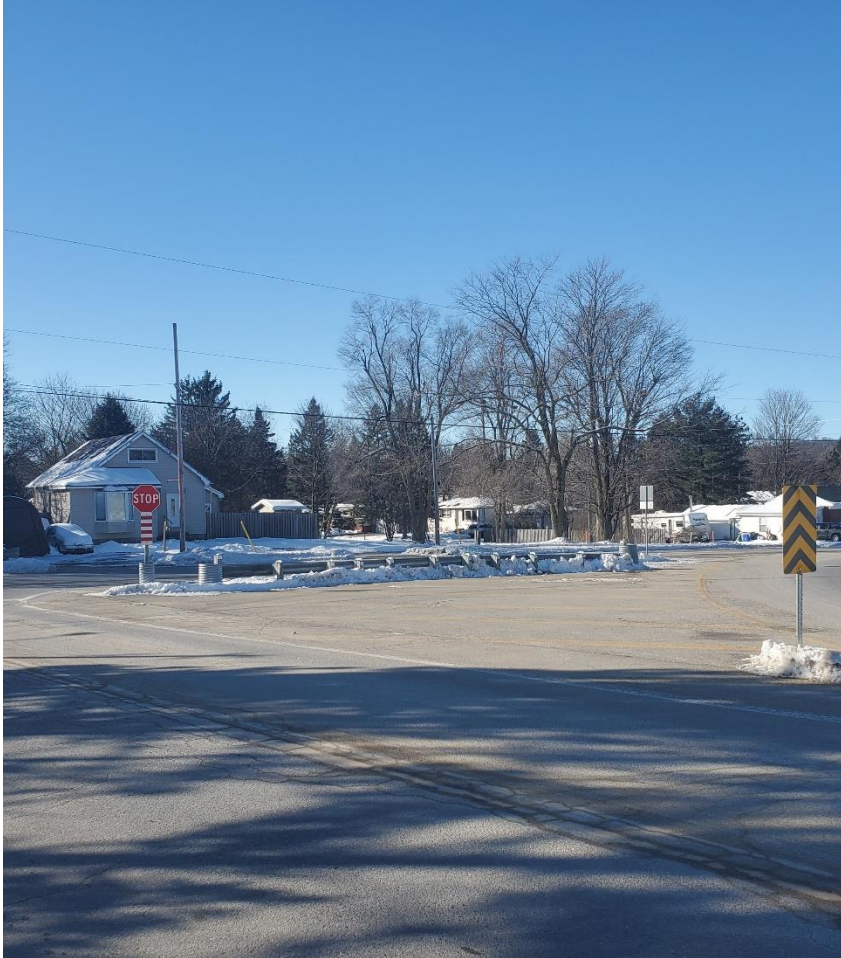
Wellington Road 52 at Ninth Line. Recommended solution includes removal of right turn channel and conversion to all-way stop control.

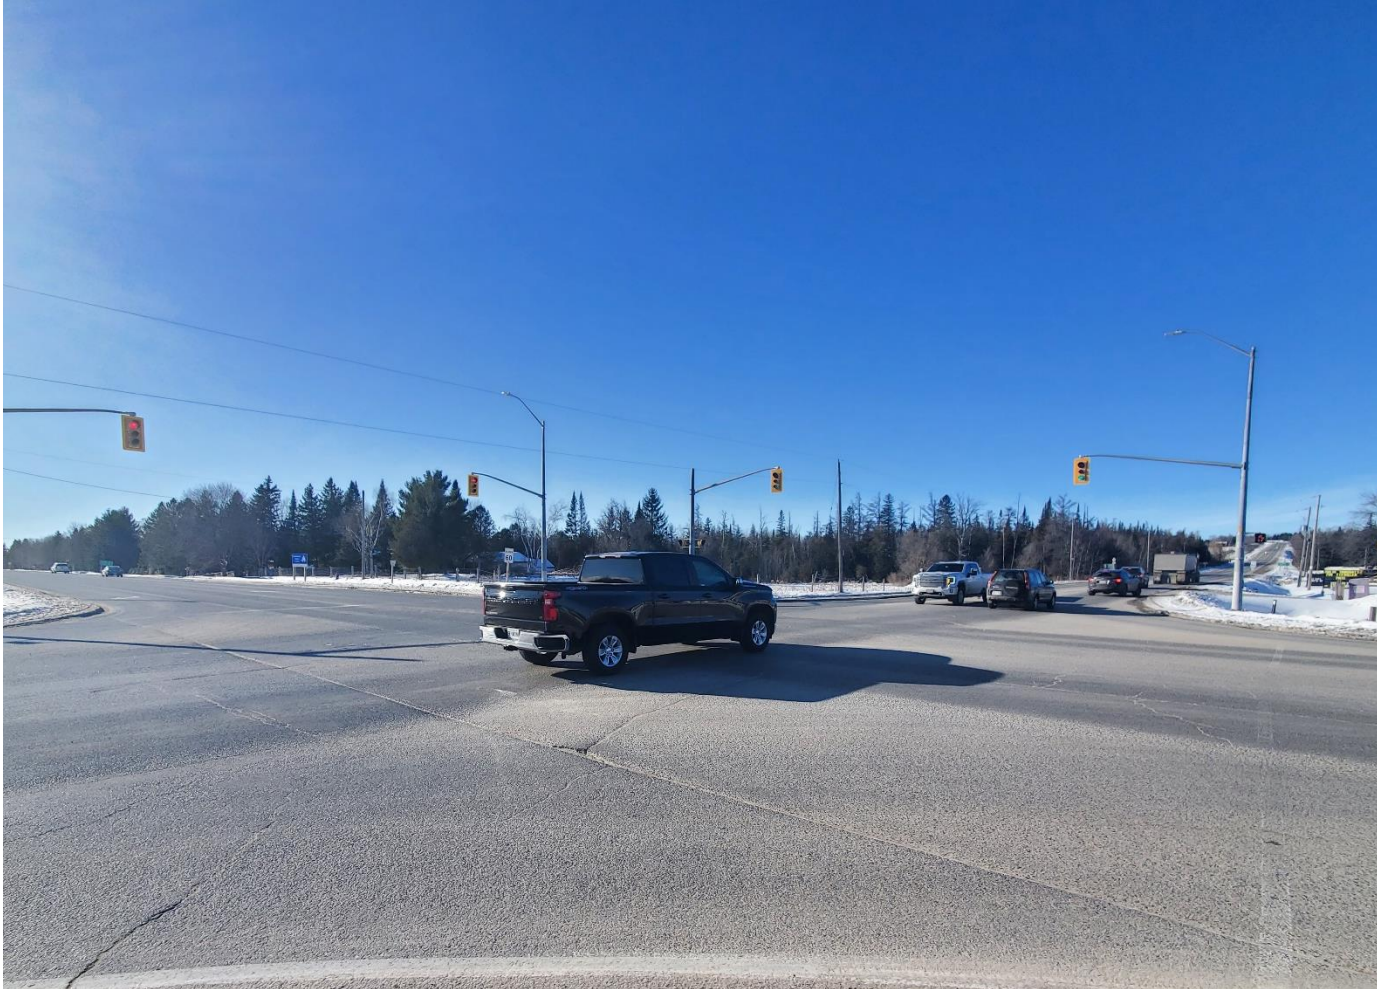
Wellington Road 24 at Wellington Road 124. Traffic signal optimization study to be completed.
