**Schedule 'C' Municipal Class Environmental
Assessment for Wellington Road 109 Bridges**
Environmental Study Report (ESR)

County of Wellington

WSP Canada Inc

April 2024

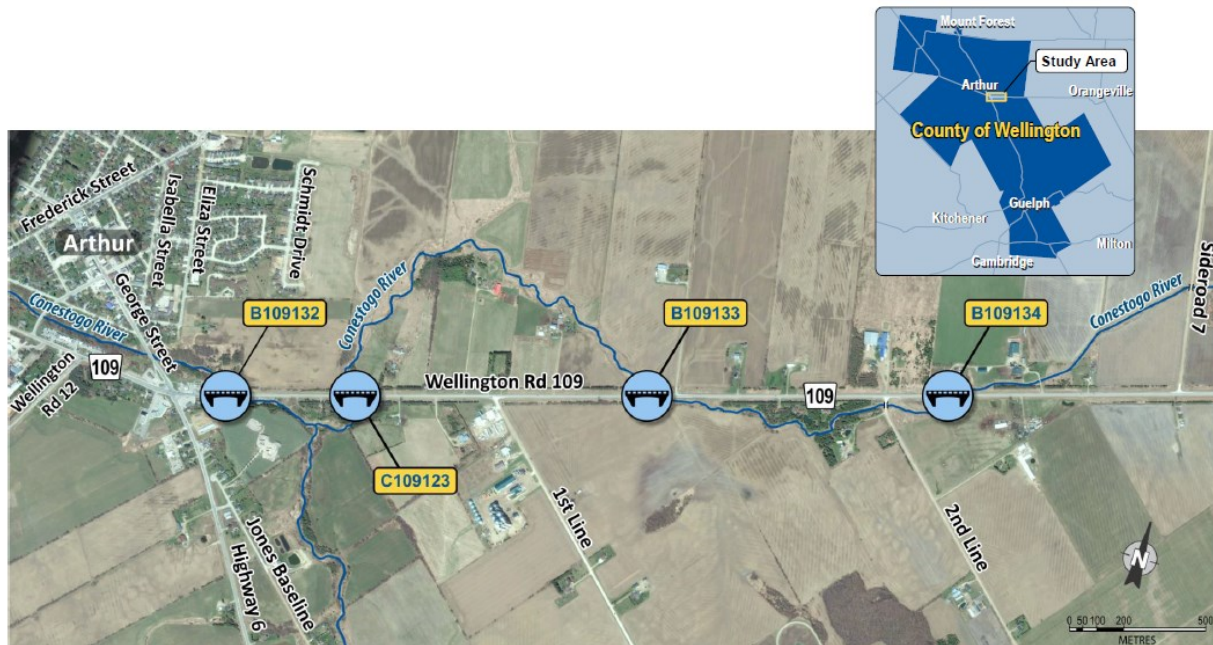
Figure 1-1: Wellington Road 109 Four Structures

The four crossing structures, identified by reference numbers (from west to east) B109132, C109123, B109133 and B109134 are all reaching the end of their design life. The bridges at all four crossings are in an advanced state of deterioration with some elements identified as not meeting current standards. The County has considered all options to address these conditions including do nothing, bridge rehabilitations, bridge replacements, and the feasibility of a localized permanent realignment of Wellington Road 109 that would eliminate or reduce the multiple bridge crossings. **Figure 1-1** depicts the four crossing structures.
