Erosion Mitigation Assessment West Credit River (Erin Branch)

Town of Erin, Wellington County

Report Title: Erosion Mitigation Assessment
Credit River Tributary
Town of Erin, Wellington County

Project Number: PN21060

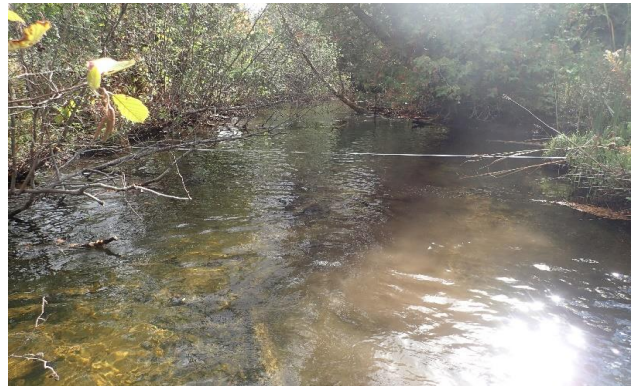
Representative Cross-Section #3

Photograph at cross section 3 (looking downstream)
