# WELLINGTON COUNTY

**Blatchford Bridge**  
**B032085**  
**2025 OSIM Inspection**  
Wellington Road 32  
0.80 km S of Wellington Road 124

Structure\_ID: B032085  
 MTO Site Number: 35-343  
 BCI: 61.67

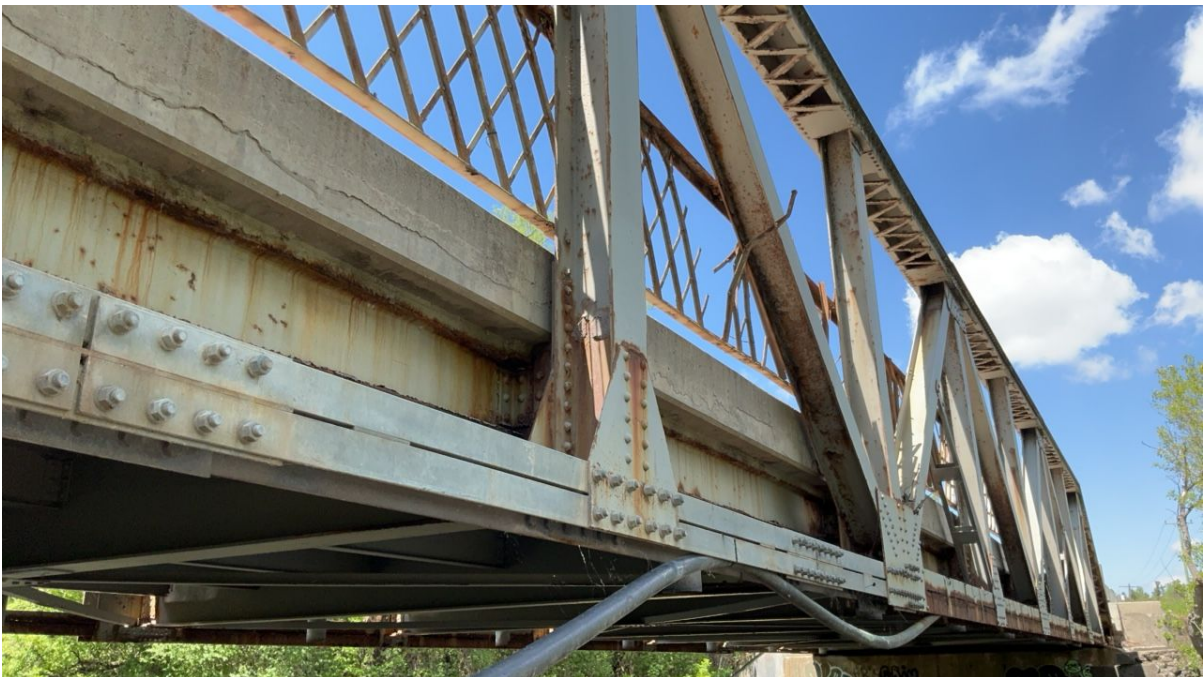
*East exterior soffit cold joint.*

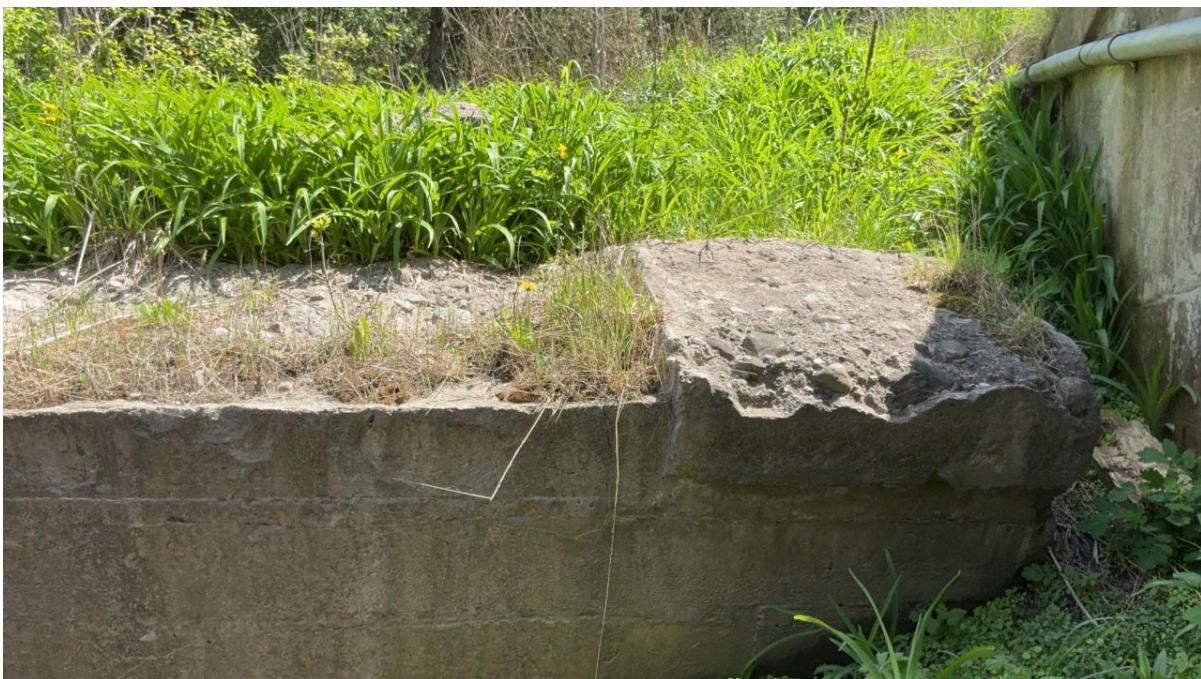
*SE embankment with previous bridge structure.*

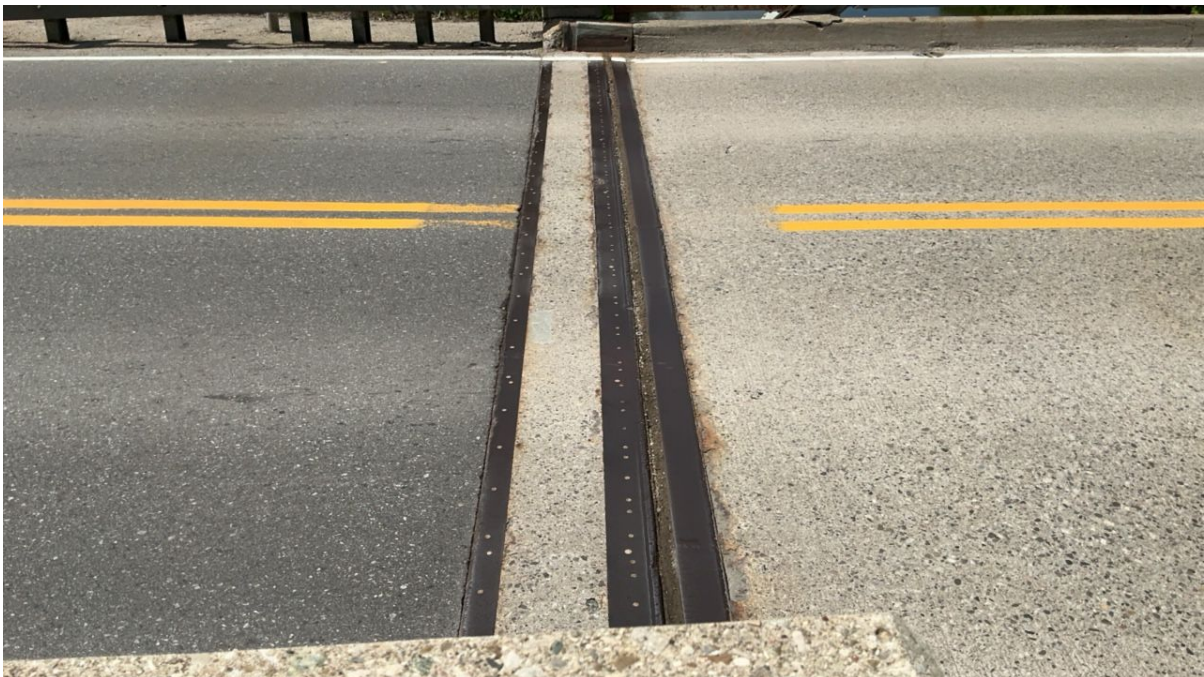
*South joint with chip marks from snow plows.*

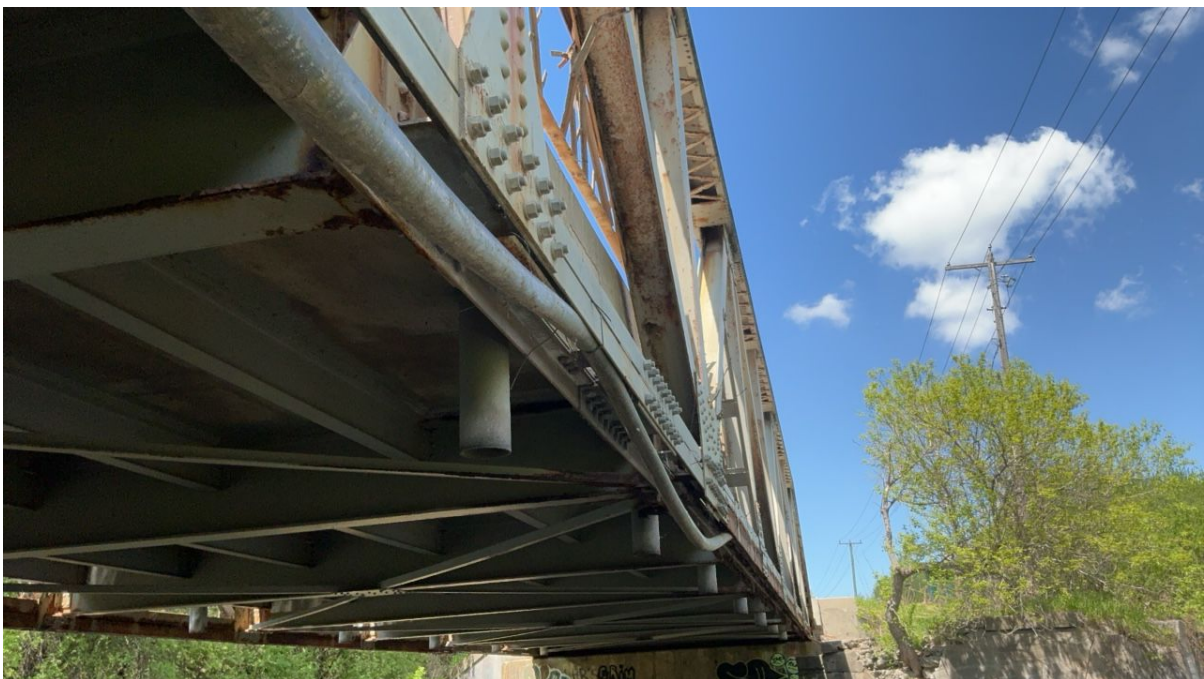
*Utilities along East chord.*

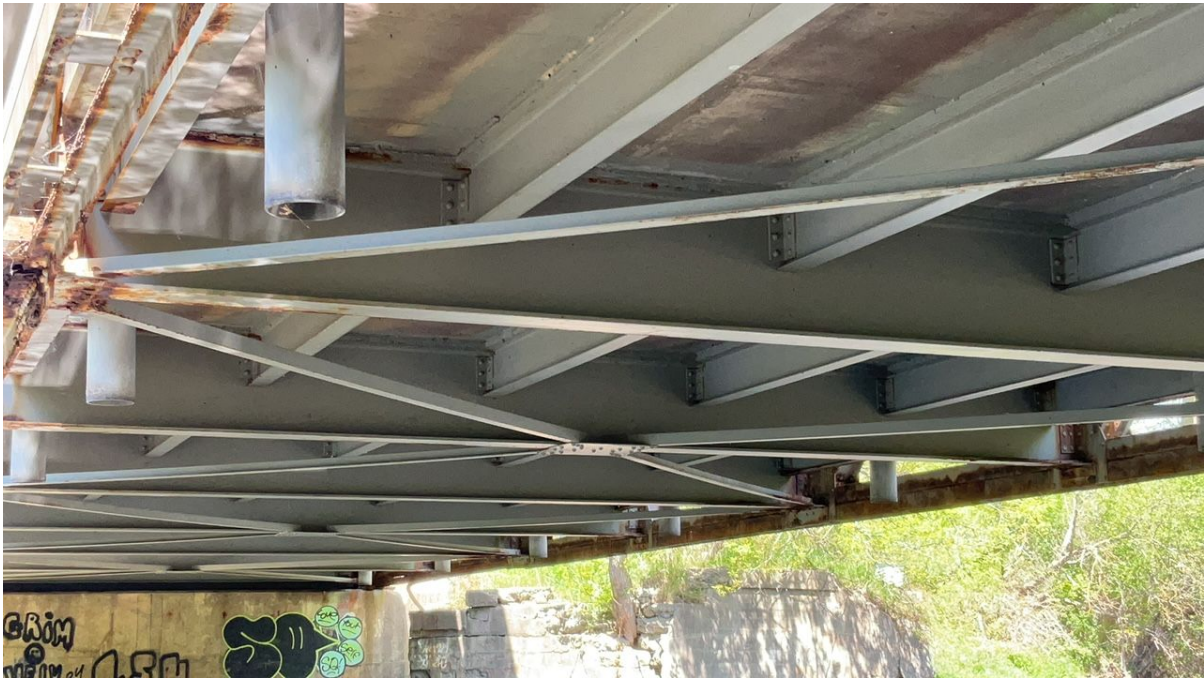
*South bracing.*

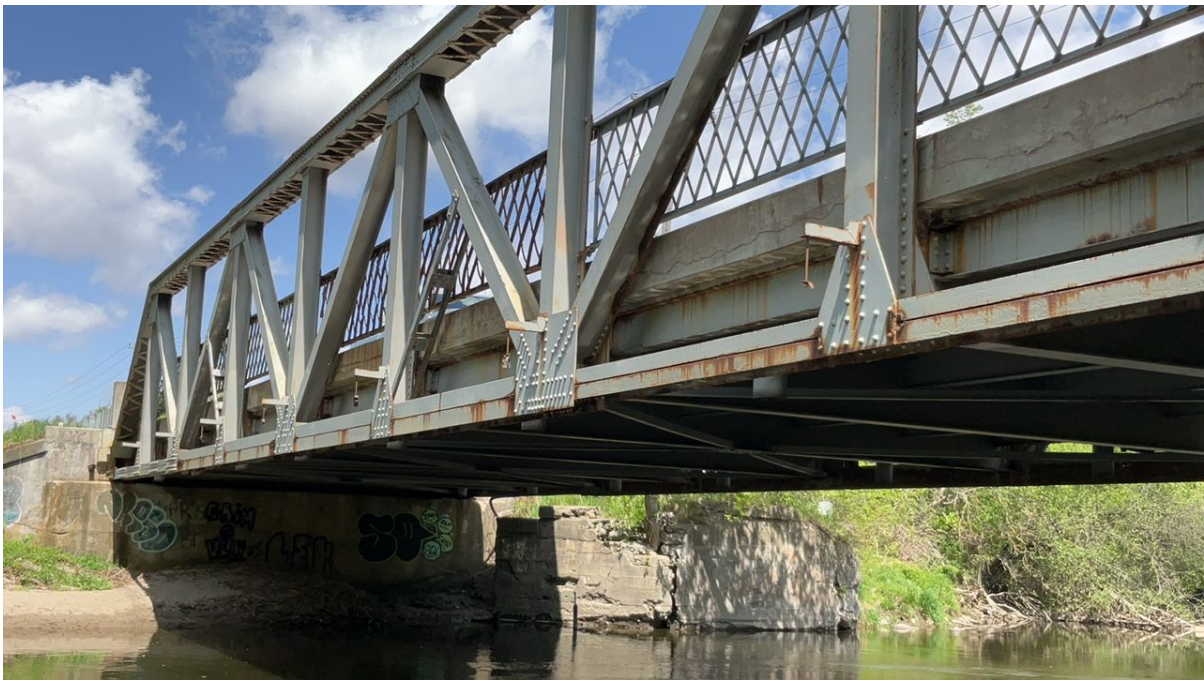
*North bracing.*

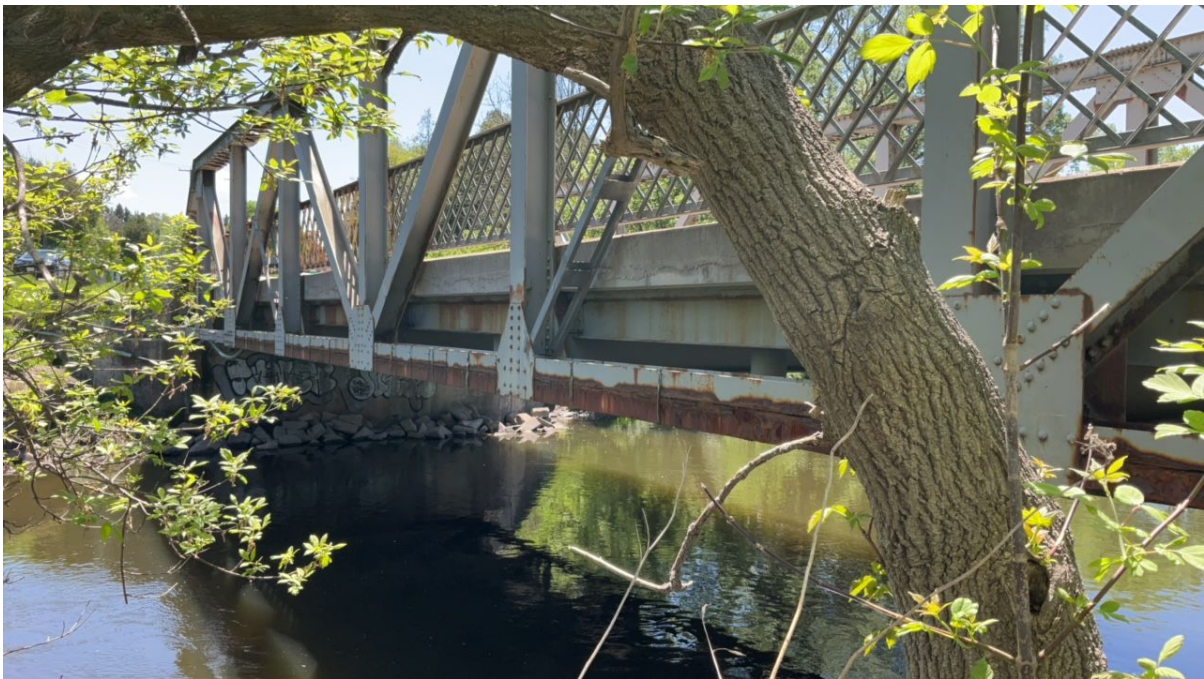
*West exterior soffit.*

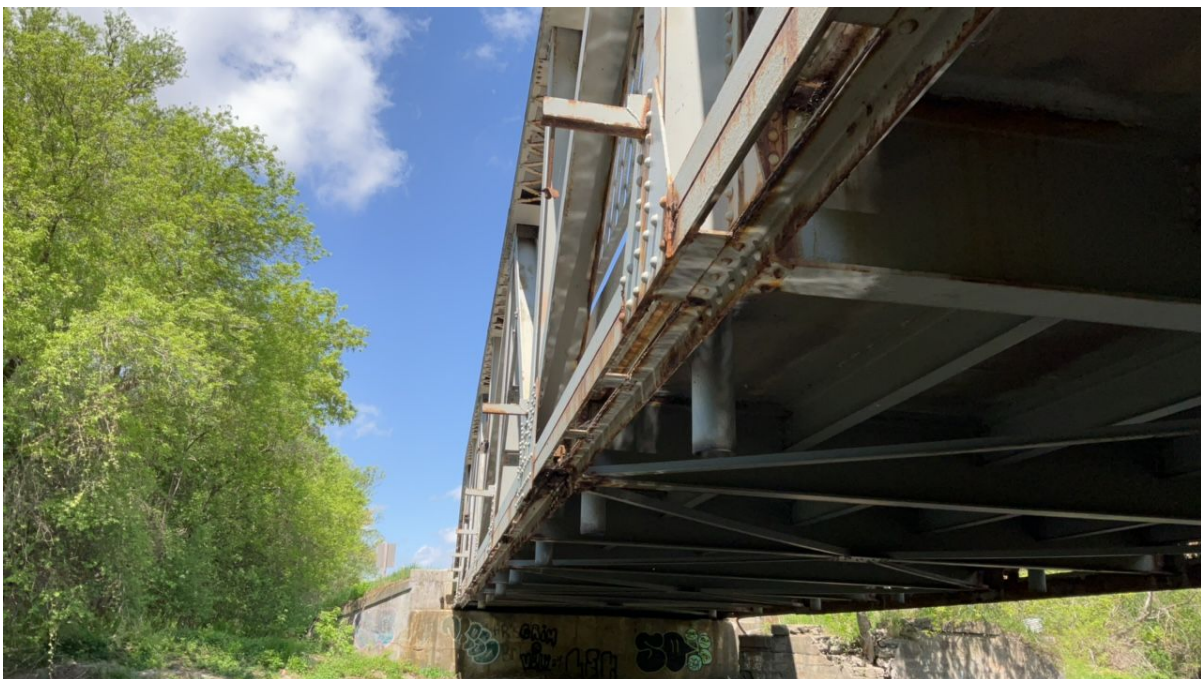
*West bottom chords.*

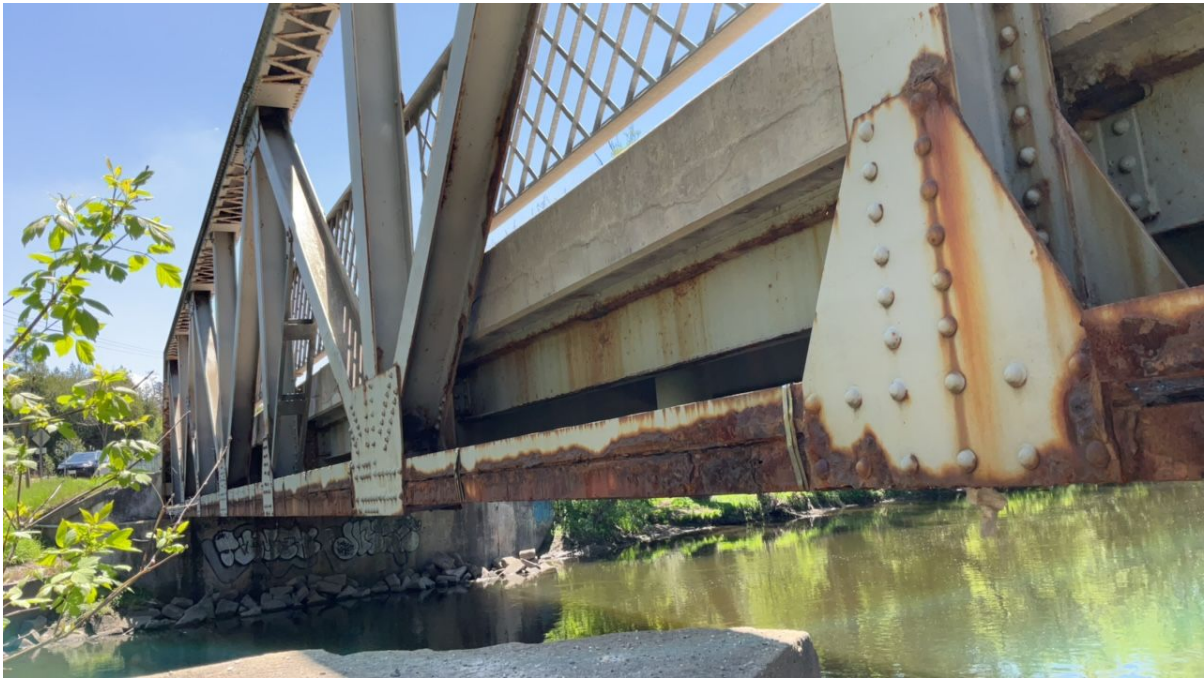
*West abandoned utilities.*
