Fluvial Geomorphology

SUBJECT: Wellington Road 109 Schedule C Municipal Class Environmental Assessment – Fluvial Geomorphology Assessment

DATE: June 28, 2023

Project No.: 17M-01271-02

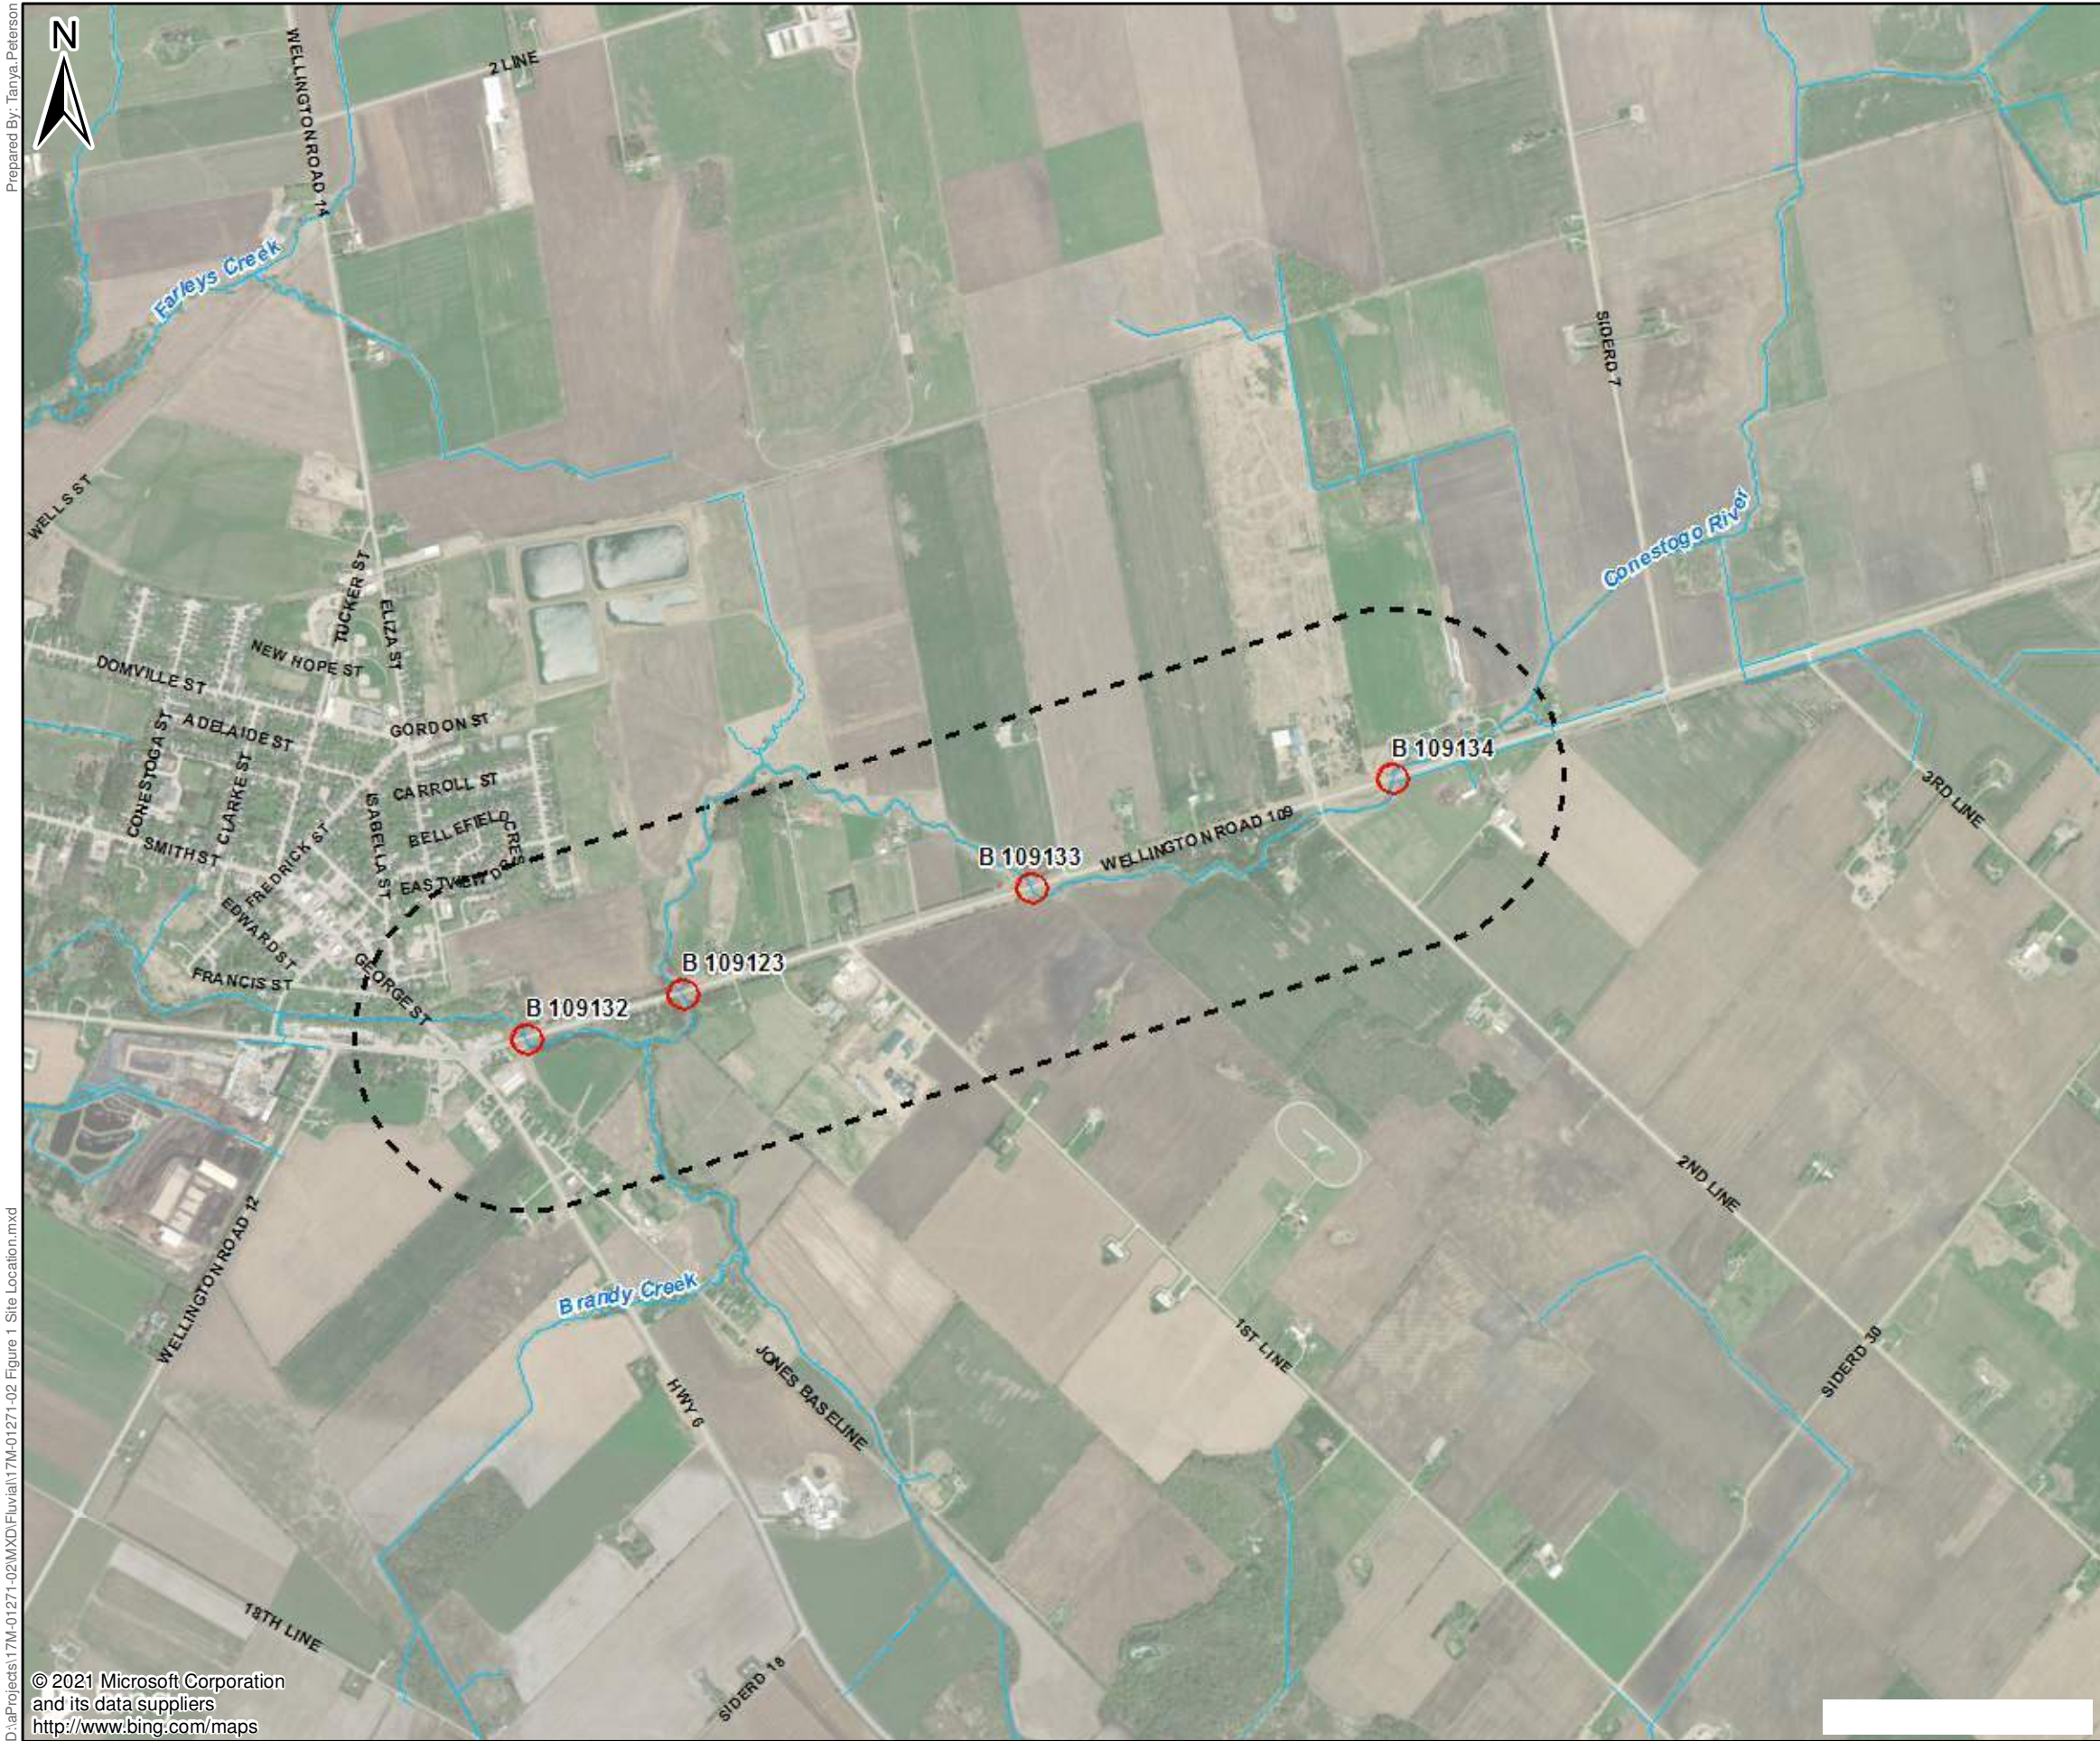
PROJECT NO.: 17M-01271-02	REVIEWED BY: PH
	DATE: NOVEMBER 2021	FIGURE: 1

As requested, this memo summarizes the fluvial geomorphology assessment for four Conestogo River crossings along Wellington Road 109, as a part of the Schedule C Municipal Class Environmental Assessment just outside of Arthur, Ontario. The crossing locations are shown on attached **Figure 1**.

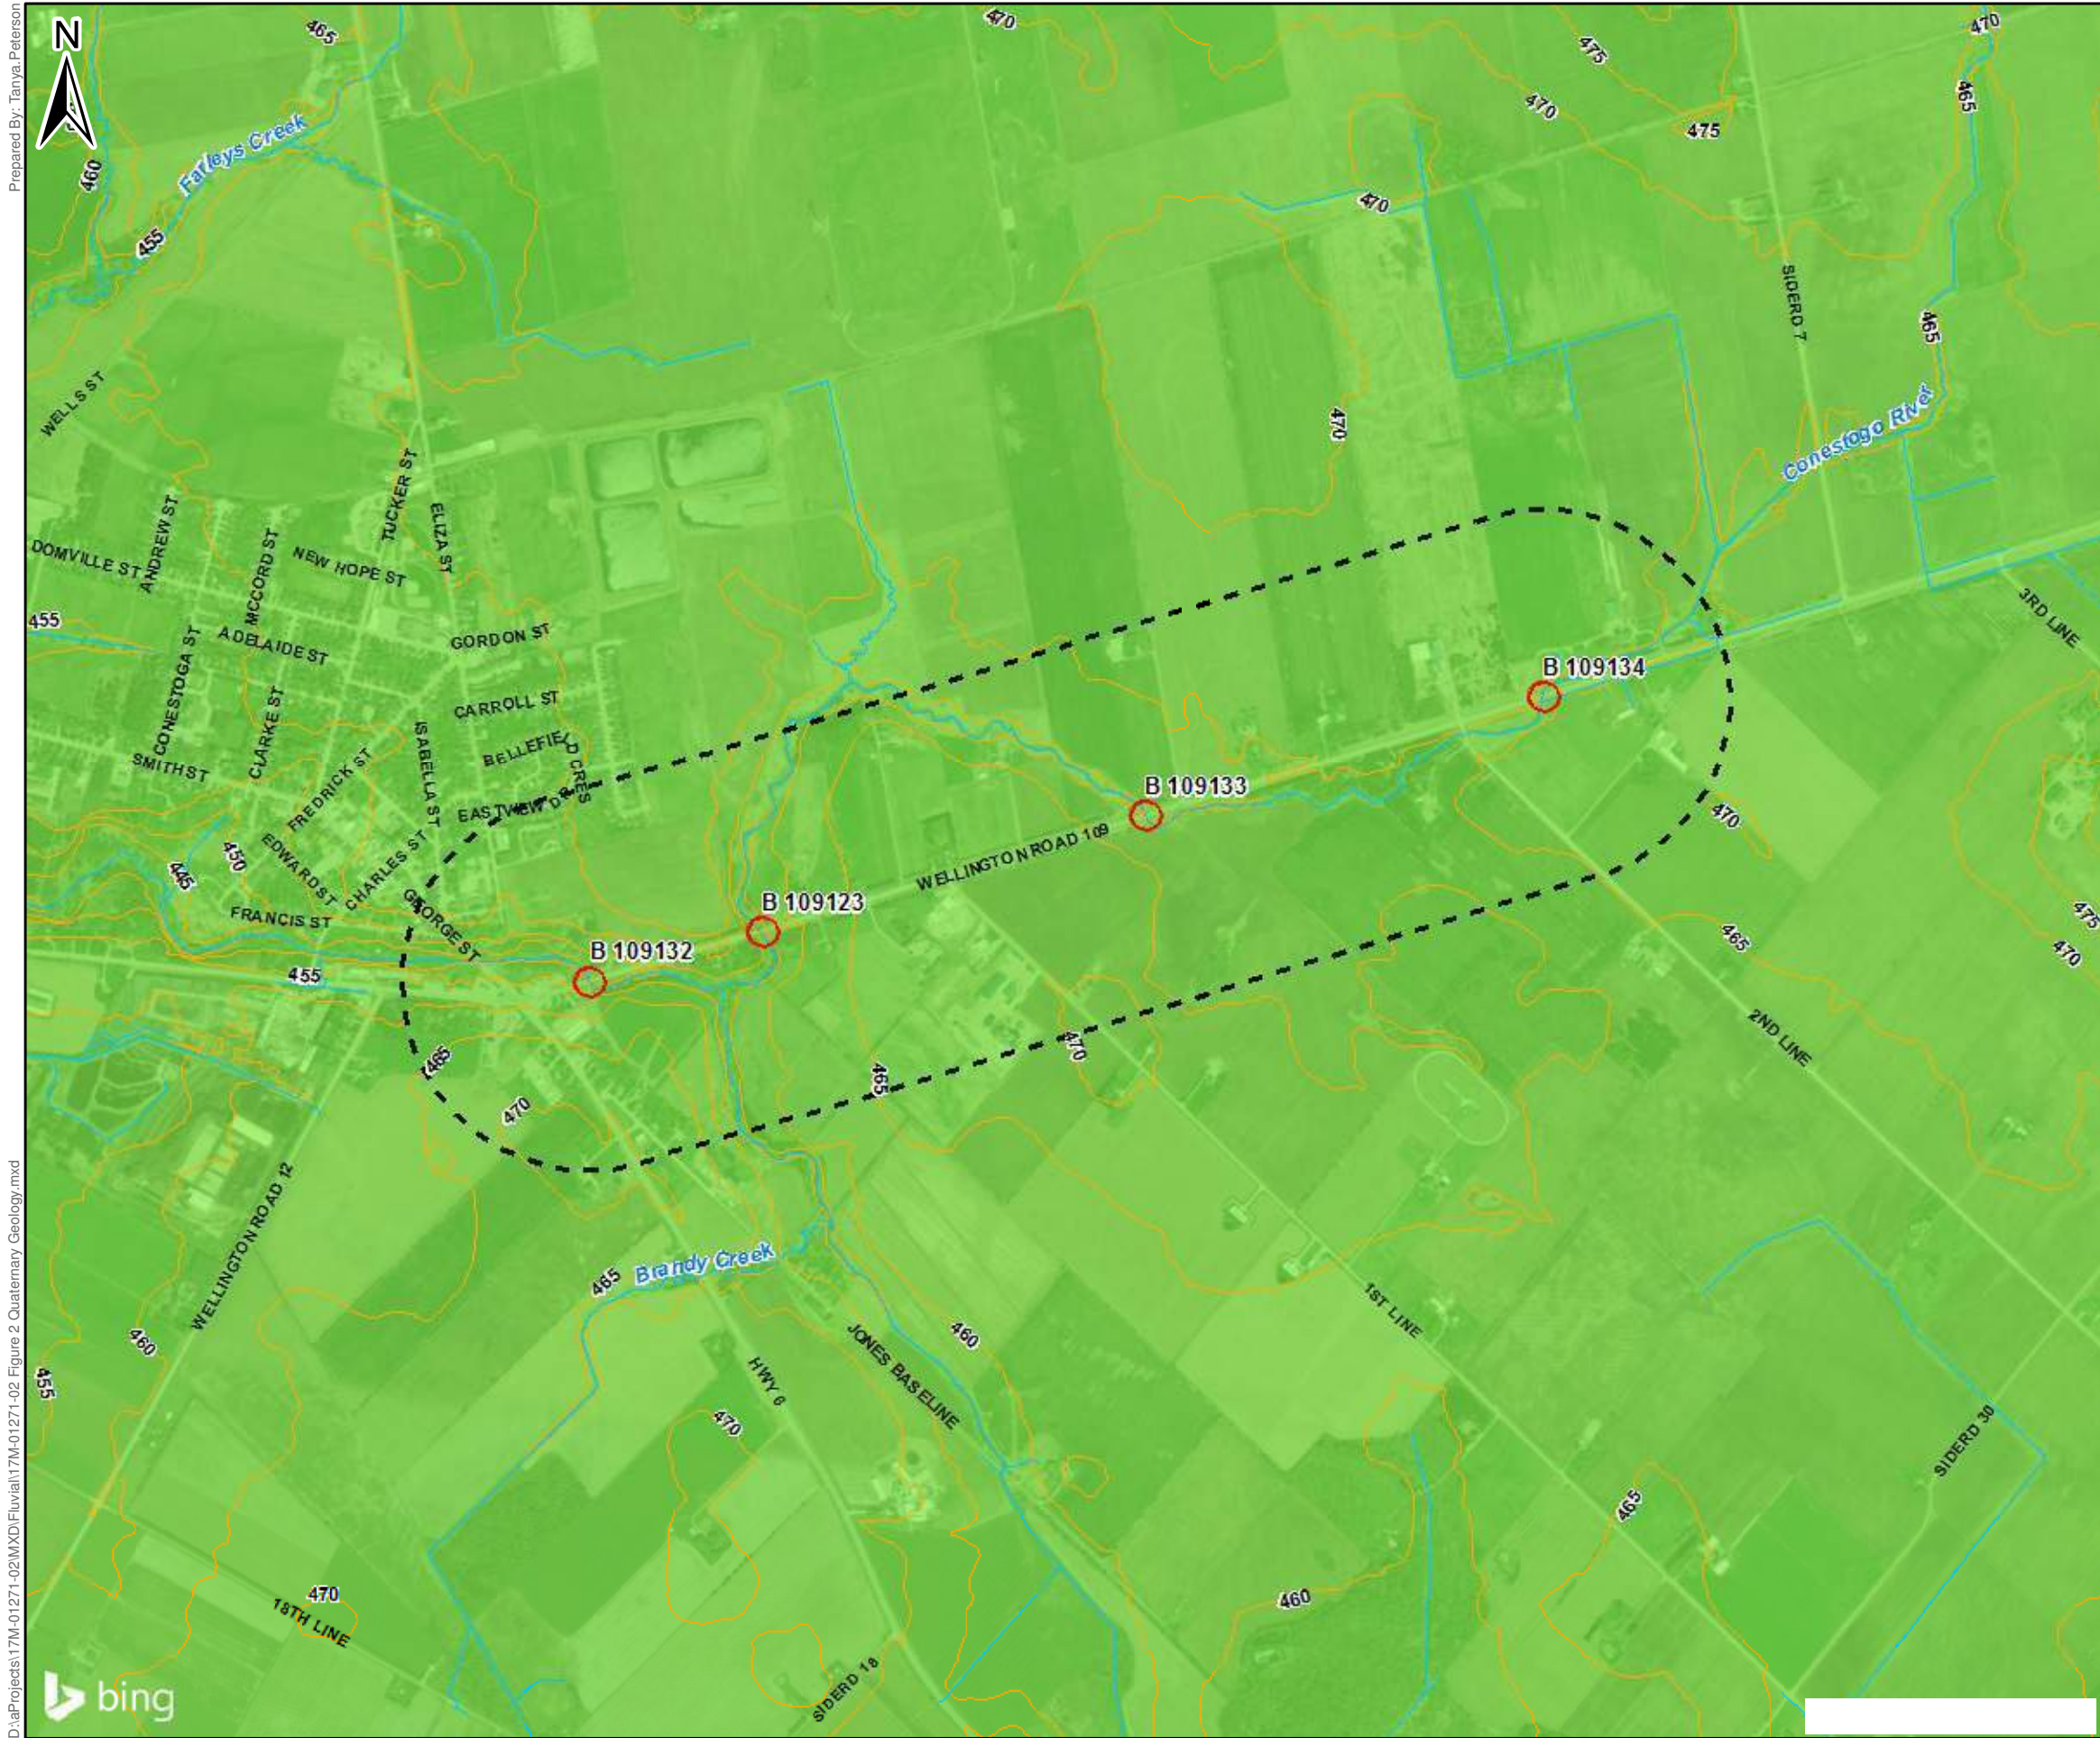
PROJECT NO.: 17M-01271-02	REVIEWED BY: PH
	DATE: NOVEMBER 2021	FIGURE: 2

Quaternary geology at the site consists of Tavistock Till, a sandy silt. Quaternary geology is shown on attached **Figure 2**.

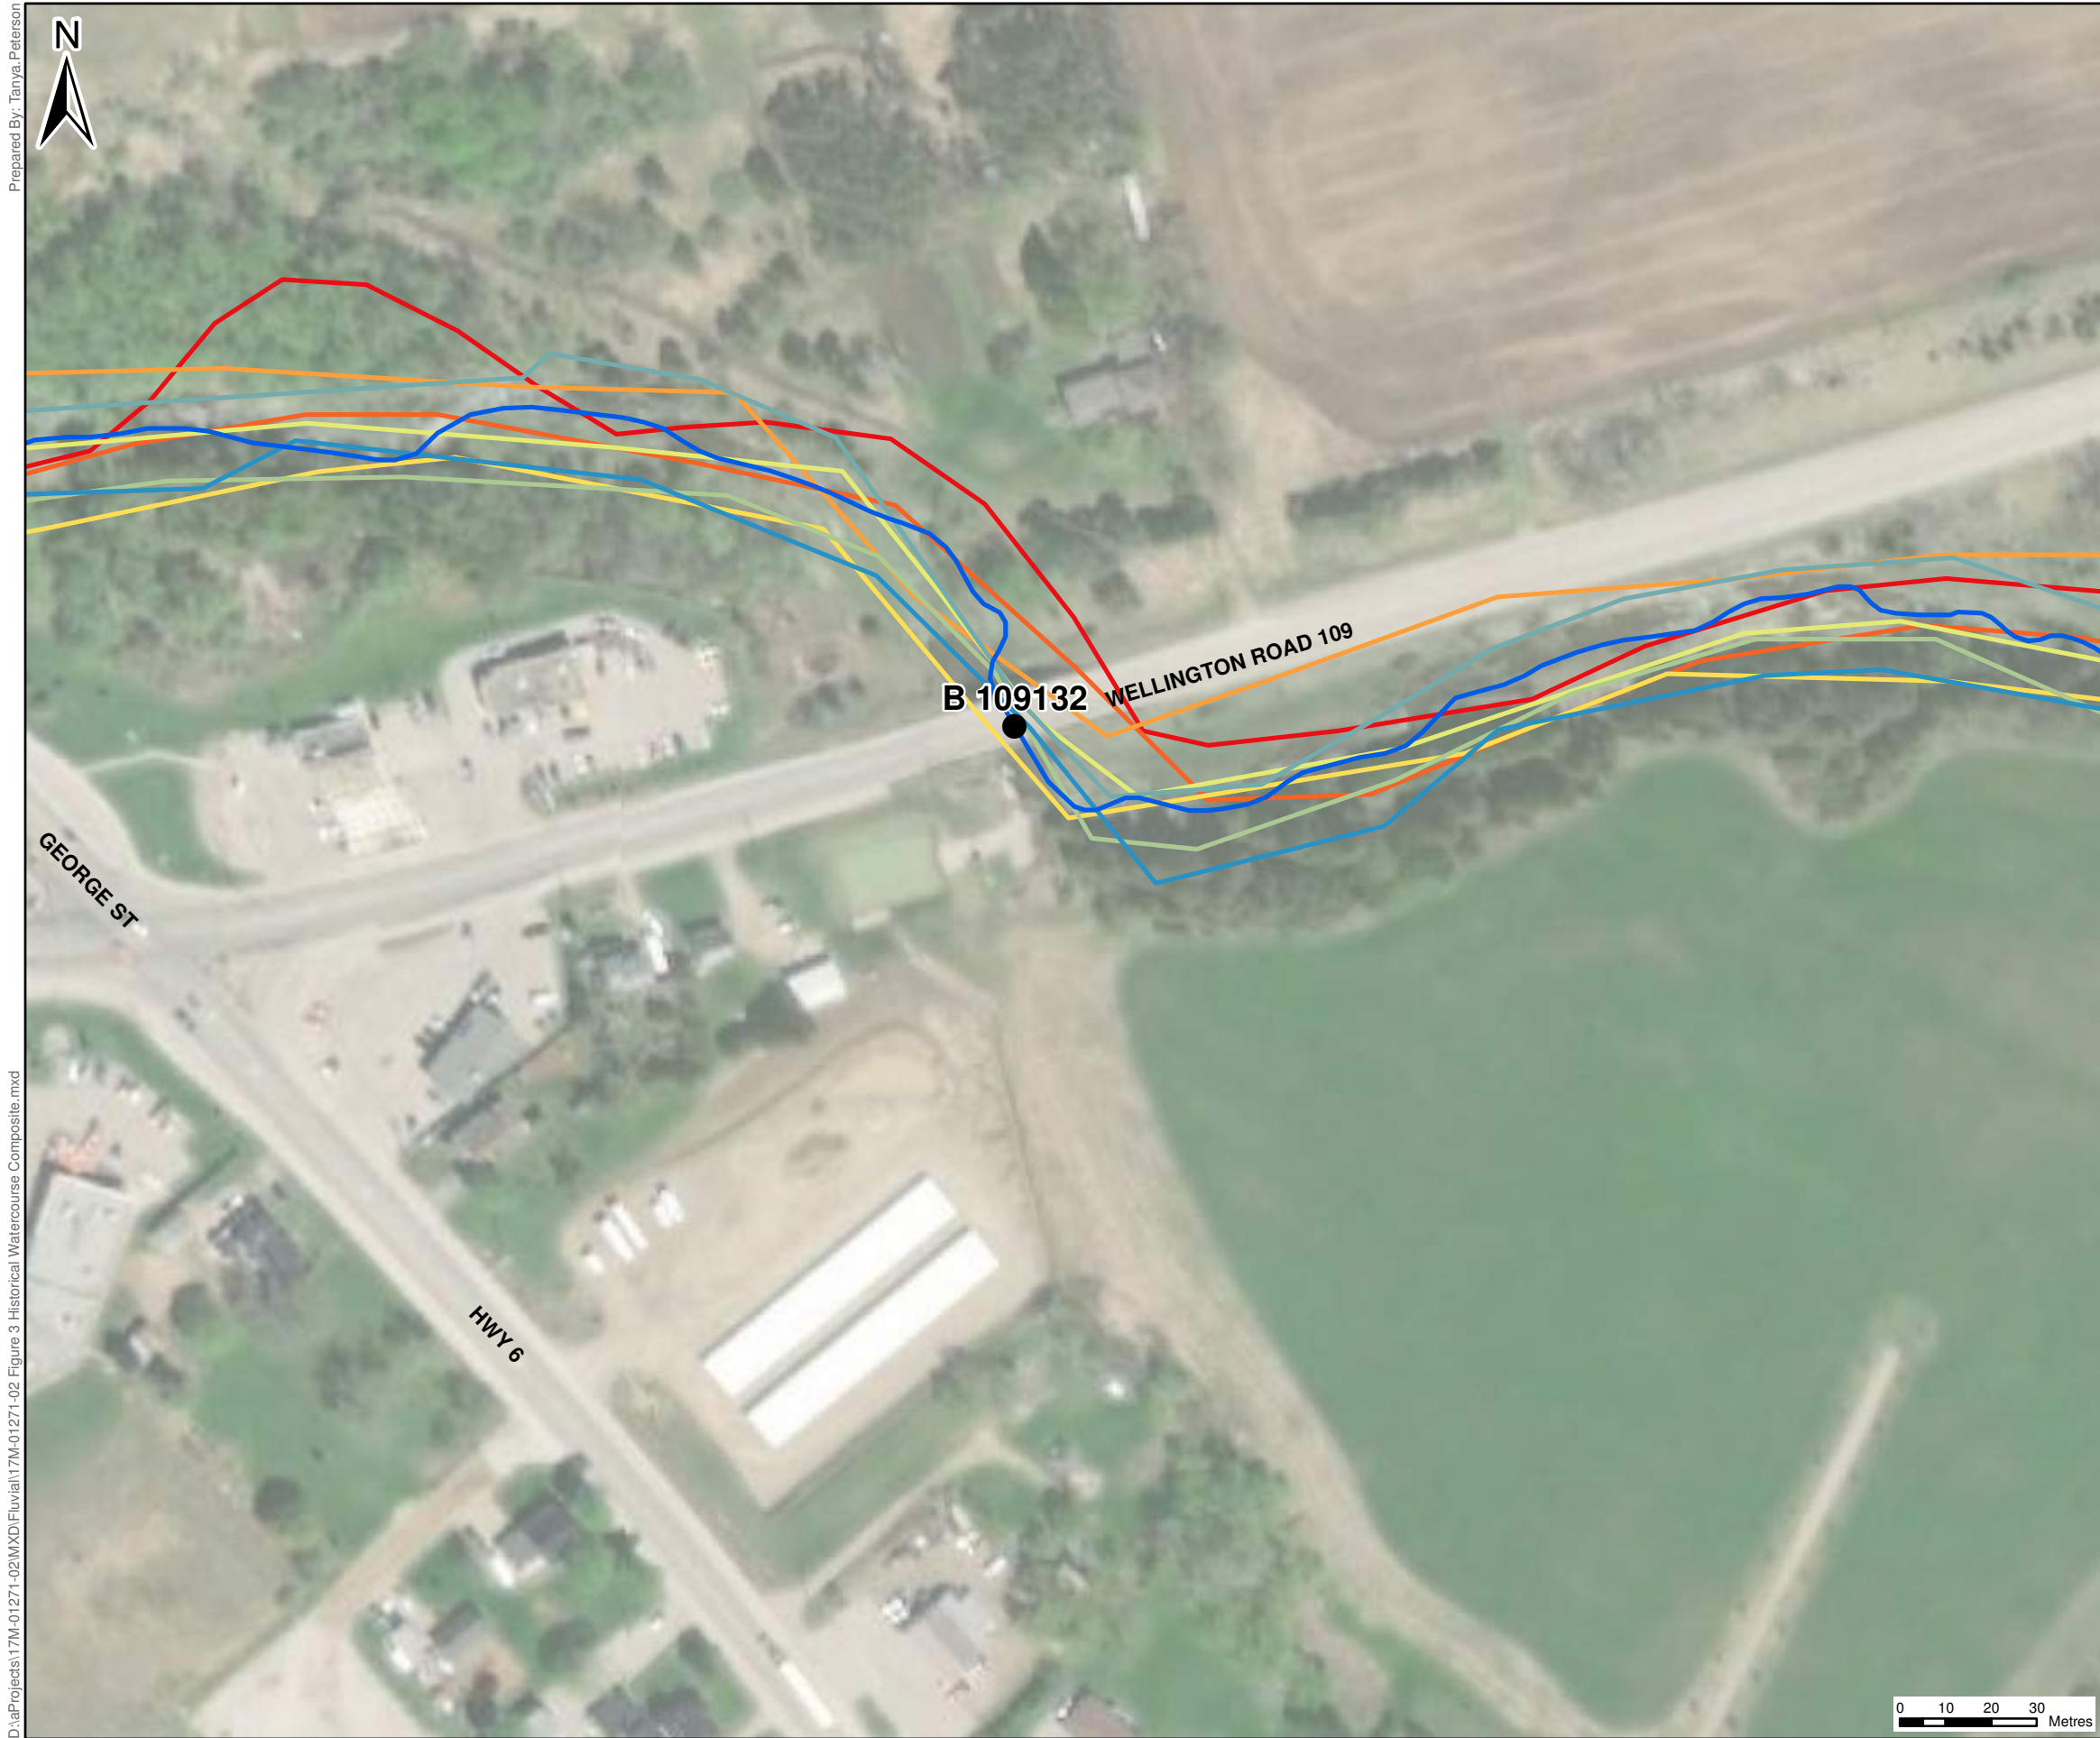
REVIEWED BY:
PH
FIGURE:
3

A). WSP approximated the channel for each available aerial and overlaid them onto one figure to highlight the historical stream channel variations of both watercourses (**Figures 3 and 4**), watercourse alignments have various colours for individual historical aerial watercourse alignments such that each can be easily identified on the composite figure.

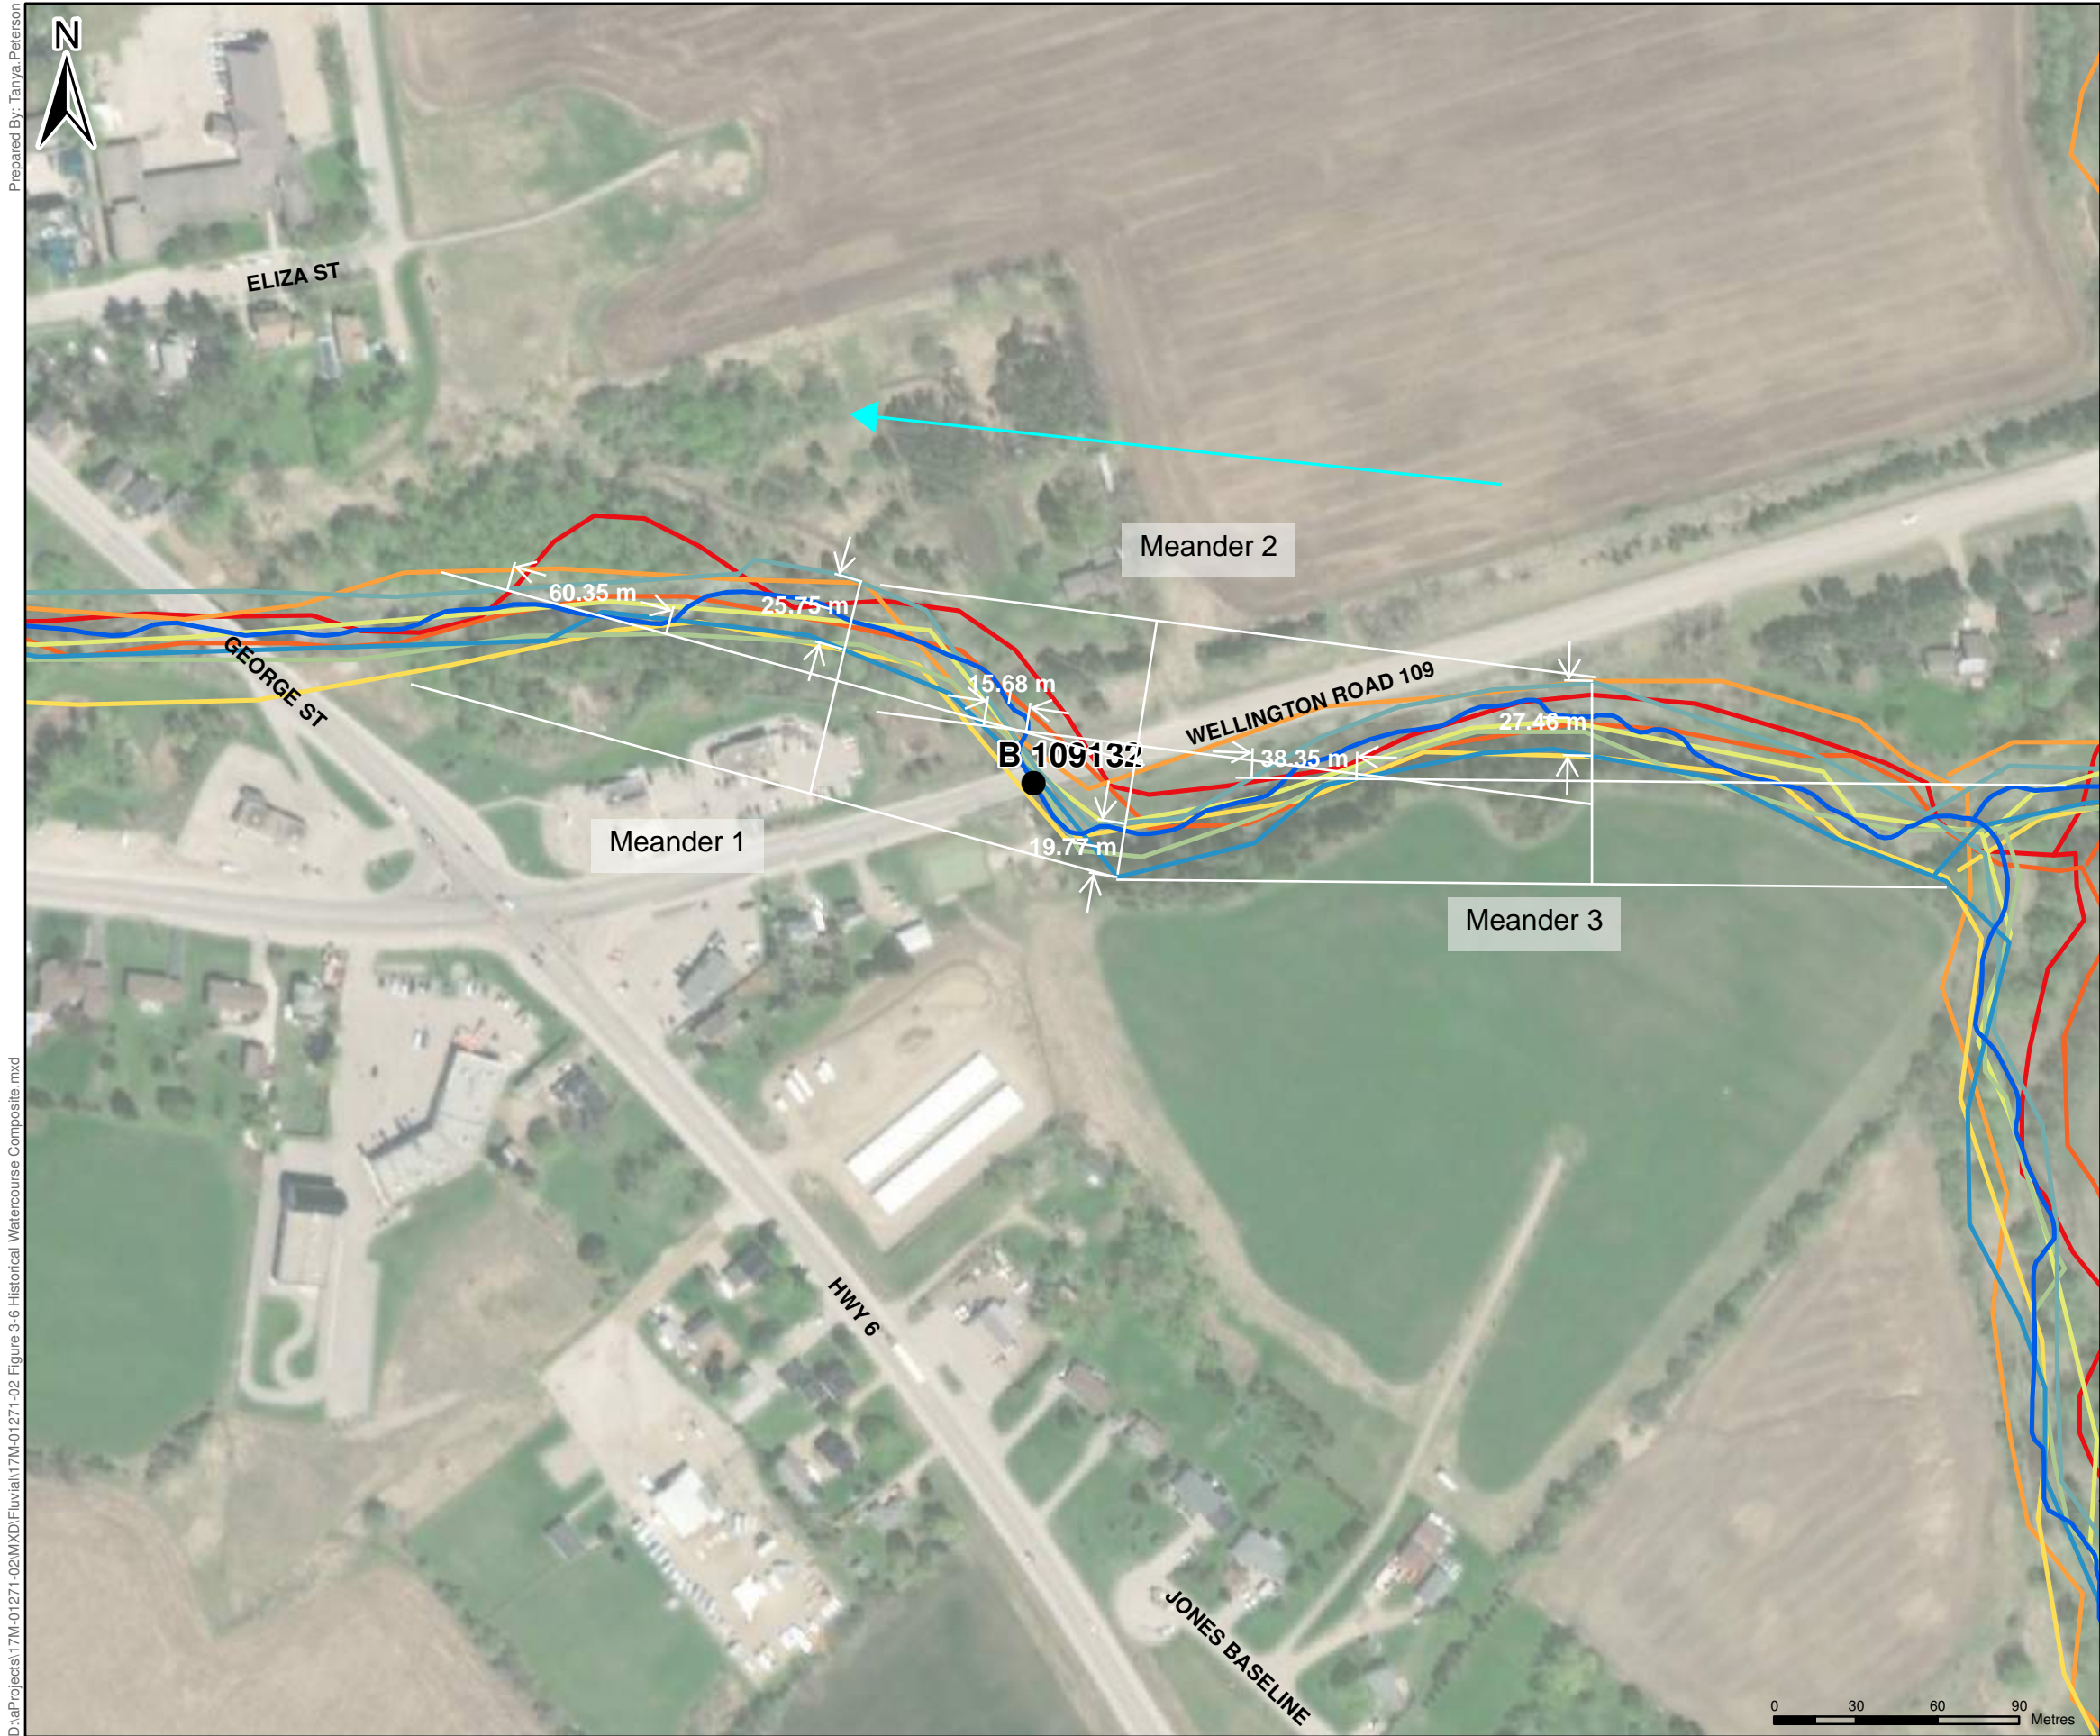
PROJECT NO.: 17M-01271-02	REVIEWED BY: PH
	DATE: NOVEMBER 2021	FIGURE: D-2

- a B109132: 49m;
 - b C109123: 44m;
 - c B109133: 39m; and
 - d B109134: 35m.
- 6 As per the general arrangements the gabion baskets will be removed and replaced at B109133 and B109134 during construction. Opportunity to restore the banks to more natural conditions (instead of replacement with gabion) will be reviewed at detail design. The erosion protection methods employed have been largely adequate to protect the abutments. It is recommended that bank protection measures be considered at B109132 and C109123 compared to the assessed meander belt and erosion rates. Also, some of the existing abutments (at all four crossings) to be removed with the works are located below the bankfull channel width and opportunity to restore the banks and bed to more natural conditions will be reviewed at detail design.

TITLE: Culvert B109132 - Lateral and Down-Valley Erosion Rates		
PROJECT: FLUVIAL ASSESSMENT WELLINGTON ROAD 109 BETWEEN HIGHWAY 6 AND SIDEROAD 7 ARTHUR, ONTARIO		
CLIENT: WELLINGTON COUNTY
