**HYDROGEOLOGICAL INVESTIGATION
PROPOSED BRIARWOOD HILLSBURGH DEVELOPMENT
5916 Trafalgar Road North, Town of Erin, Ontario**

Project No. 2100428AH

August 3, 2022

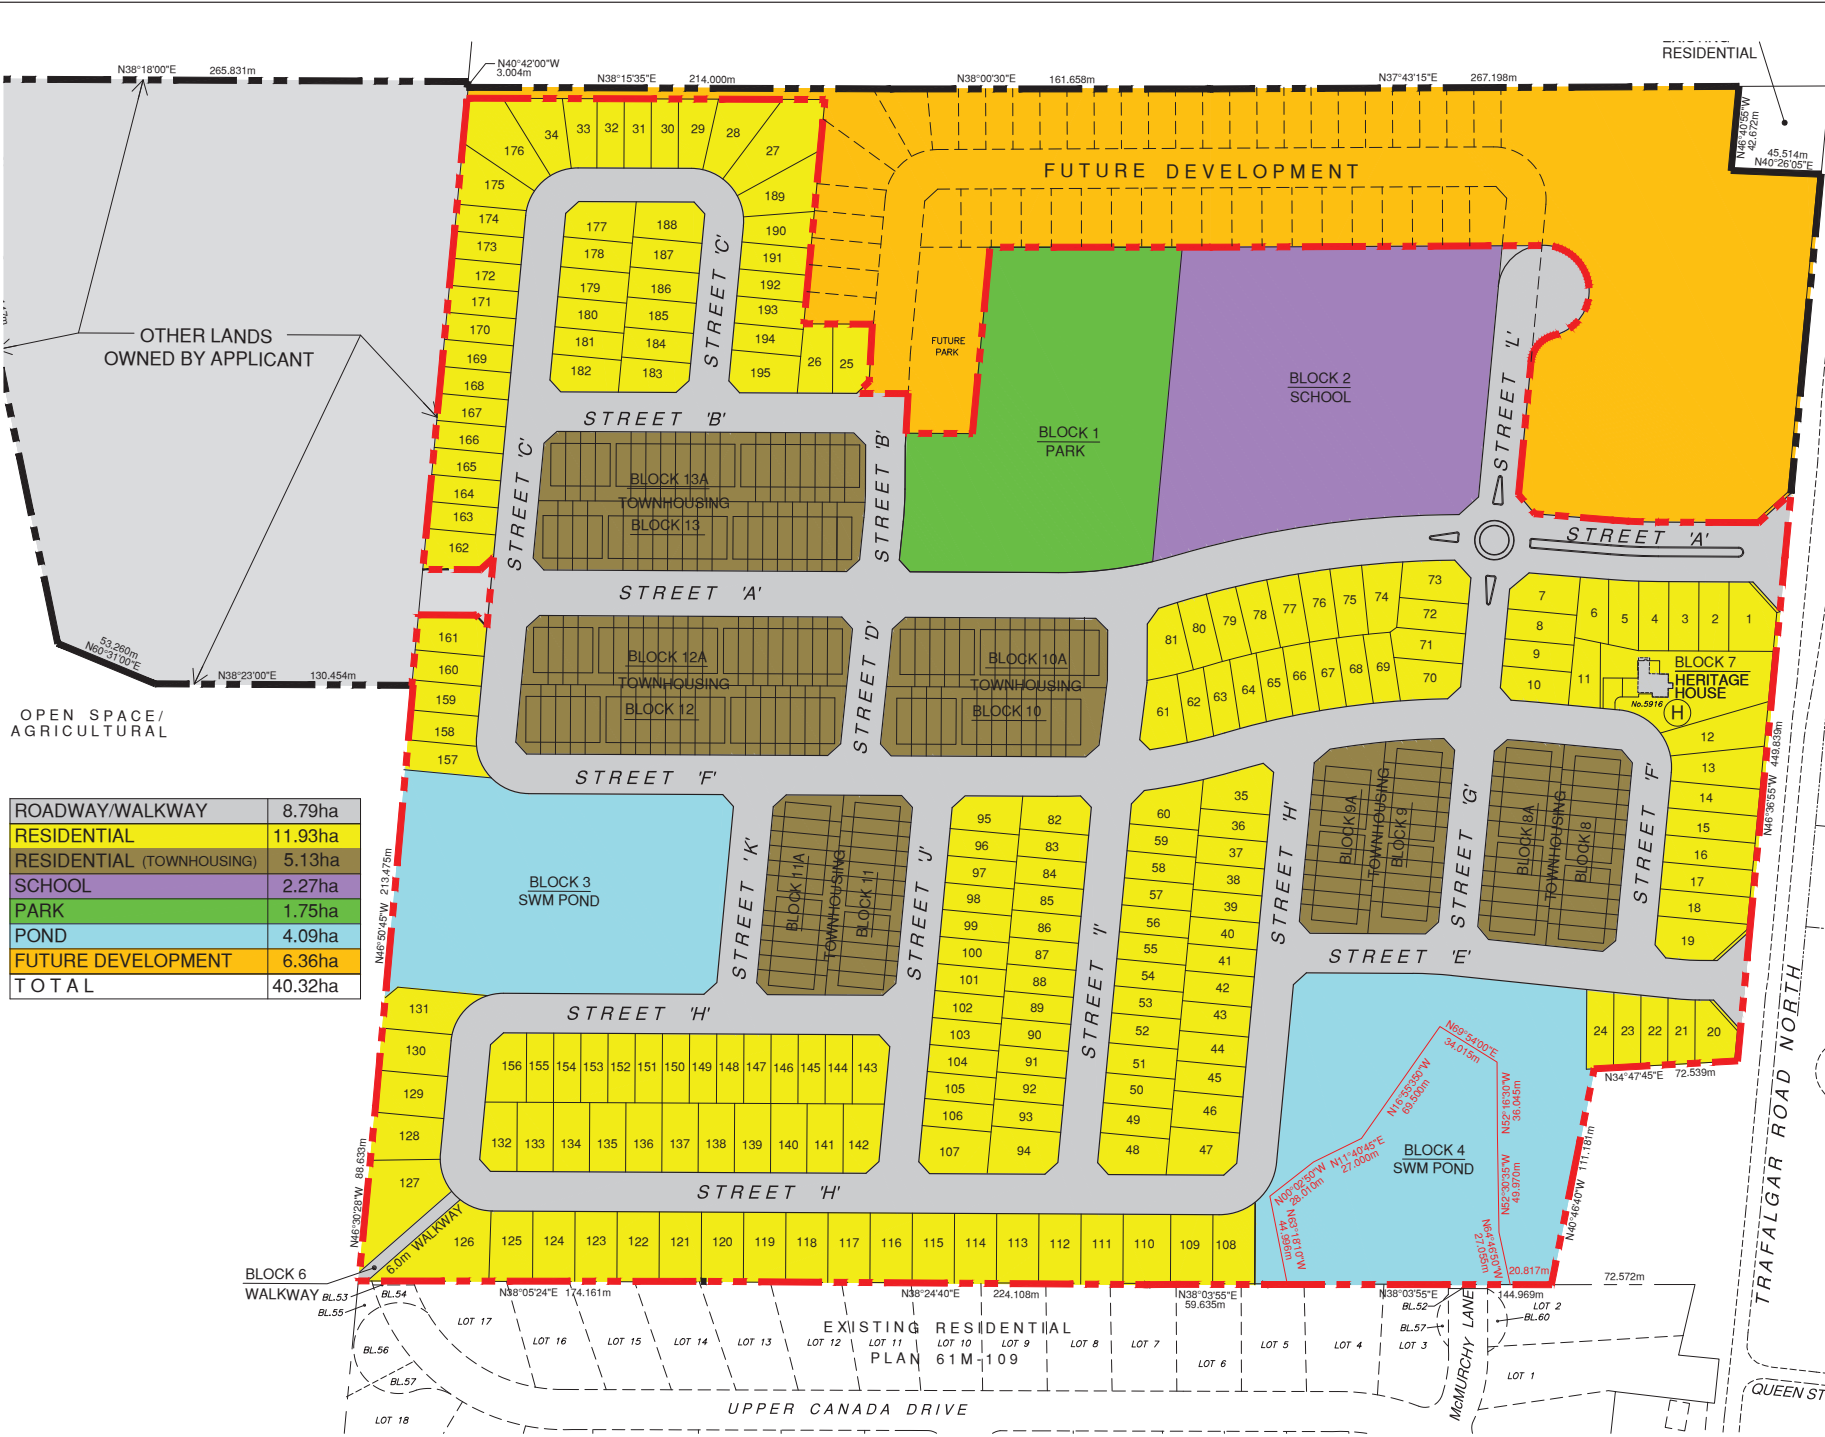
ROADWAY/WALKWAY	8.79ha
RESIDENTIAL	11.93ha
RESIDENTIAL (TOWNHOUSING)	5.13ha
SCHOOL	2.27ha
PARK	1.75ha
POND	4.09ha
FUTURE DEVELOPMENT	6.36ha
TOTAL	40.32ha
