# **APPENDIX K**

# **Intersection Assessment**

Subject: Wellington County Road Master Action Plan - Intersection Assessment

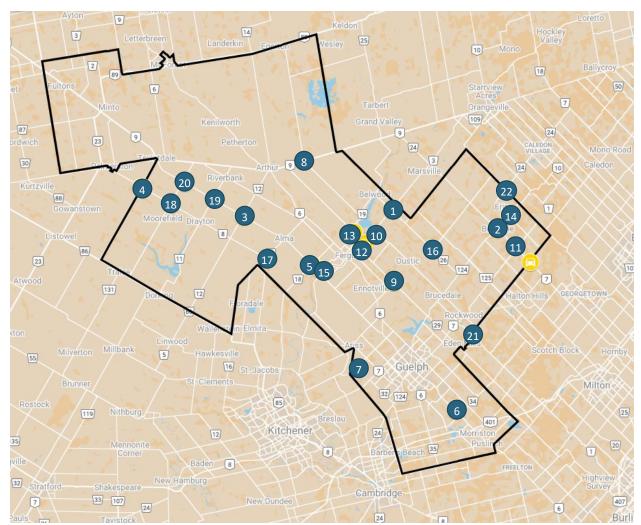
Figure 1: Locations of assessed intersections.

As a component of the Wellington County Road Master Action Plan (RMAP), Dillon Consulting Limited (Dillon) was retained by the County to review a total of 22 intersections to determine potential solutions to identified safety and operational issues. The intersection locations were selected based on input from County staff, councillors and through public consultation from the initial RMAP engagement exercise. The locations of these intersections are identified in Figure 1.

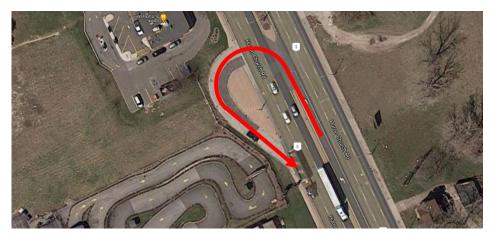
Figure 1: Turnaround example from Heron-Church Road in Windsor, ON

- Install a traffic signal at Bridle Path and limit Fox Run to right-in/right-out with traffic turning left off Fox Run redirected to Hamersley Road (estimated value of \$240,000<sup>3</sup>); or
- Construct turnarounds sufficiently far beyond either intersection to allow drivers to safely cross lanes and turn to face their preferred travel direction. This concept would allow drivers to enter WR46 by turning right off of Fox Run and then turn around within a protected laneway (see concept below, estimated value of \$200,000 plus property per turnaround). Traffic volume, speed and sight distance studies would need to be reviewed to determine if making a left off of WR46 into the turnaround would be desirable from a safety perspective.

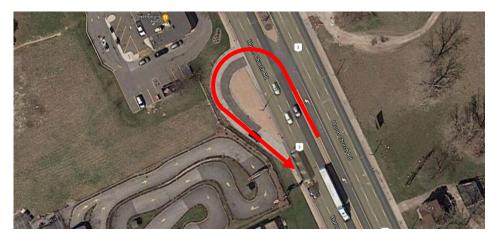
Figure 1: Turnaround example from Heron-Church Road in Windsor, ON

- Install coordinated signals at the intersections (estimated value of \$420,000<sup>2</sup>);
- Install a traffic signal at Bridle Path and limit Fox Run to right-in/right-out with traffic turning left off Fox Run redirected to Hamersley Road (estimated value of \$240,000³); or
- Construct turnarounds sufficiently far beyond either intersection to allow drivers to safely cross
  lanes and turn to face their preferred travel direction. This concept would allow drivers to enter
  WR46 by turning right off of Bridle Path and then turn around within a protected laneway (see
  concept below, estimated value of \$200,000 plus property per turnaround). Traffic volume,
  speed and sight distance studies would need to be reviewed to determine if making a left off of
  WR46 into the turnaround would be desirable from a safety perspective.
