**Hydrogeological Investigation  
Proposed Residential Development  
Southwest Quadrant of Eliza Street  
and Wells Street East  
Arthur, Ontario**

GEMTEC Project: 101764.038

**Re: Hydrogeological Investigation Report  
Proposed Residential Development, Southwest Quadrant of Eliza Street and  
Wells Street East, Arthur, Ontario**

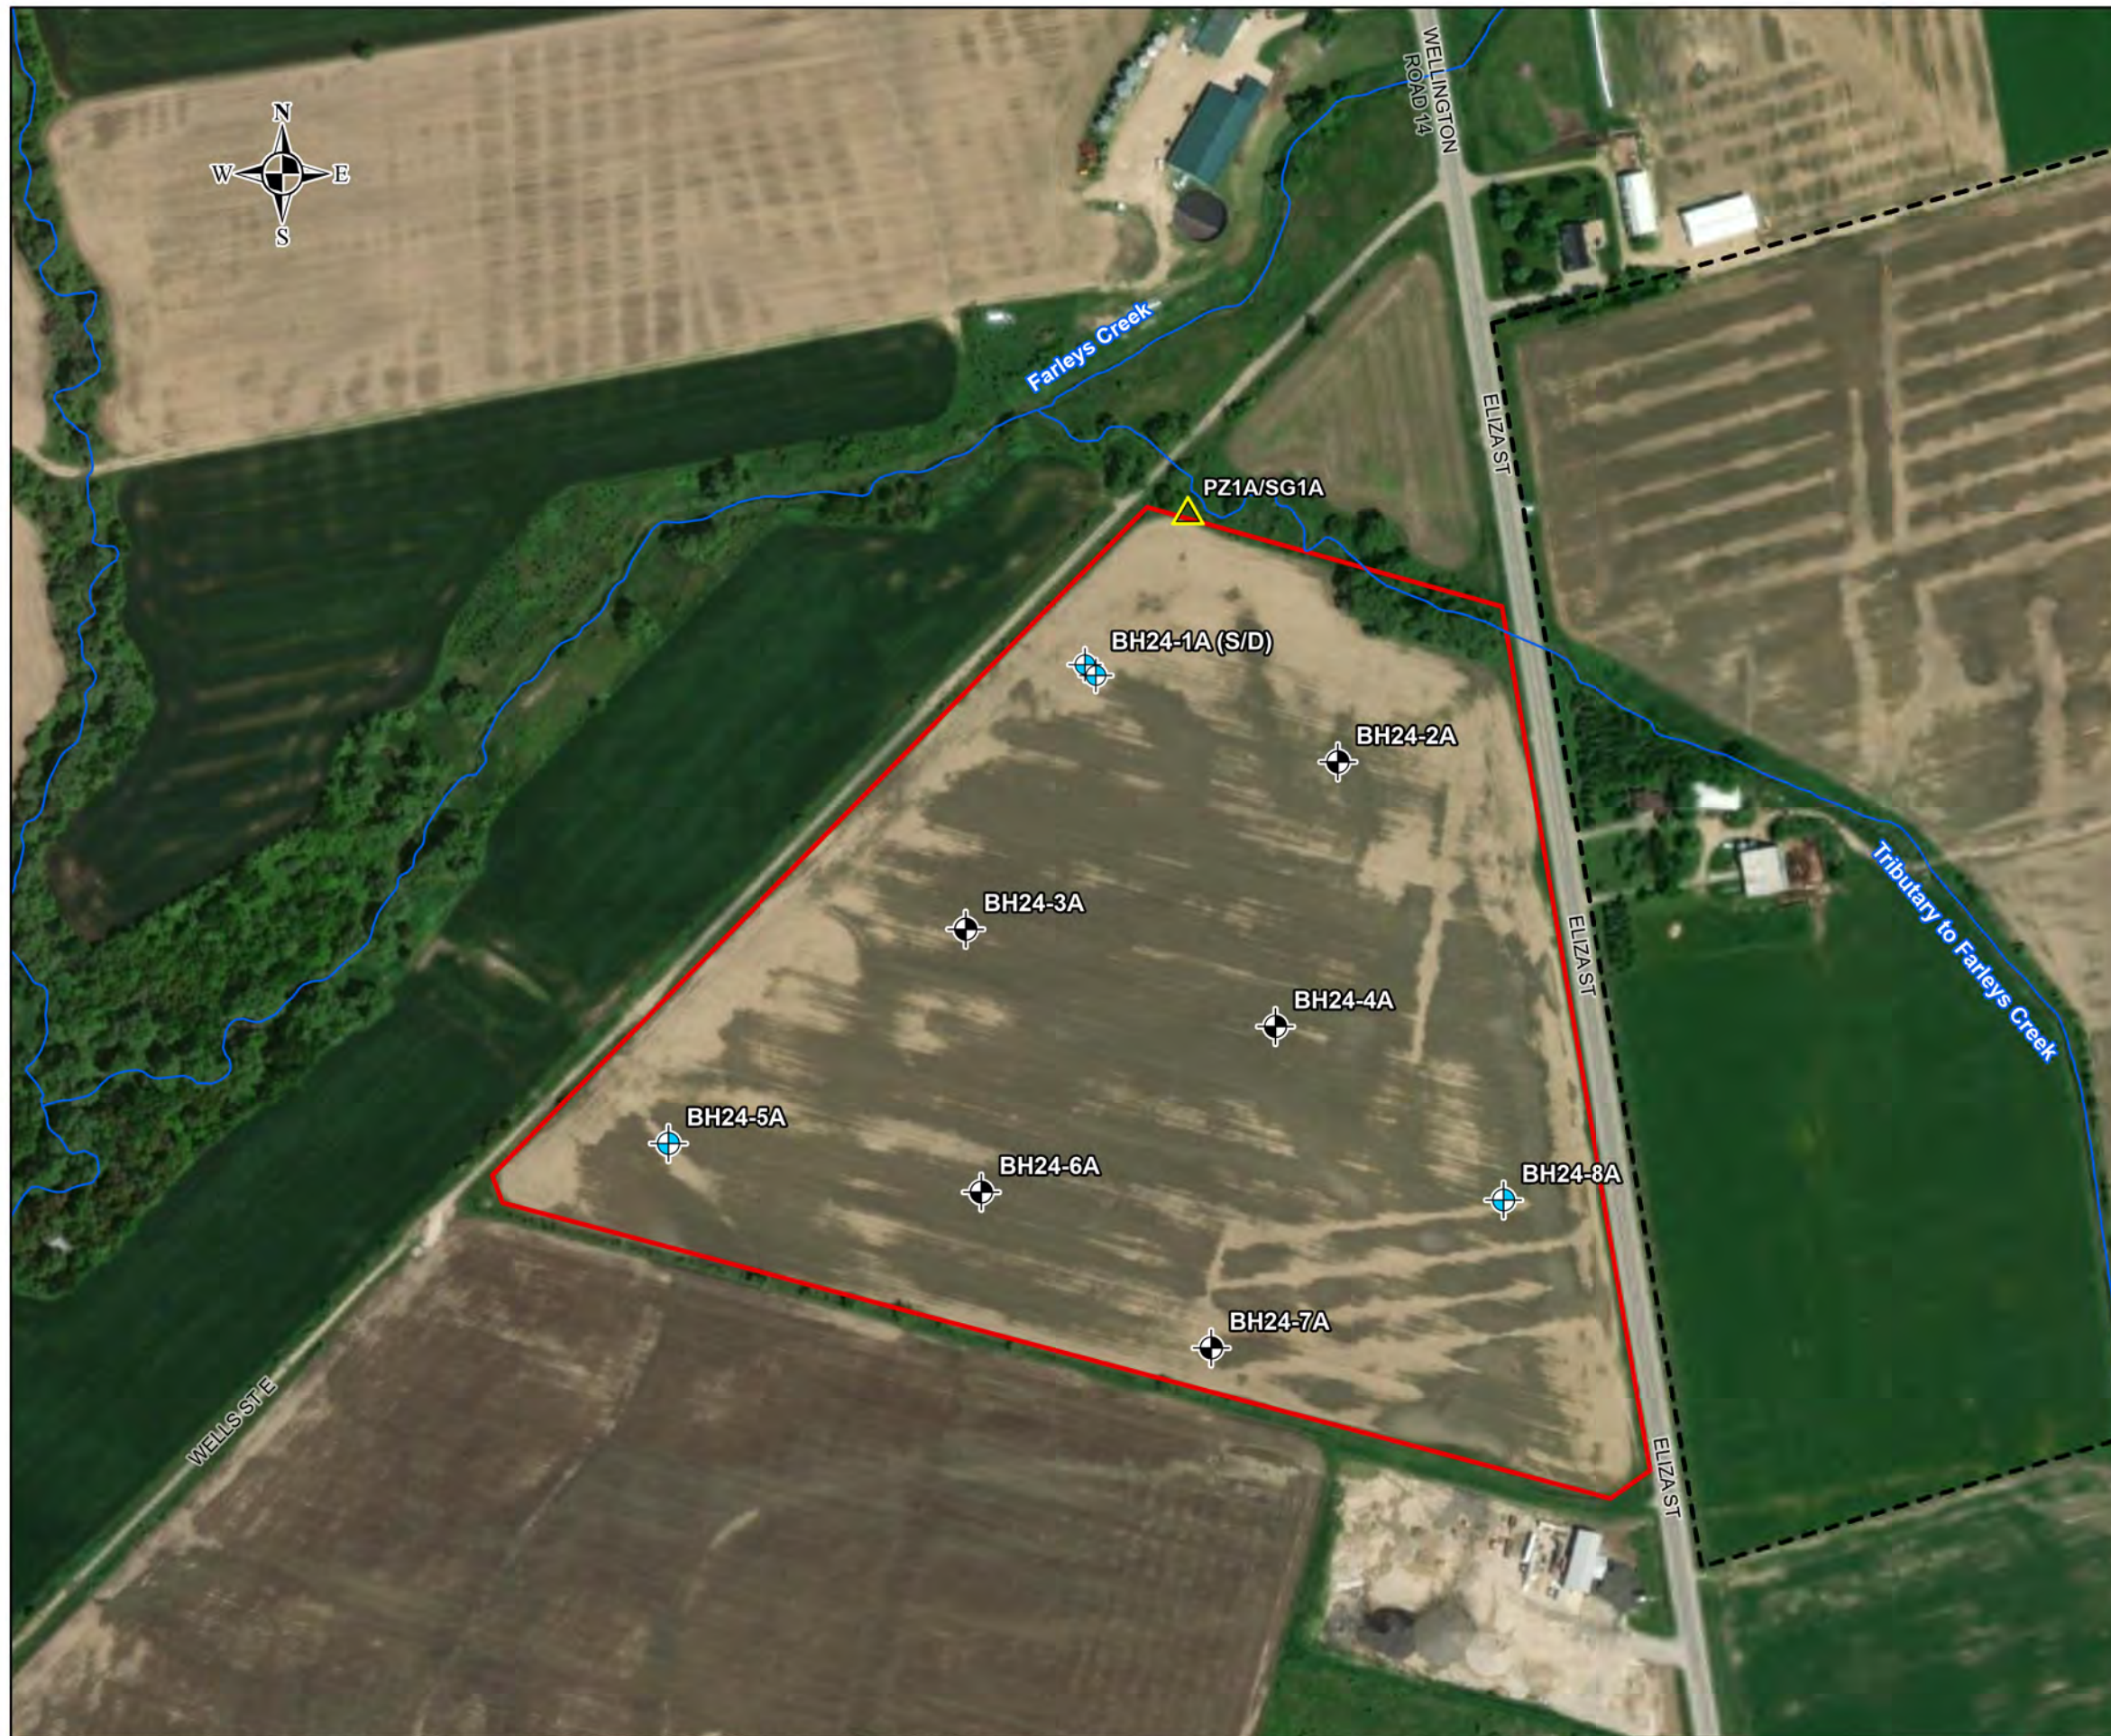
The site is located approximately 350 metres (m) to 1,000 m south of Line 2 and west of Eliza Street in Arthur, Ontario, with an approximate area of 18.4 hectares (ha). The land use at the site is predominantly agricultural with a watercourse (tributary to Farleys Creek) running past the northern portion of the site. The approximate site location and boundaries are shown on Figure 1, Site Plan, attached.
