# WELLINGTON COUNTY

**Blatchford Bridge**  
**B032085**  
**2025 OSIM Inspection**  
Wellington Road 32  
0.80 km S of Wellington Road 124

Structure\_ID: B032085  
 MTO Site Number: 35-343  
 BCI: 61.67

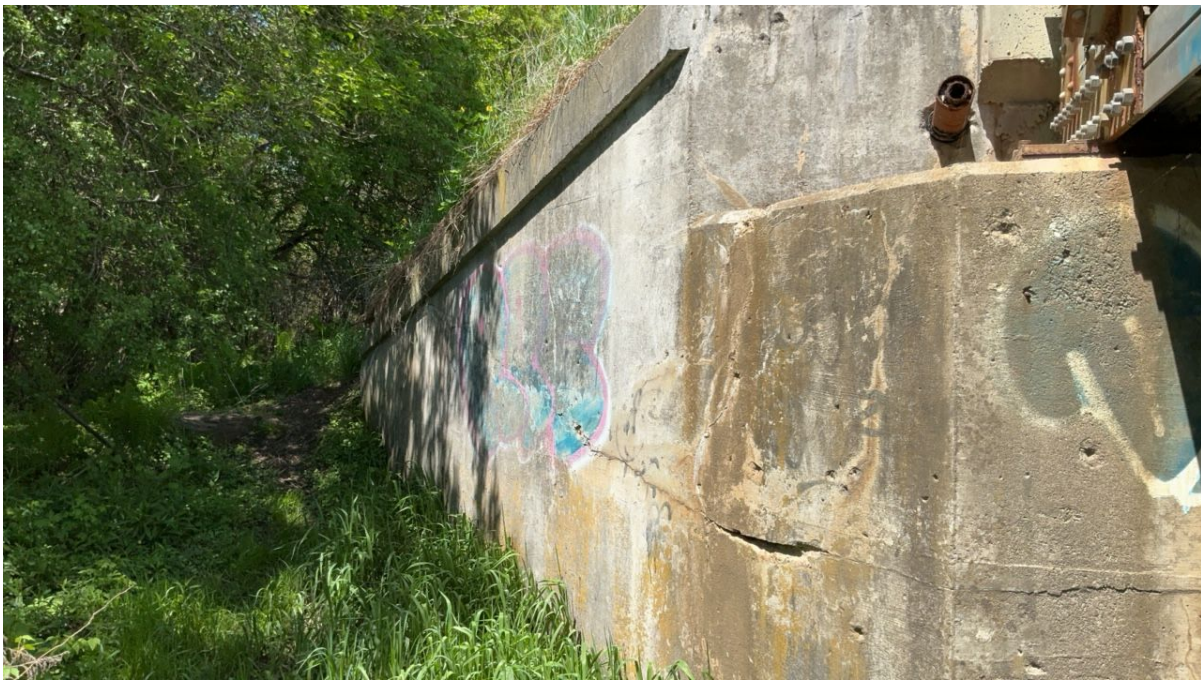
*NW wingwall.*

| Comments: | | Medium scaling, spalling, delamination and map cracks with efflorescence at SW, spalling, delamination and cracks with efflorescence at NW, horizontal cracking and scaling at SW, scaling and spall at NE. | | | | |

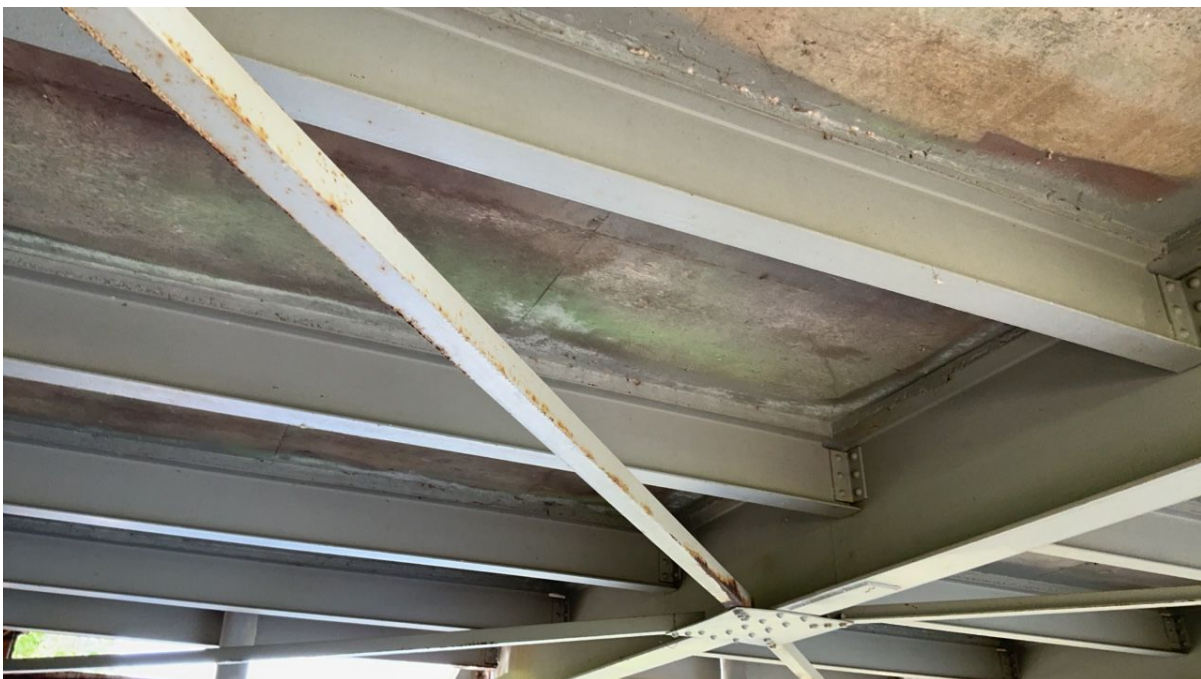
*Typical stringers.*

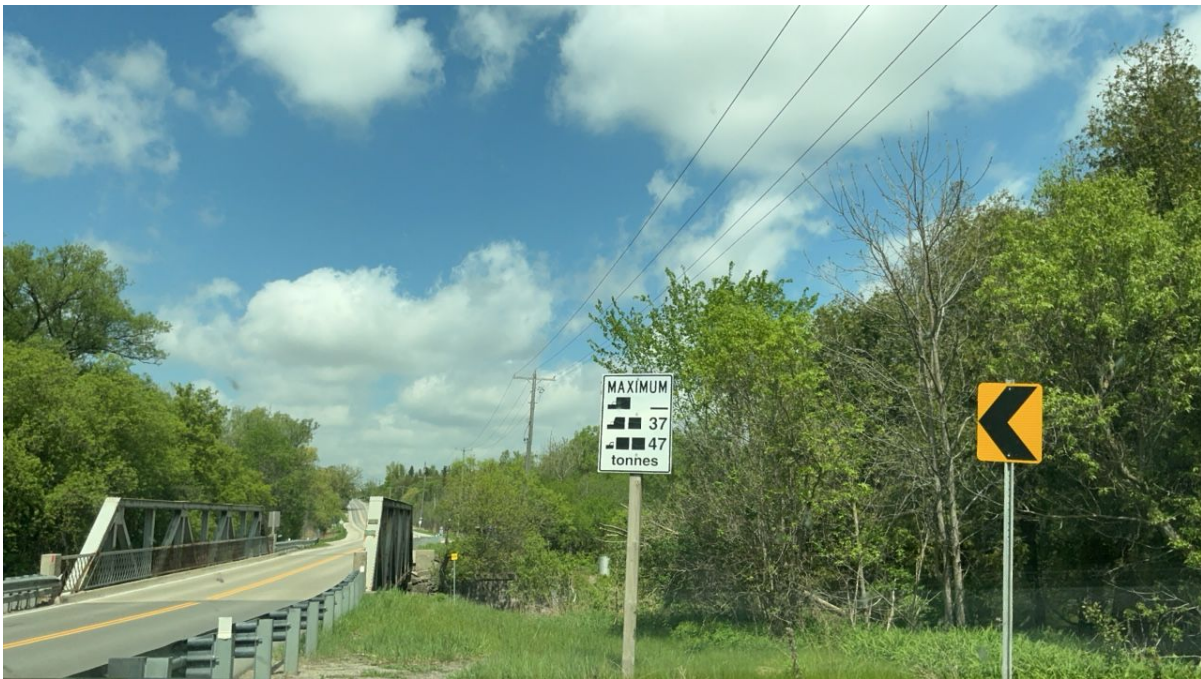
*Load restriction sign.*

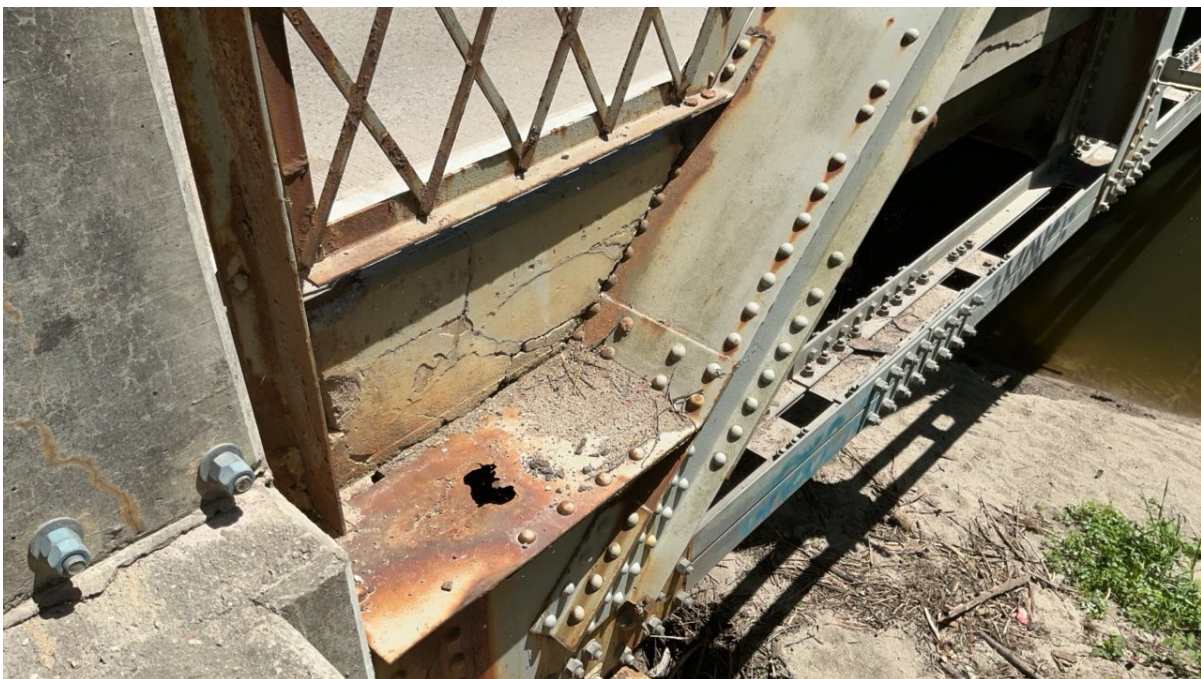
| Comments: | | Rust staining at connection plates, light to medium corrosion at soffit connections, perforation at NE end floor beams,, | | | | | |

*NW end perforations.*

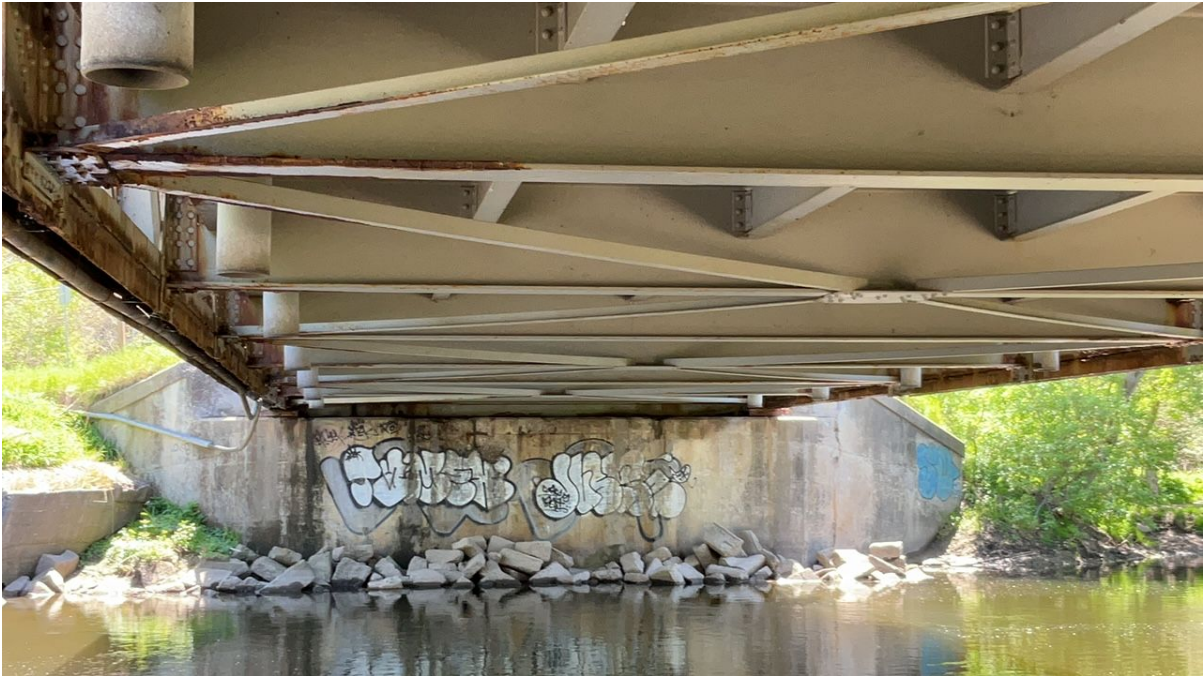
*South abutment.*

| Comments: | | Large spall with exposed rebars at South abutment, spall with exposed rebar at East end of South ballast wall, light scaling on North abutment, spall near NE bearing, narrow horizontal crack along North abutment. | | | | |

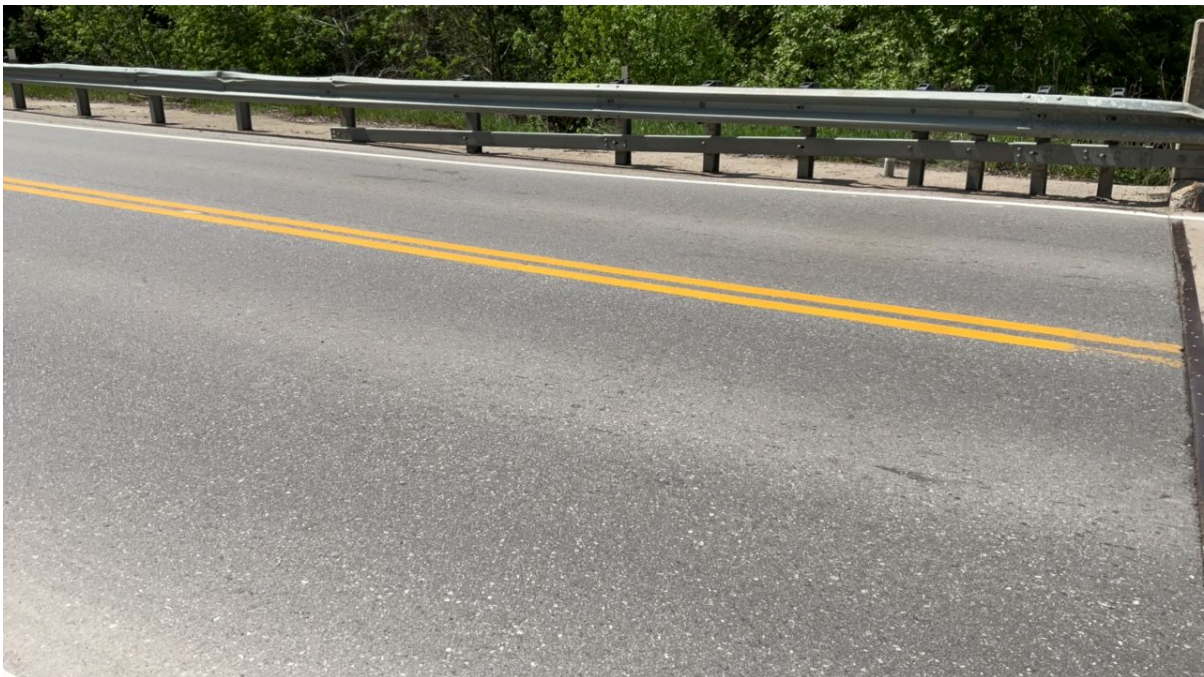
*South approach.*

| Comments: | | Transverse alligator cracks at end of South approach. | | | | |

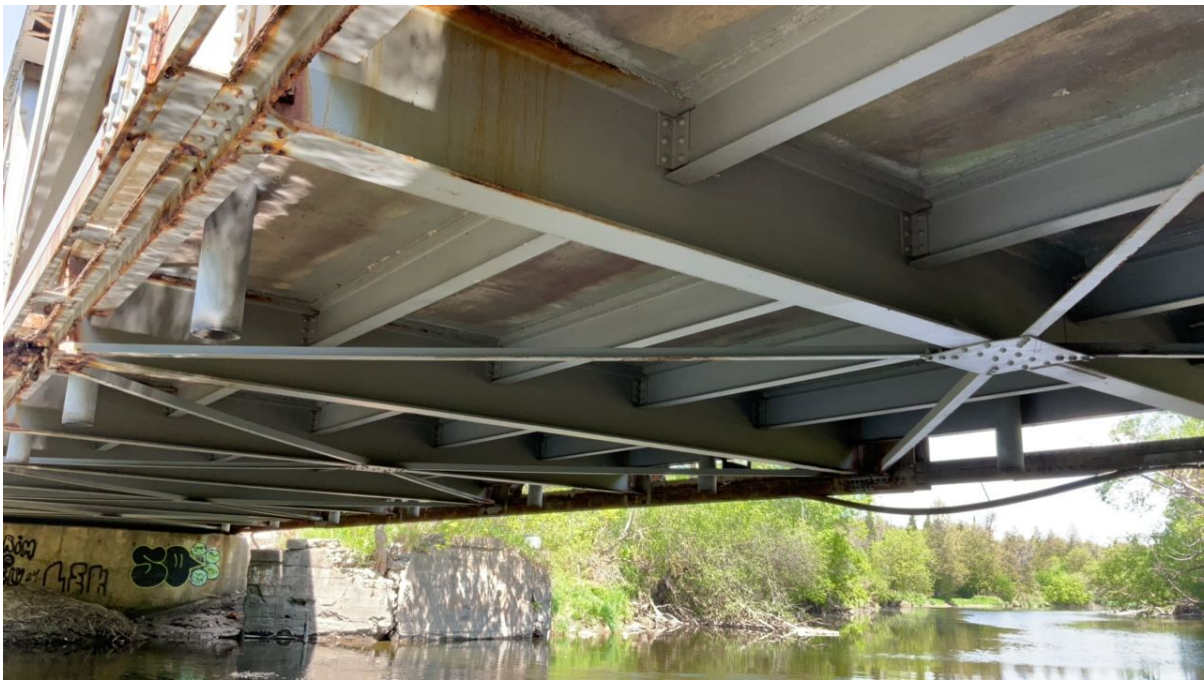
*South stringers.*

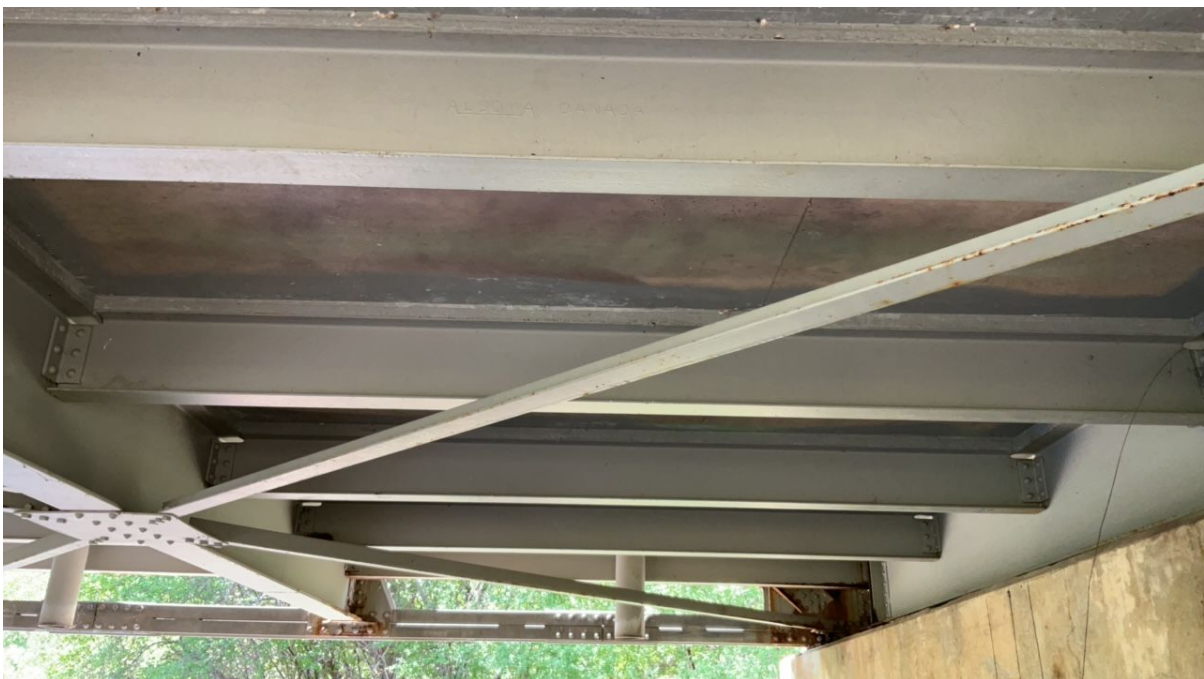
*South stringers middle.*

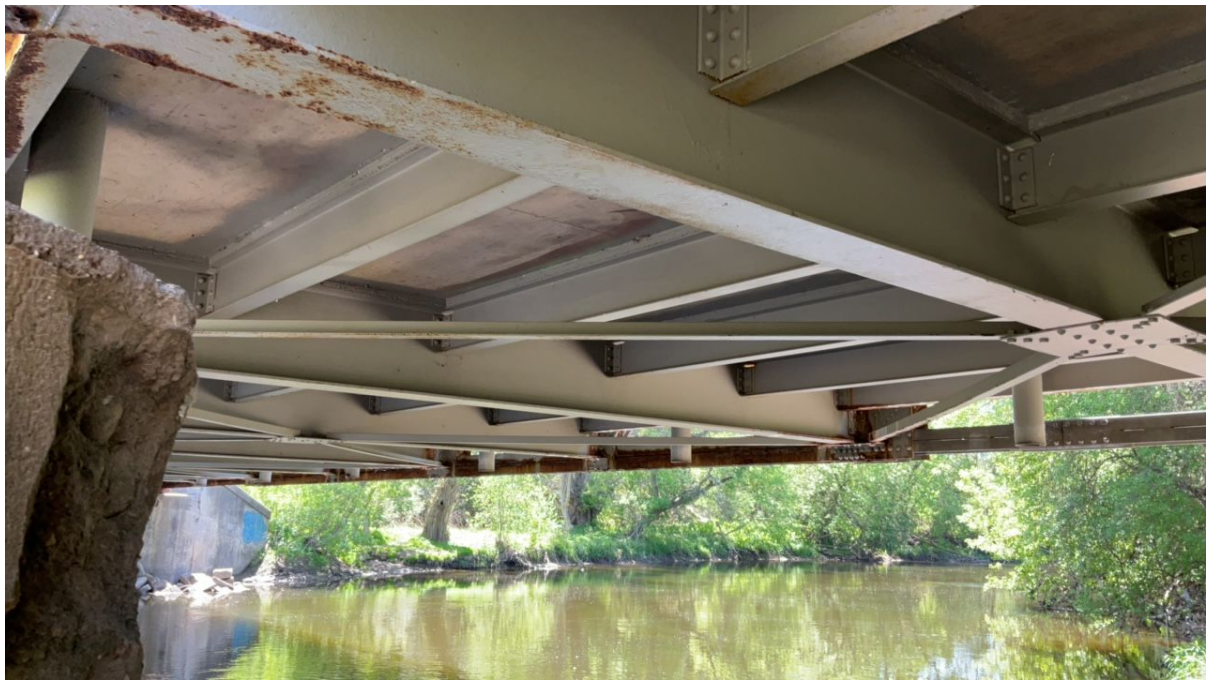
*North stringers.*

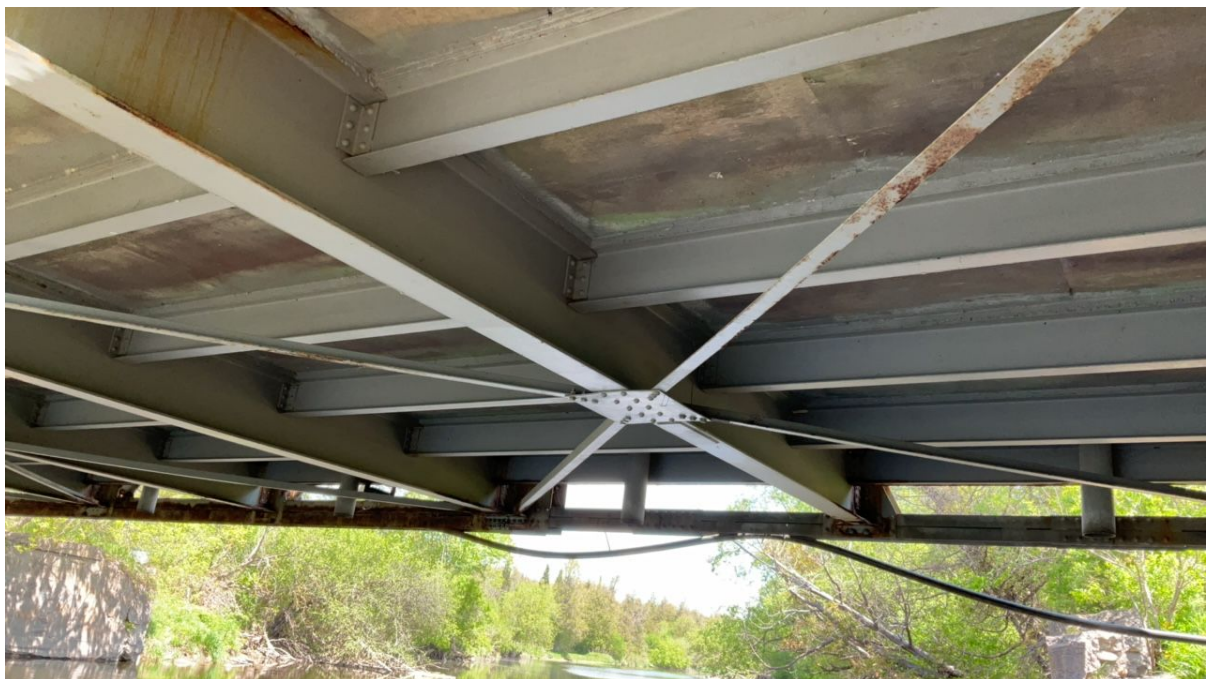
*North stringers middle.*

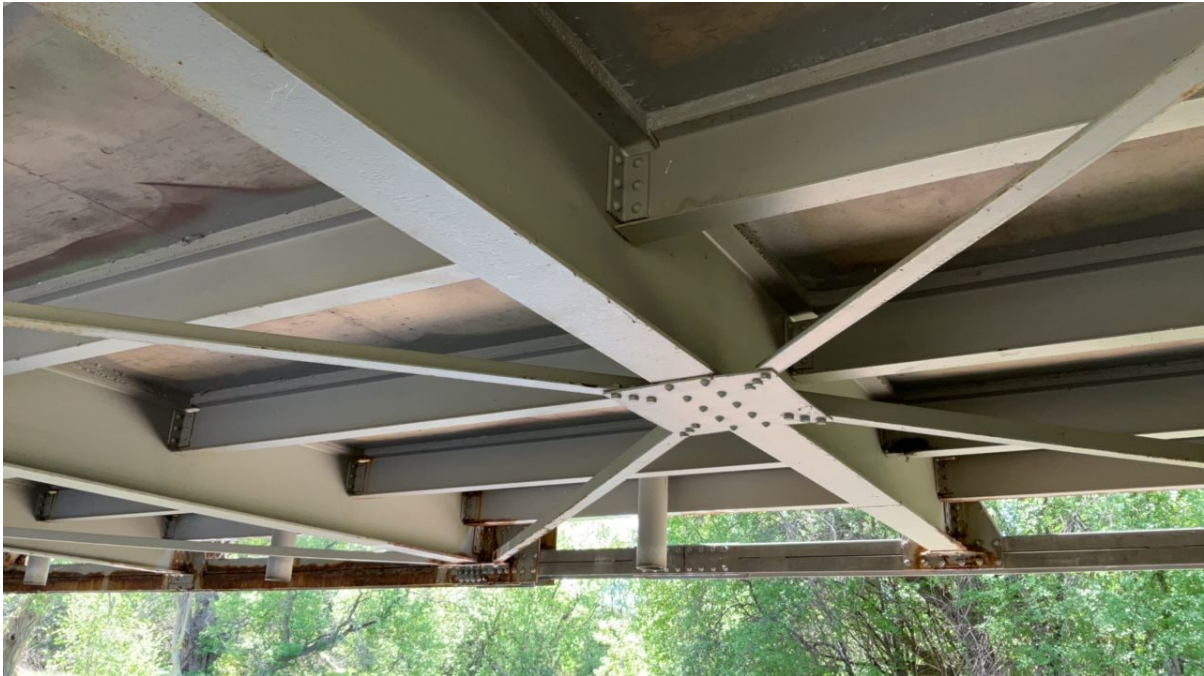
*South bracing middle.*

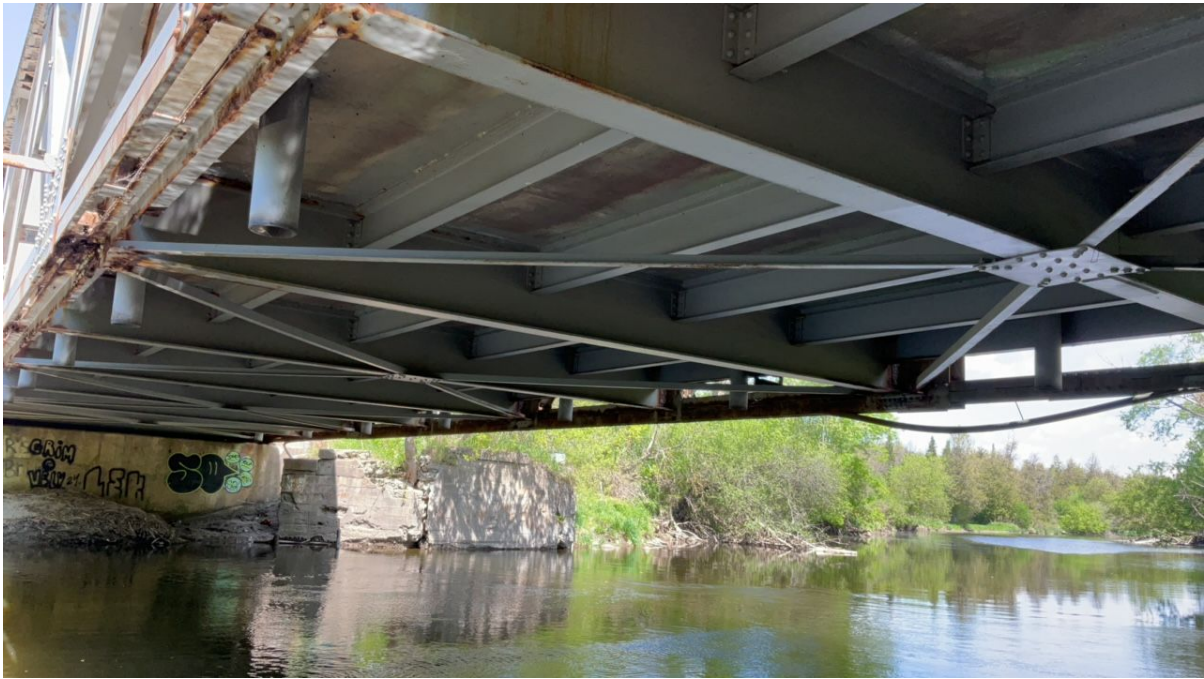
*East exterior soffit.*

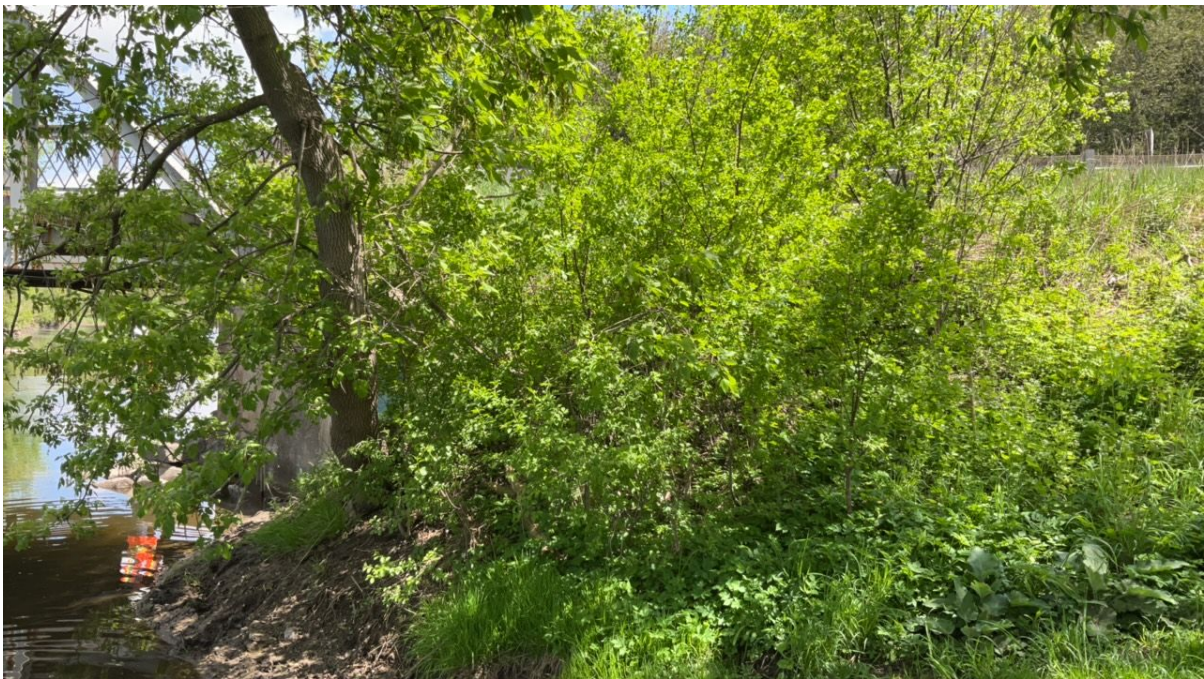
*NW embankment.*

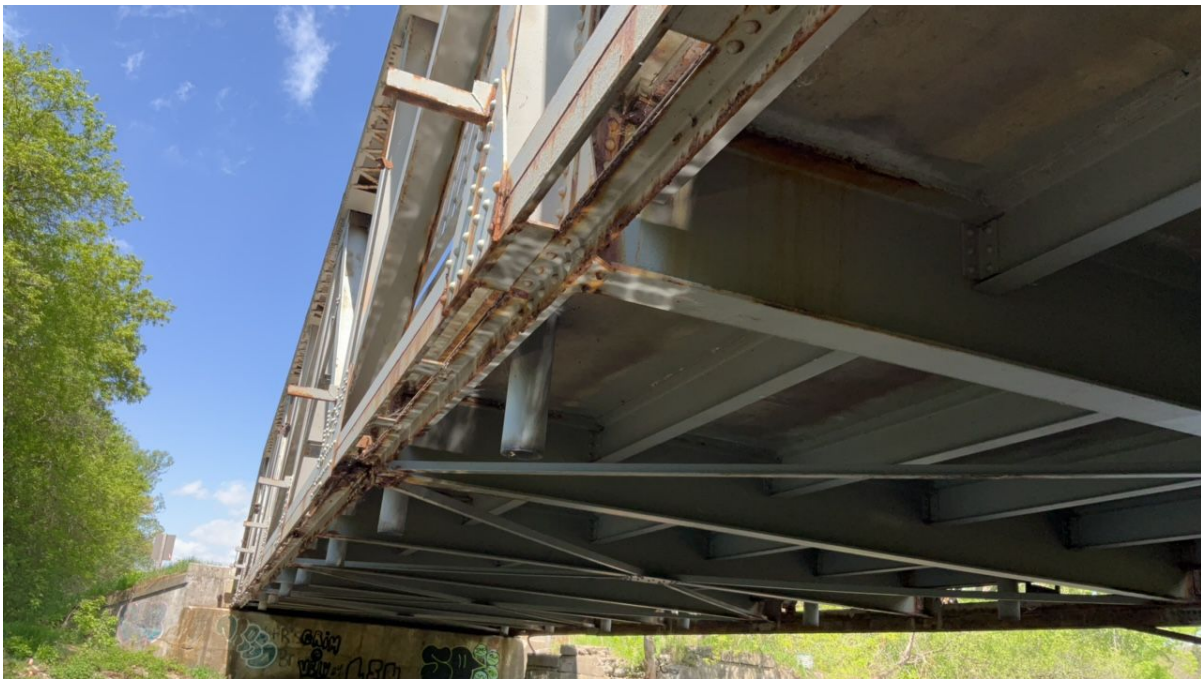
*East curb.*
